## MULTIFACTOR ASSESSMENT OF HYDRAULIC STRUCTURES IN SEISMICALLY ACTIVE ZONES: A CASE STUDY OF THE TASOTKEL RESERVOIR, REPUBLIC OF KAZAKHSTAN

**Abstract.** *This article presents a multifactor assessment of the technical condition of the Tasotkel Dam, located in the seismically active zone of southern Kazakhstan. With the increasing frequency and intensity of earthquakes in the region - including the March 28, 2025, earthquake near the village of Merke in the Zhambyl region - there is a growing need for a systematic approach to evaluating the seismic safety of hydraulic structures. The investigation employed a range of modern techniques, including visual inspection, instrumental monitoring, geodetic surveying, non-destructive testing of concrete structures, as well as laboratory and in-situ analysis of the physical and mechanical properties of the dam body and its foundation soils. The assessment revealed localized defects in the facing, signs of erosion, reduced piezometric levels compared to design values, and high filtration activity of the foundation. Geodetic data confirmed the absence of critical deformations but identified areas of potential instability. Based on the collec

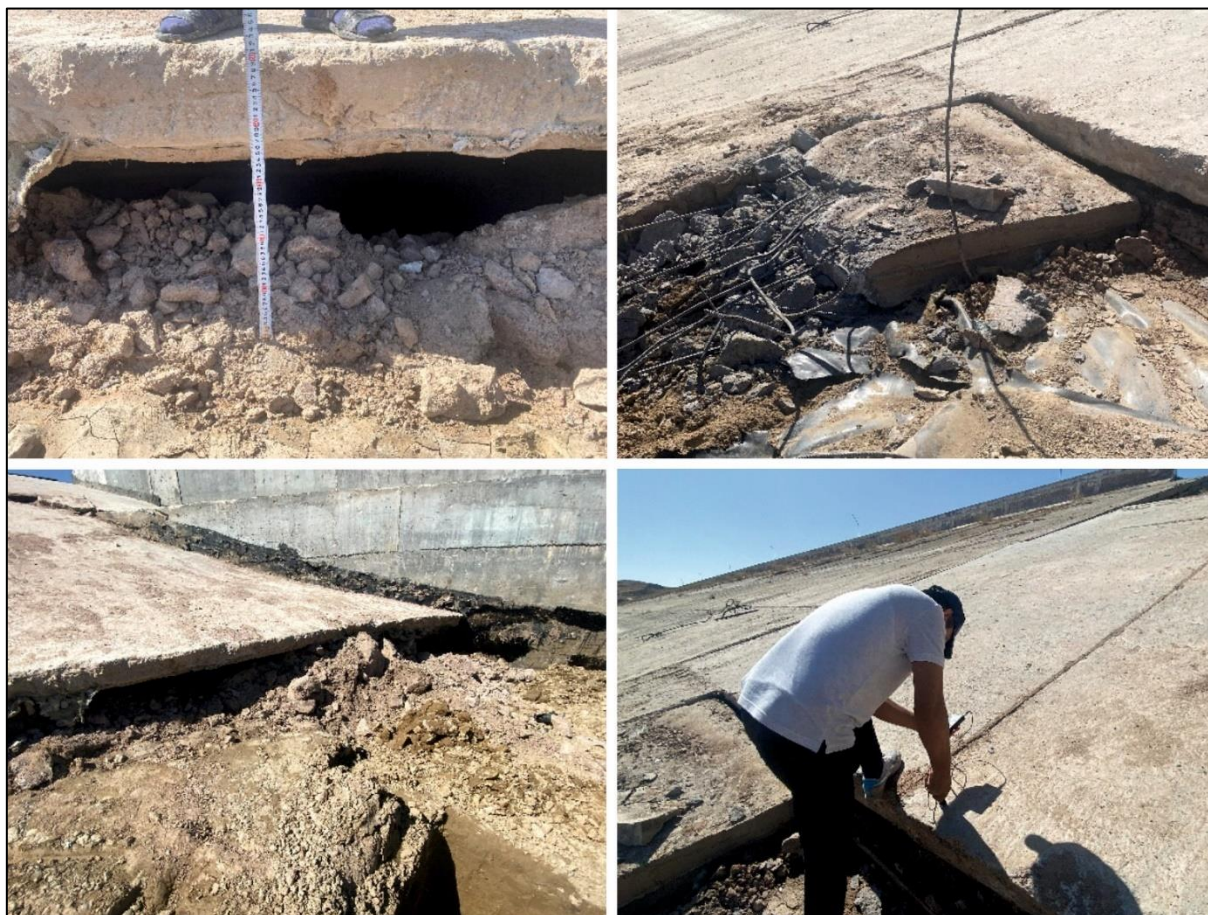
**Figure 3** – Inspection Fragments

During the inspection, two local sections of damaged facing were identified, accompanied by soil washout to a depth of up to 40 cm due to wind wave action. Surface displacement of the turf layer was also observed on the downstream slope.

**Figure 3** presents fragments documented during the visual and instrumental inspection of the Tasotkel Dam. The images illustrate characteristic defects in the facing slabs, areas of soil washout, and structural elements affected by surface erosion and filtration processes. This visual data confirms the necessity of implementing reconstruction measures and reinforcing specific sections of the dam.

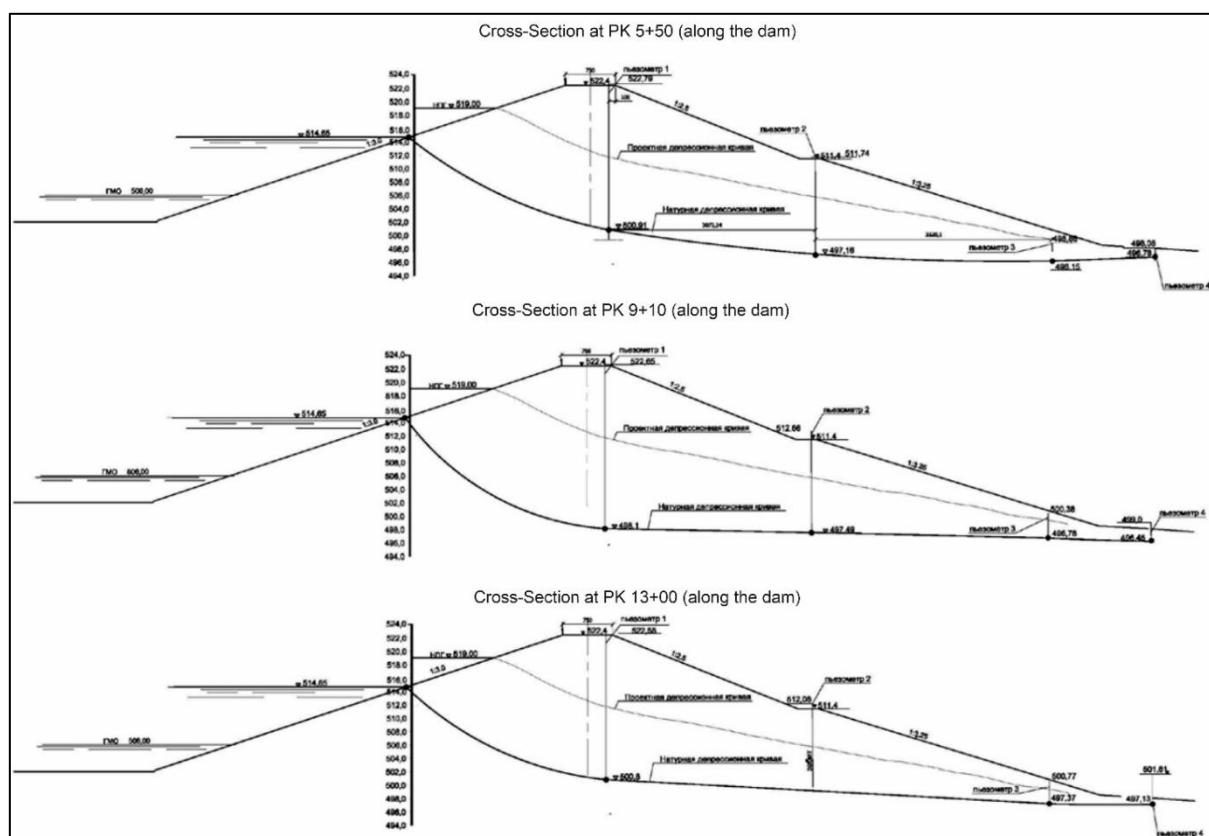
Figure 4 - Position of the Phreatic Surface

These findings indicate a high drainage capacity of foundation soils relative to the design assumptions. At the observed locations, the actual phreatic surface lies significantly lower than the projected line - by 3.1 to 7.2 meters.

Figure 4 shows the actual position of the phreatic surface at a reservoir level of 514.65 m, the expected profile at NPL 519.0 m, and the maximum allowable position of the depression curve.

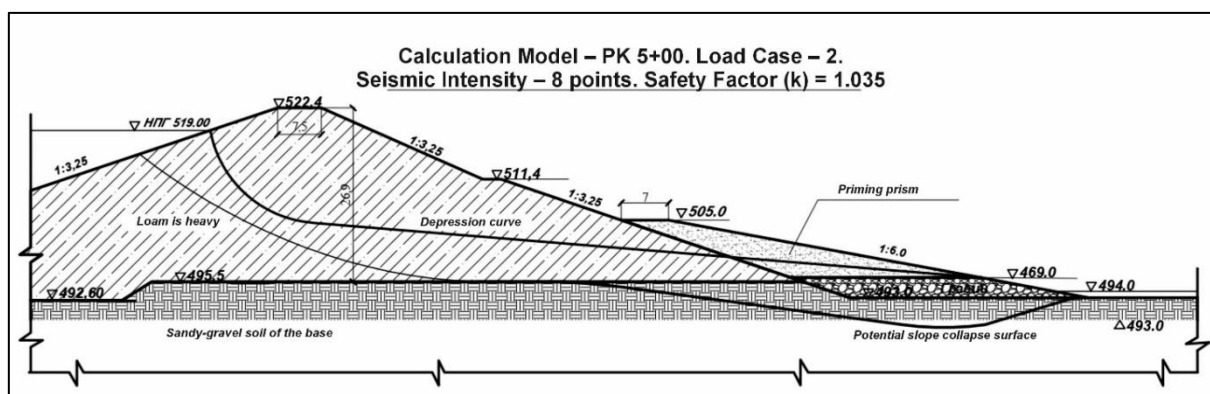
**Figure 5** - Calculation Model at Cross-Section PK 5+00

**Figure 5** shows the calculation model for cross-section PK 5+00, including the slope geometry, water levels, outlines of reconstructed sections, the phreatic line at the upstream water level of 519.0 m, and the potential failure surface under seismic loading with an intensity of 8 on the MSK scale.

- Under static conditions, the safety factor exceeded 1.5, meeting regulatory requirements;
- Under seismic conditions with an intensity of 8, the safety factor ranged between 1.1 and 1.2, which is within acceptable limits and confirms the adequacy of the proposed stabilization measures.

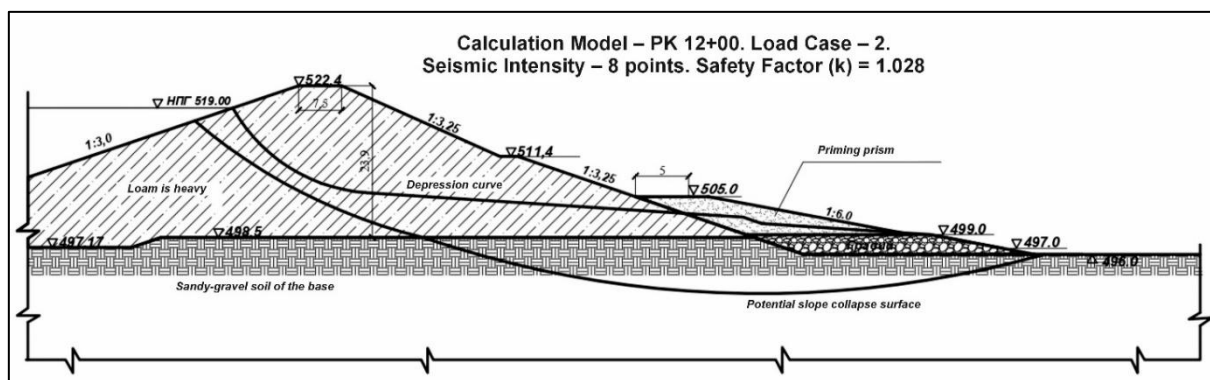
**Figure 6** - Calculation Model at Cross-Section PK 12+00

**Figure 6** presents the corresponding model for cross-section PK 12+00, used for evaluating slope stability following the implementation of reinforcement and reconstruction measures. In both cases, seismic conditions were considered in accordance with SP RK 2.03–30–2017\* for soil type II, with a design peak ground acceleration of  $a_g = 0.279g$ .

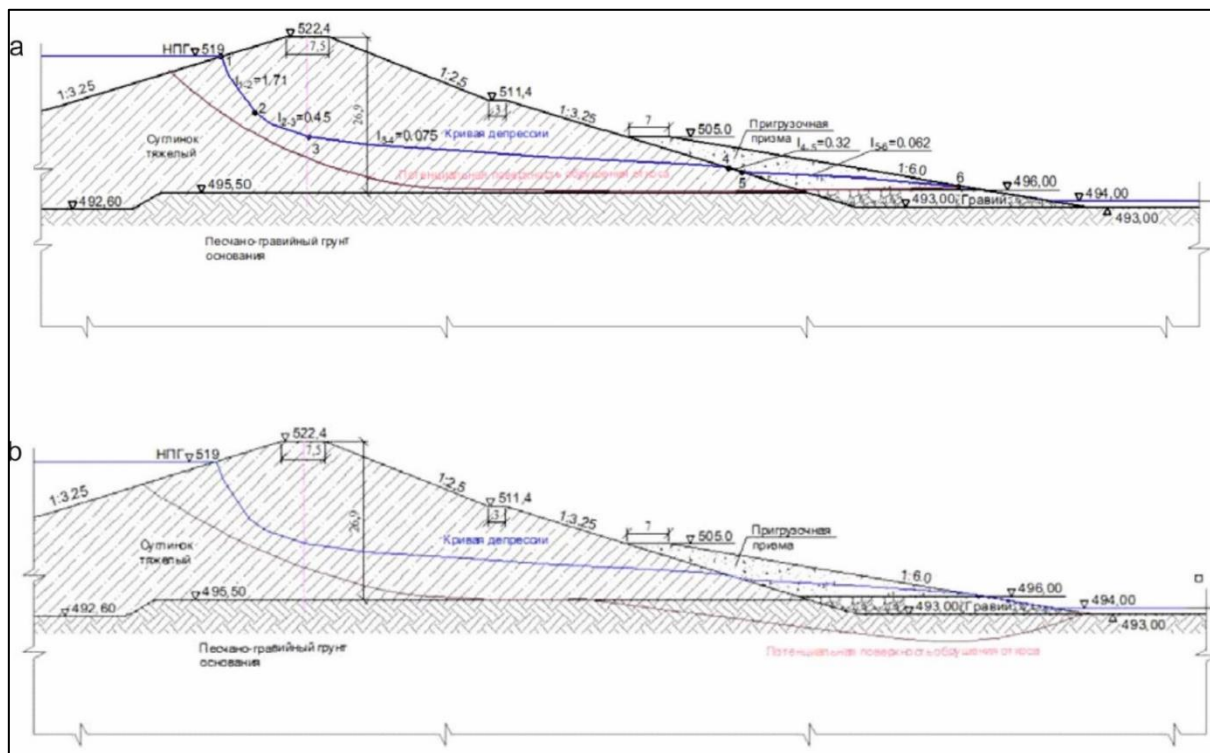
**Figure 7 – Calculation Schemes:**  
a – PK 5+00, Load Case 1, Seismic Intensity – 7 points, Safety Factor ( $k$ ) = 1.227;  
b – PK 5+00, Load Case 2, Seismic Intensity – 8 points, Safety Factor ( $k$ ) = 1.035

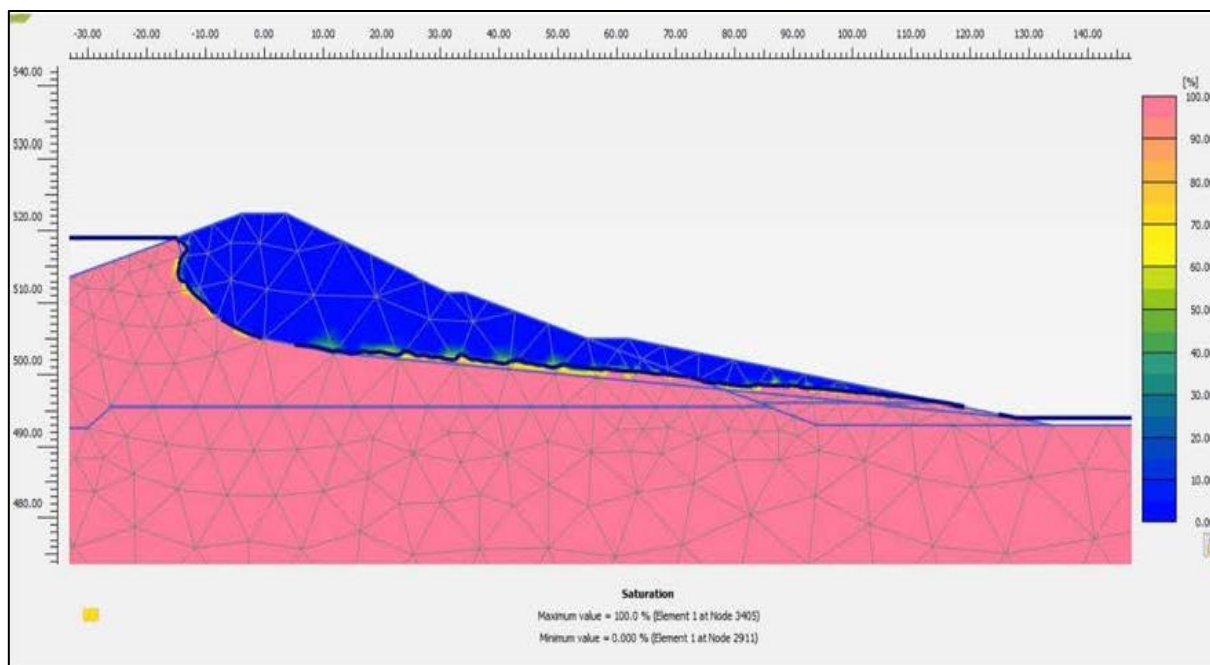
**Figure 8 – Phreatic Surface at the Upstream Water Level of 519 m**

**Figure 8** illustrates the phreatic surface position at an upstream water level of 519 m. The configuration of the seepage line allows for the assessment of hydrogeological behavior and the effectiveness of the drainage system under operational conditions.

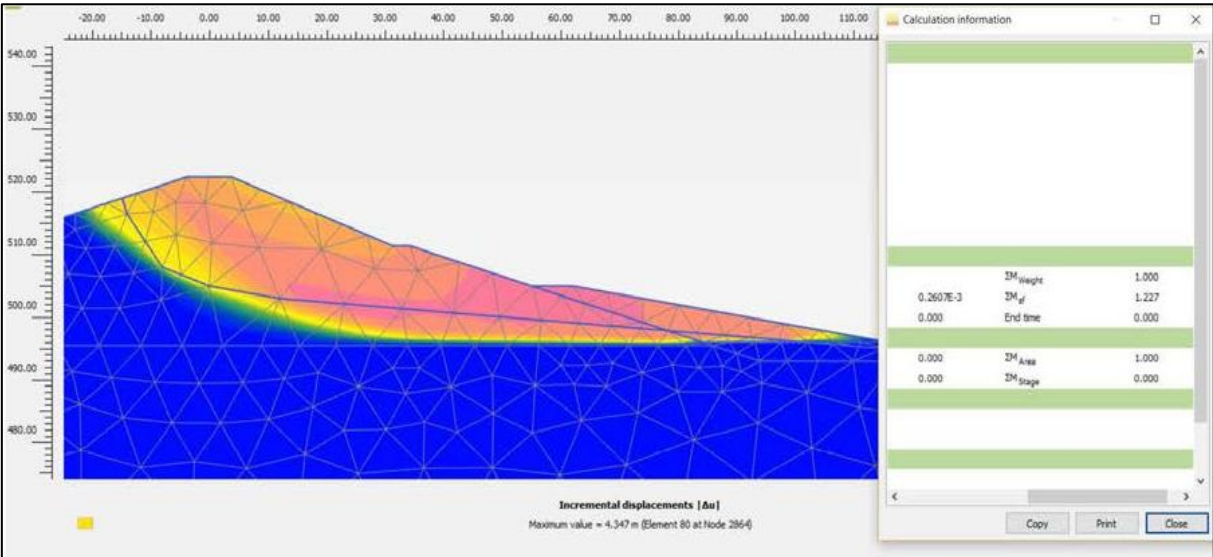
Figure 9 – Special Case 1: Potential Failure Surface of the Downstream Slope and Safety Factor

**Figures 9, 10, and 11** show three critical load cases representing the potential failure surfaces of the downstream slope under increasing seismic intensity. **Figure 9** depicts the most probable slip surface formed under moderate saturation and dynamic loading conditions. **Figure 10** highlights stress redistribution within the dam body and potential deformation development in weakened zones. **Figure 11** models a worst-case scenario involving full saturation, maximum seepage, and peak seismic intensity. In all three cases, the safety factors approach minimally acceptable values, requiring further analysis and design measures.

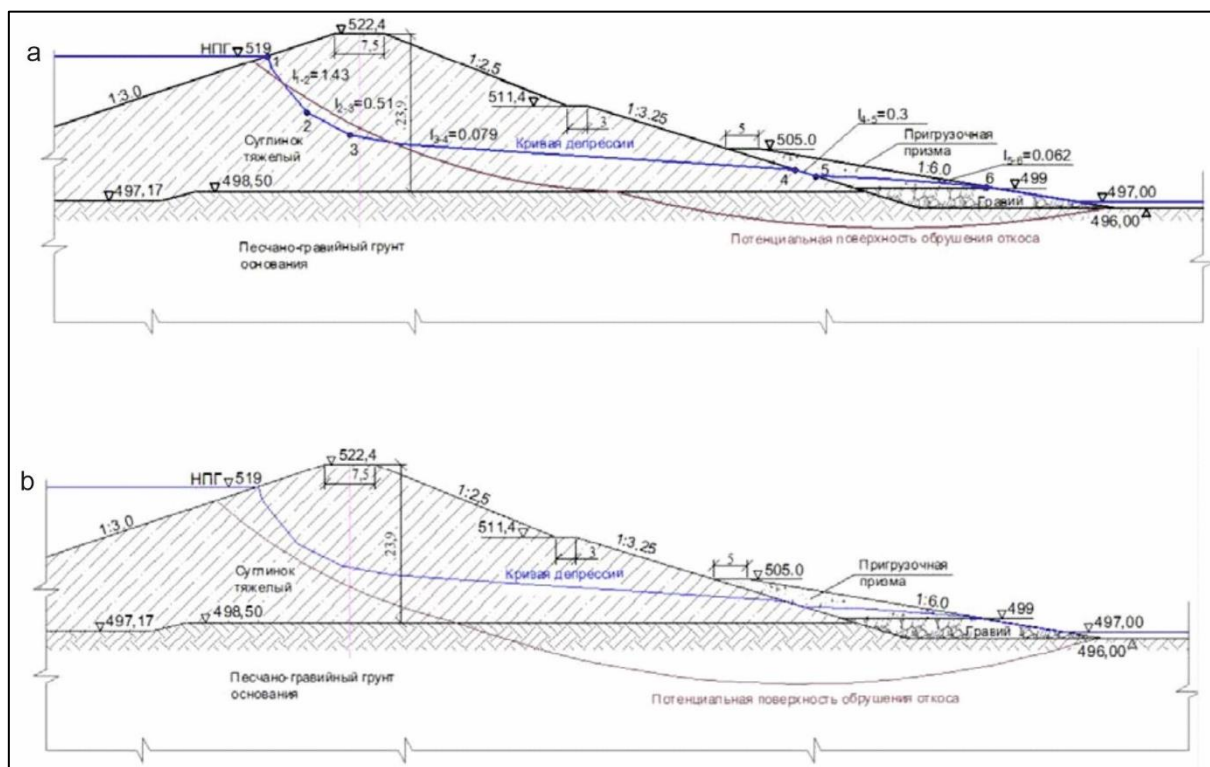
Figure 13 – Calculation Schemes:

- a – PK 12+00, Load Case 1, Seismic Intensity – 7 points, Safety Factor ( $k$ ) = 1.209;
- b – PK 5+00, Load Case 2, Seismic Intensity – 8 points, Safety Factor ( $k$ ) = 1.028

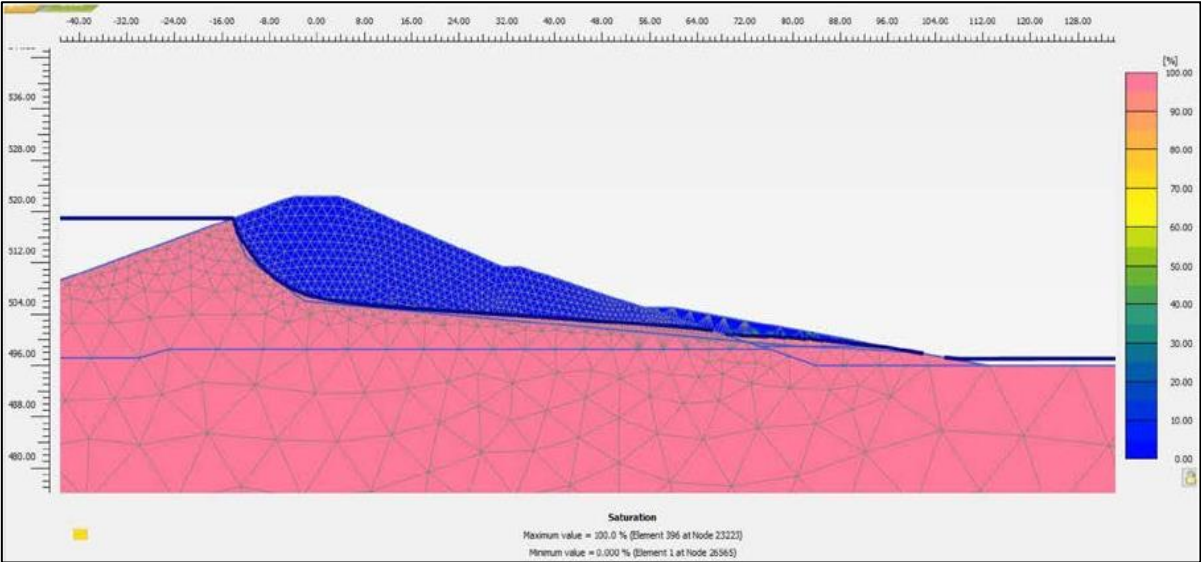
Figure 14 – Phreatic Surface at the Upstream Water Level of 519 m

**Figure 14** displays the phreatic surface for PK 12+00 at an upstream water level of 519 m. The results highlight specific features of the seepage regime and help evaluate the performance of drainage elements in this section. **Figures 15, 16, and 17** illustrate additional special seismic load cases at PK 12+00. Each model varies the saturation and seismic intensity parameters to simulate structural behavior under critical combinations of loads. The results identify areas of potential local instability, providing a foundation for future strengthening measures.

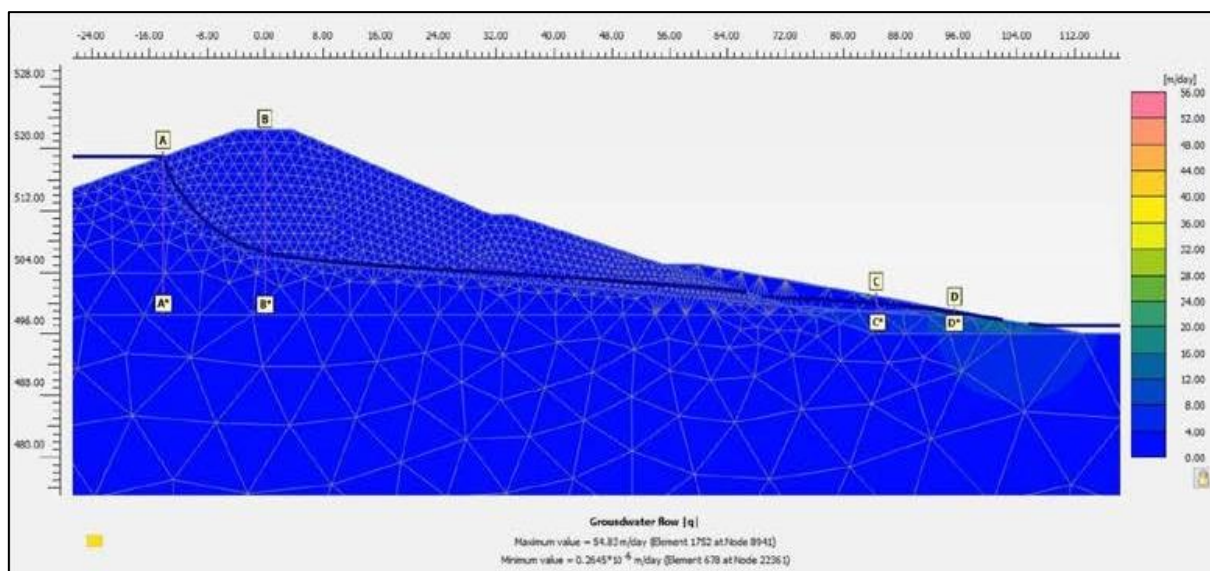
Figure 18 – Water Flow within the Dam Body at PK 12+00

**Figure 18** presents the distribution of seepage flows within the dam body at PK 12+00. The vector field helps identify zones of increased water inflow and material migration, which can impact on the structural integrity and long-term reliability of the dam.
