MULTIFACTOR ASSESSMENT OF HYDRAULIC STRUCTURES IN SEISMICALLY ACTIVE ZONES: A CASE STUDY OF THE TASOTKEL RESERVOIR, REPUBLIC OF KAZAKHSTAN

Abstract. *This article presents a multifactor assessment of the technical condition of the Tasotkel Dam, located in the seismically active zone of southern Kazakhstan. With the increasing frequency and intensity of earthquakes in the region - including the March 28, 2025, earthquake near the village of Merke in the Zhambyl region - there is a growing need for a systematic approach to evaluating the seismic safety of hydraulic structures. The investigation employed a range of modern techniques, including visual inspection, instrumental monitoring, geodetic surveying, non-destructive testing of concrete structures, as well as laboratory and in-situ analysis of the physical and mechanical properties of the dam body and its foundation soils. The assessment revealed localized defects in the facing, signs of erosion, reduced piezometric levels compared to design values, and high filtration activity of the foundation. Geodetic data confirmed the absence of critical deformations but identified areas of potential instability. Based on the collected eng

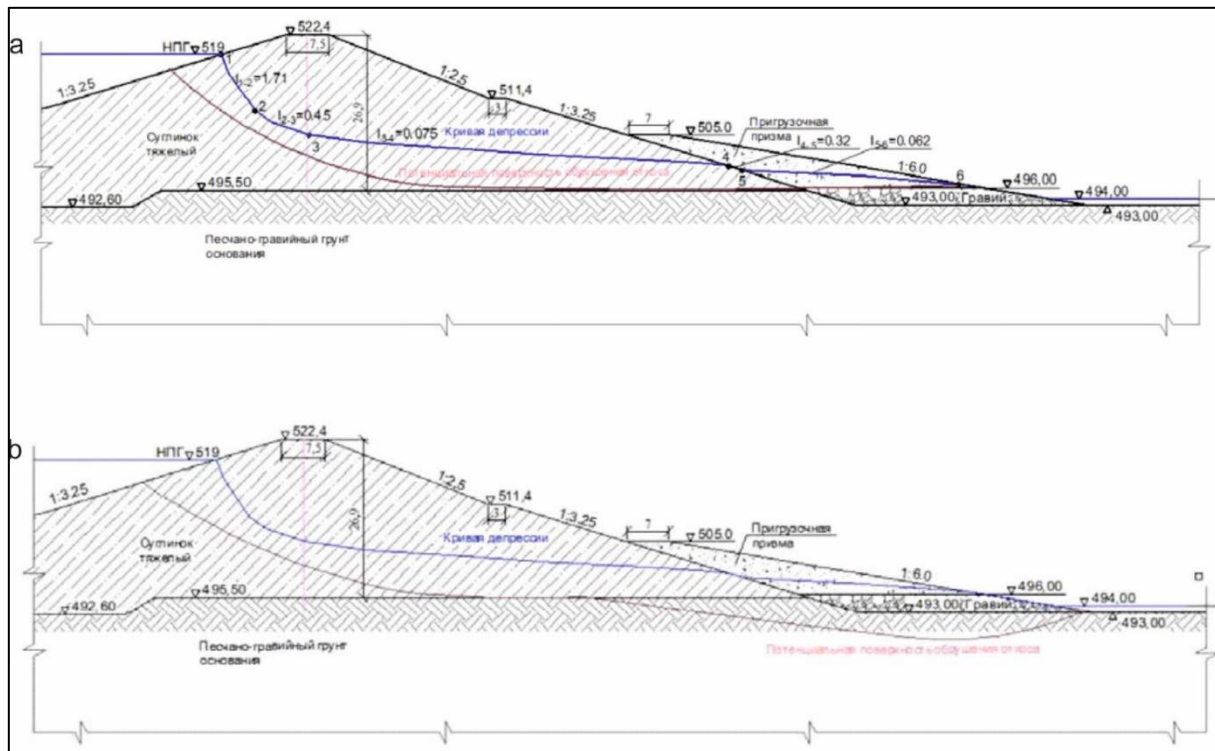
Figure 7 – Calculation Schemes:
a – PK 5+00, Load Case 1, Seismic Intensity – 7 points, Safety Factor (k) = 1.227;
b – PK 5+00, Load Case 2, Seismic Intensity – 8 points, Safety Factor (k) = 1.035

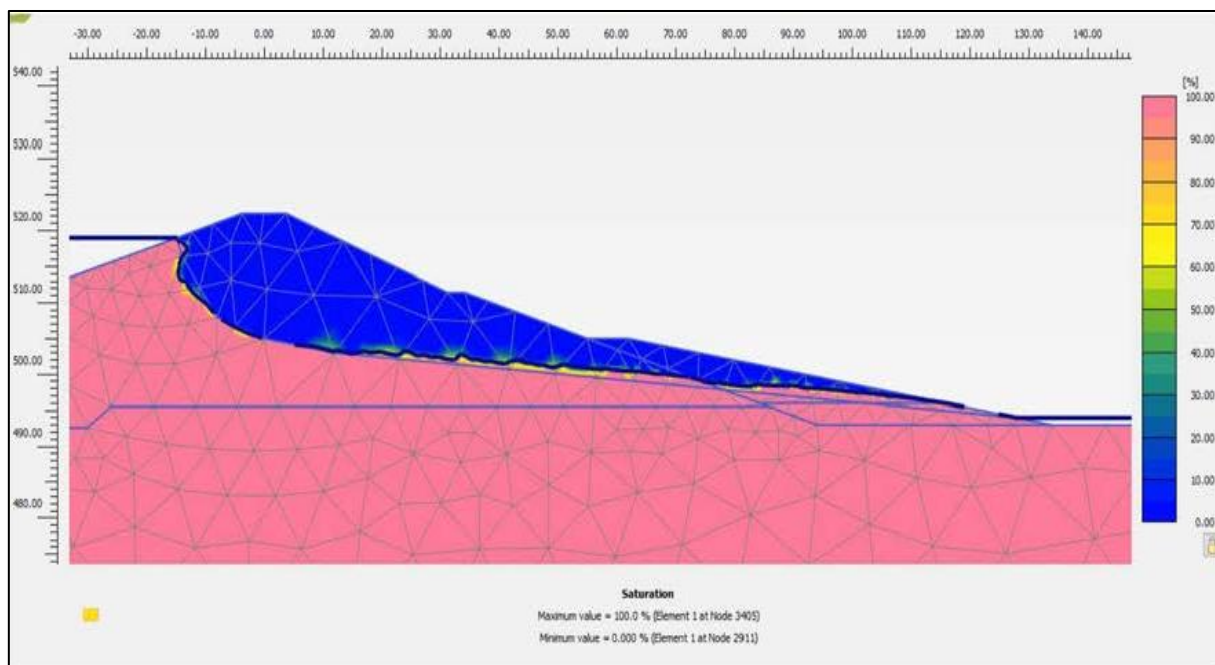
Figure 8 – Phreatic Surface at the Upstream Water Level of 519 m

Figure 8 illustrates the phreatic surface position at an upstream water level of 519 m. The configuration of the seepage line allows for the assessment of hydrogeological behavior and the effectiveness of the drainage system under operational conditions.

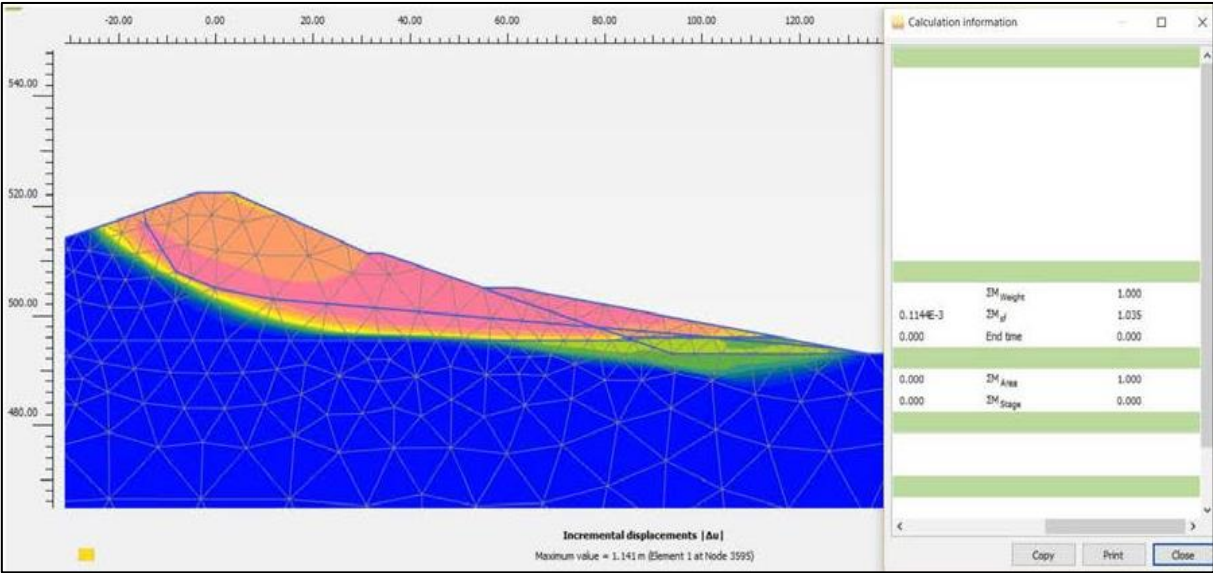
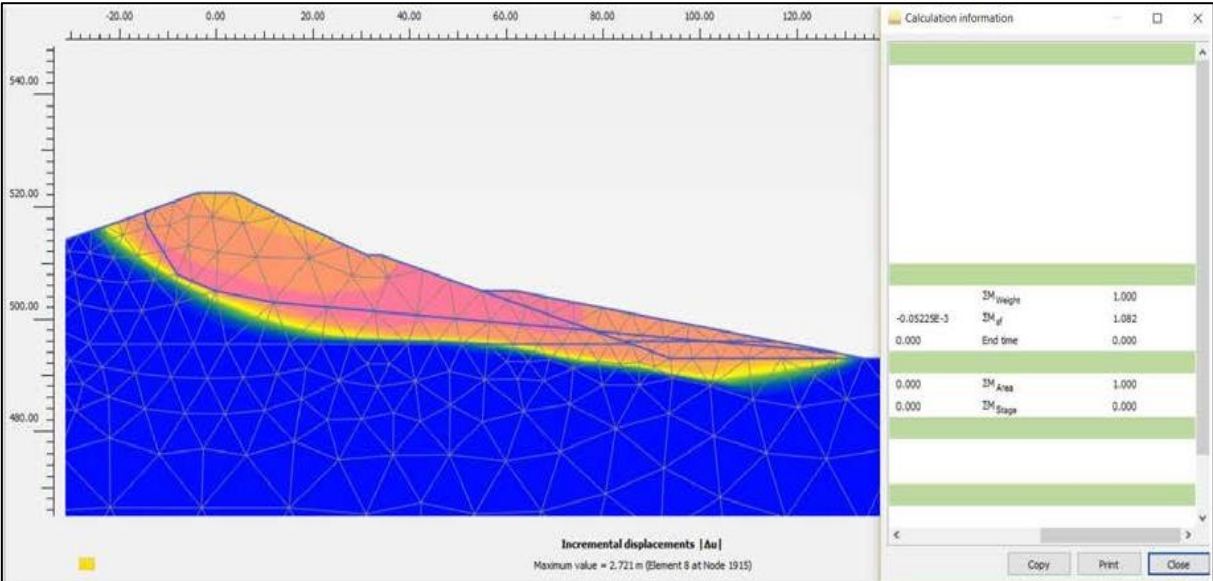
Figures 9, 10, and 11 show three critical load cases representing the potential failure surfaces of the downstream slope under increasing seismic intensity. **Figure 9** depicts the most probable slip surface formed under moderate saturation and dynamic loading conditions. **Figure 10** highlights stress redistribution within the dam body and potential deformation development in weakened zones. **Figure 11** models a worst-case scenario involving full saturation, maximum seepage, and peak seismic intensity. In all three cases, the safety factors approach minimally acceptable values, requiring further analysis and design measures.
