IMPROVING THE RELIABILITY AND EFFICIENCY OF OPERATION OF HYDRAULIC STRUCTURES OF THE ASTANA RESERVOIR THROUGH RECONSTRUCTION AND MODERNIZATION

Abstract. *This paper examines ways to improve the reliability and operational efficiency of the Astana Reservoir hydraulic structures through reconstruction and modernization. The reservoir, commissioned in 1970, is a key facility for water supply to Astana and irrigation, and its earth dam has a total length of 1,154 m and a maximum height of 32 m. The study is based on the 2023 dam safety declaration and the 2025 verification report on overall stability and seepage strength. Numerical analyses were performed in PLAXIS 2D using the finite element method, the Mohr–Coulomb model, and a strength-reduction approach for five representative cross-sections. The assessment compared the existing condition with two reconstruction scenarios: installation of an anti-filtration screen, and installation of an anti-filtration screen combined with a cement grout curtain. The results showed that, despite a generally satisfactory visual condition, the existing dam configuration has unsafe seepage behavior and critical local instability in the most unfavora

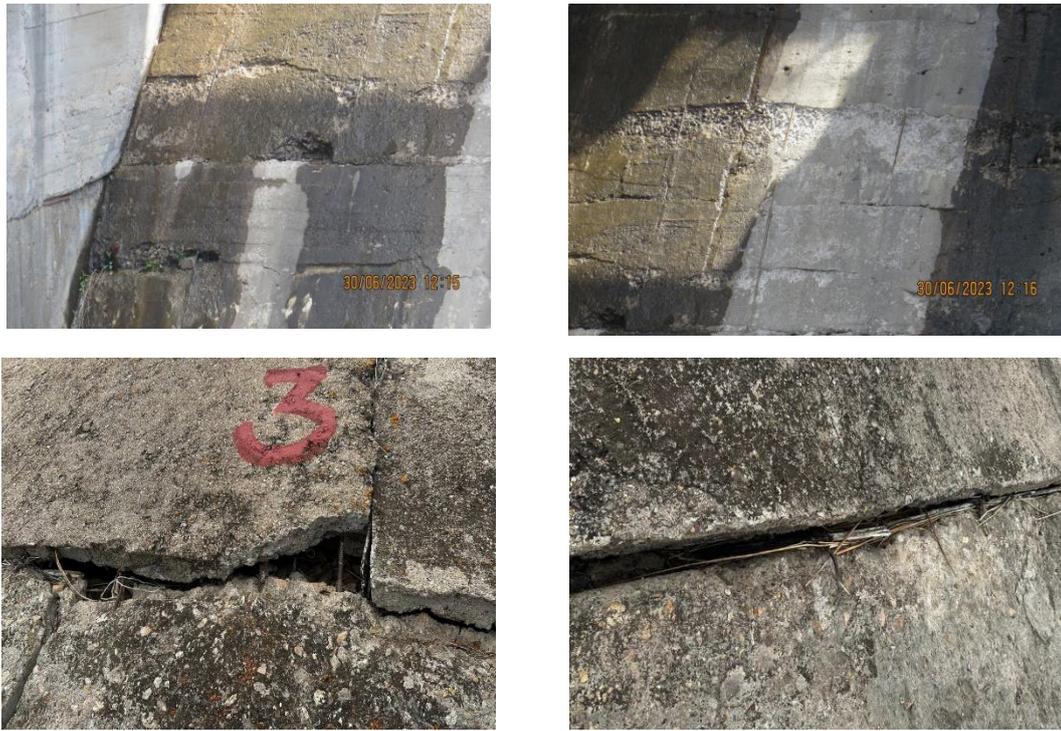
Figure 2 – Inspection fragments showing cracking and opening of joints in the deteriorated area. (author’s materials)

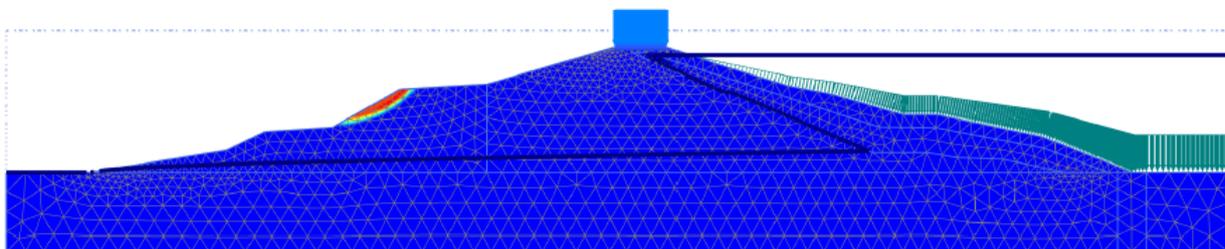
Figure 4 represents Gate 5 turned out to be the most unfavorable of all the design sections considered. For the existing position of the dam at the NPU, the minimum stability coefficients $M_{sf} = 0.3166$ for the main design case and $M_{sf} = 0.1226$ for the special case were obtained, which indicates the unsecured stability of the slope in this particular alignment. The summary results of the report also show that gate 5 is the most problematic in terms of stability among all five design sections.

Figure 4 – Gate 5. A general view of the loss of stability during FPU and AK loading. The coefficient of safety margin $M_{sf} = 1.667$. Stability is assured. (author’s materials)

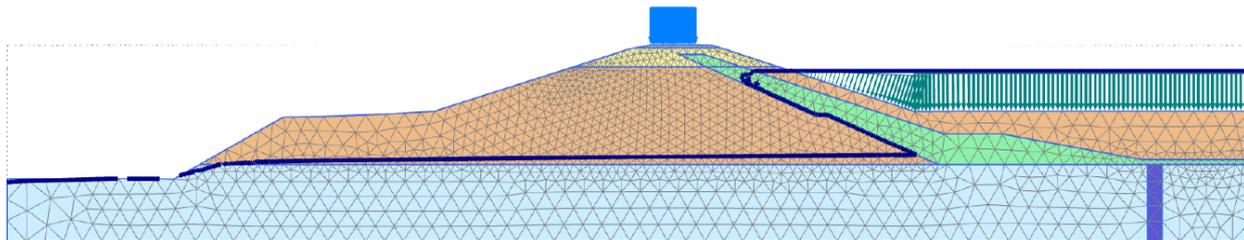
Figure 5 and 6 shows second result is the clear seepage-related mechanism behind this instability. In cross-section 5, the depression surface remains high within the dam body and exits on the downstream slope rather than penetrating deeper into the foundation. Such a configuration indicates intensive water saturation of the embankment and reduced effective stresses in the lower slope

zone. The calculated hydraulic gradient in the same section reached 0.8381 in the main case and 0.9591 in the special case, while filtration velocity in section 5 was about 9.50 m/day and the seepage discharge reached 18.49 m³/day per running meter in the main case. Across sections 3 to 5, seepage velocities were approximately 9.5–12.8 m/day and discharge values reached up to 33.94 m³/day per running meter. The report therefore concluded that seepage-strength safety was not ensured in four of the five analysed sections. Summary of key results for the critical cross-section and dam behaviour are presented in **Table 2**.

Figure 5 – Critical cross-section 5: calculated depression curve in the existing condition. (author’s materials)

The third result is that reconstruction with a clay anti-filtration screen changes the behaviour of the dam fundamentally. For cross-sections 3 to 5, the minimum stability coefficient increased to 1.680, 1.669, and 1.234 in the main design case and remained above the required level in the special case as well. Seepage velocities decreased to approximately 0.35–0.60 m/day, and the verification report explicitly states that seepage-strength safety became ensured. This is the key engineering argument for reconstruction: the screen does not simply reduce leakage, but transforms the dam from a locally unsafe seepage regime to a controlled and acceptable one (Aniskin et al., 2024; Pianosi et al., 2020).

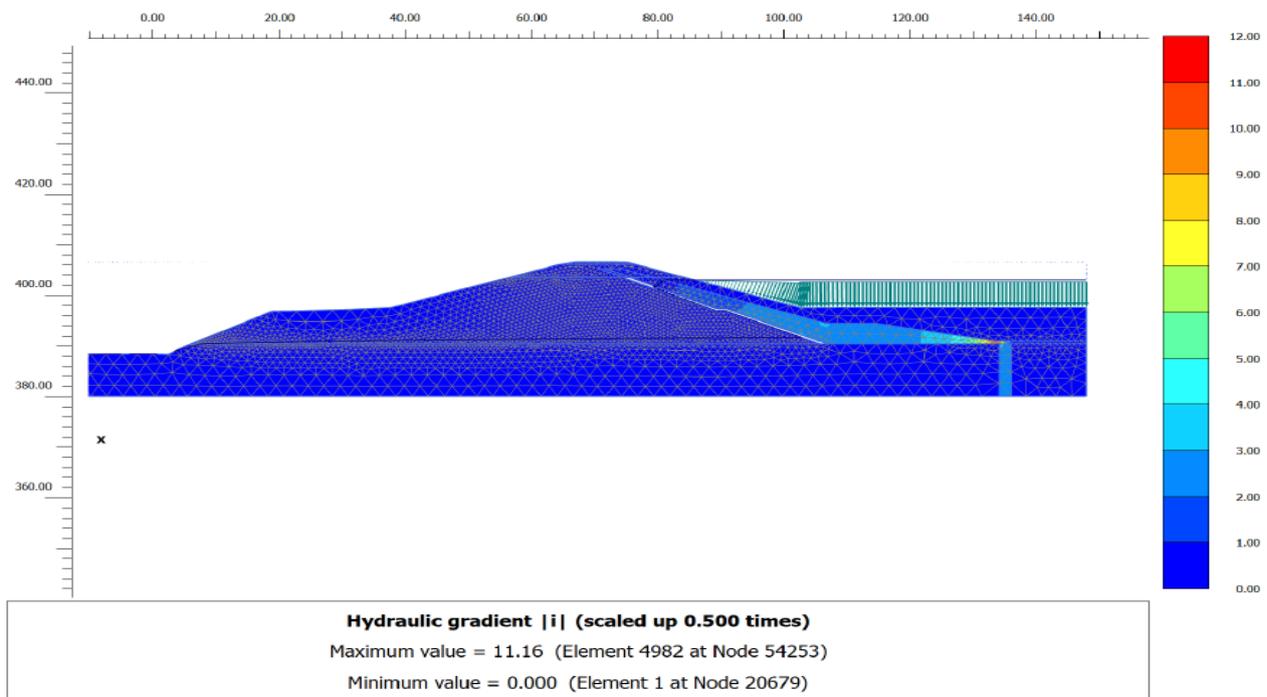
Figure 6 – Hydraulic-gradient field in critical cross-section 5 under the normal operating condition. (author’s materials)
