IMPROVING THE RELIABILITY AND EFFICIENCY OF OPERATION OF HYDRAULIC STRUCTURES OF THE ASTANA RESERVOIR THROUGH RECONSTRUCTION AND MODERNIZATION

Abstract. *This paper examines ways to improve the reliability and operational efficiency of the Astana Reservoir hydraulic structures through reconstruction and modernization. The reservoir, commissioned in 1970, is a key facility for water supply to Astana and irrigation, and its earth dam has a total length of 1,154 m and a maximum height of 32 m. The study is based on the 2023 dam safety declaration and the 2025 verification report on overall stability and seepage strength. Numerical analyses were performed in PLAXIS 2D using the finite element method, the Mohr–Coulomb model, and a strength-reduction approach for five representative cross-sections. The assessment compared the existing condition with two reconstruction scenarios: installation of an anti-filtration screen, and installation of an anti-filtration screen combined with a cement grout curtain. The results showed that, despite a generally satisfactory visual condition, the existing dam configuration has unsafe seepage behavior and critical local instability in the most unfavora

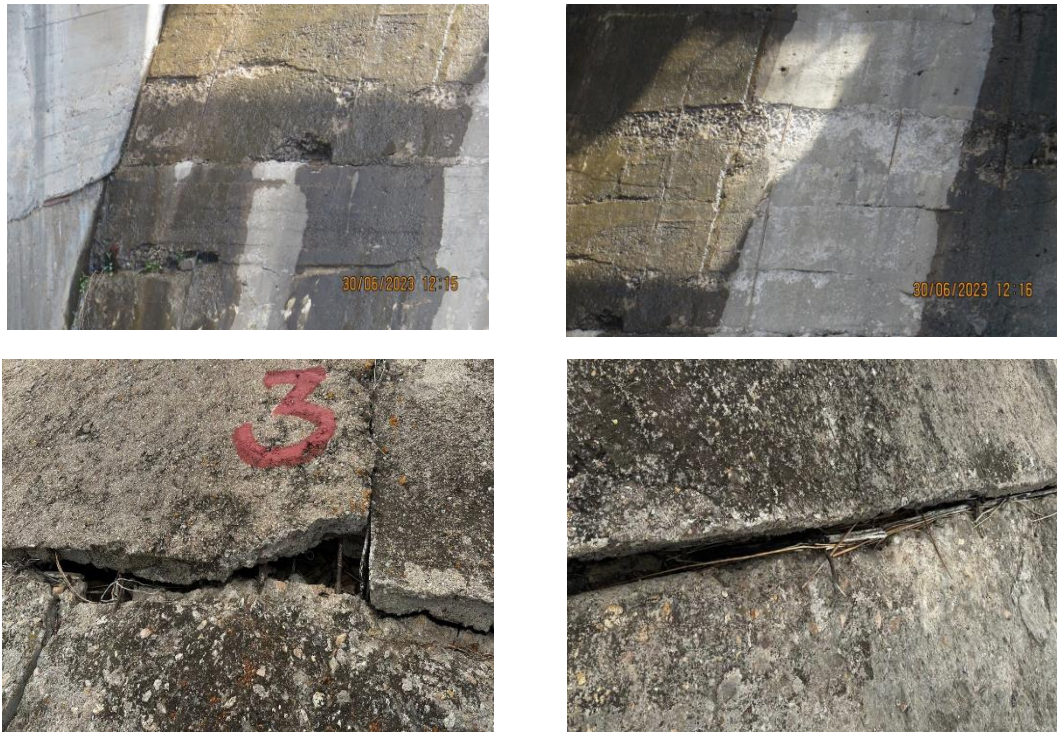
Figure 2 – Inspection fragments showing cracking and opening of joints in the deteriorated area. (author’s materials)

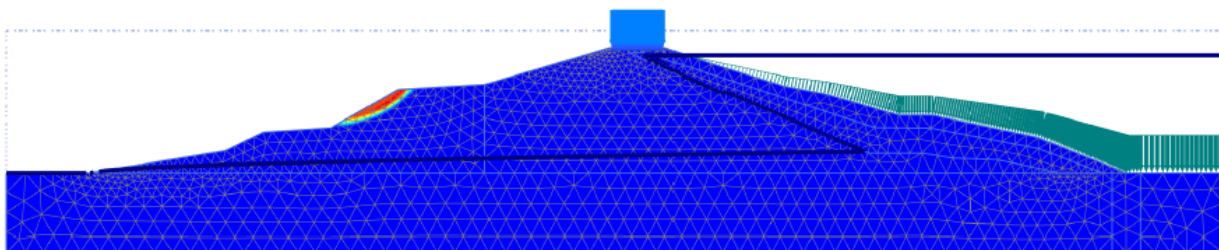
Figure 4 represents Gate 5 turned out to be the most unfavorable of all the design sections considered. For the existing position of the dam at the NPU, the minimum stability coefficients $M_{sf} = 0.3166$ for the main design case and $M_{sf} = 0.1226$ for the special case were obtained, which indicates the unsecured stability of the slope in this particular alignment. The summary results of the report also show that gate 5 is the most problematic in terms of stability among all five design sections.

Figure 4 – Gate 5. A general view of the loss of stability during FPU and AK loading. The coefficient of safety margin $M_{sf} = 1.667$. Stability is assured. (author's materials)

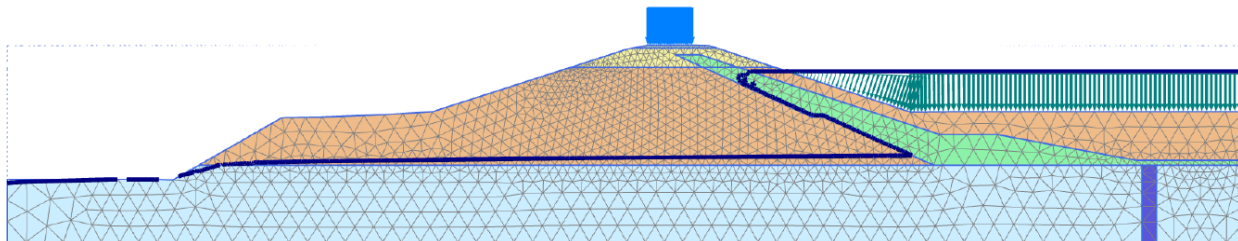
Figure 5 and 6 shows second result is the clear seepage-related mechanism behind this instability. In cross-section 5, the depression surface remains high within the dam body and exits on the downstream slope rather than penetrating deeper into the foundation. Such a configuration indicates intensive water saturation of the embankment and reduced effective stresses in the lower slope

zone. The calculated hydraulic gradient in the same section reached 0.8381 in the main case and 0.9591 in the special case, while filtration velocity in section 5 was about 9.50 m/day and the seepage discharge reached 18.49 m³/day per running meter in the main case. Across sections 3 to 5, seepage velocities were approximately 9.5–12.8 m/day and discharge values reached up to 33.94 m³/day per running meter. The report therefore concluded that seepage-strength safety was not ensured in four of the five analysed sections. Summary of key results for the critical cross-section and dam behaviour are presented in **Table 2**.

Figure 5 – Critical cross-section 5: calculated depression curve in the existing condition. (author’s materials)

The third result is that reconstruction with a clay anti-filtration screen changes the behaviour of the dam fundamentally. For cross-sections 3 to 5, the minimum stability coefficient increased to 1.680, 1.669, and 1.234 in the main design case and remained above the required level in the special case as well. Seepage velocities decreased to approximately 0.35–0.60 m/day, and the verification report explicitly states that seepage-strength safety became ensured. This is the key engineering argument for reconstruction: the screen does not simply reduce leakage, but transforms the dam from a locally unsafe seepage regime to a controlled and acceptable one (Aniskin et al., 2024; Pianosi et al., 2020).

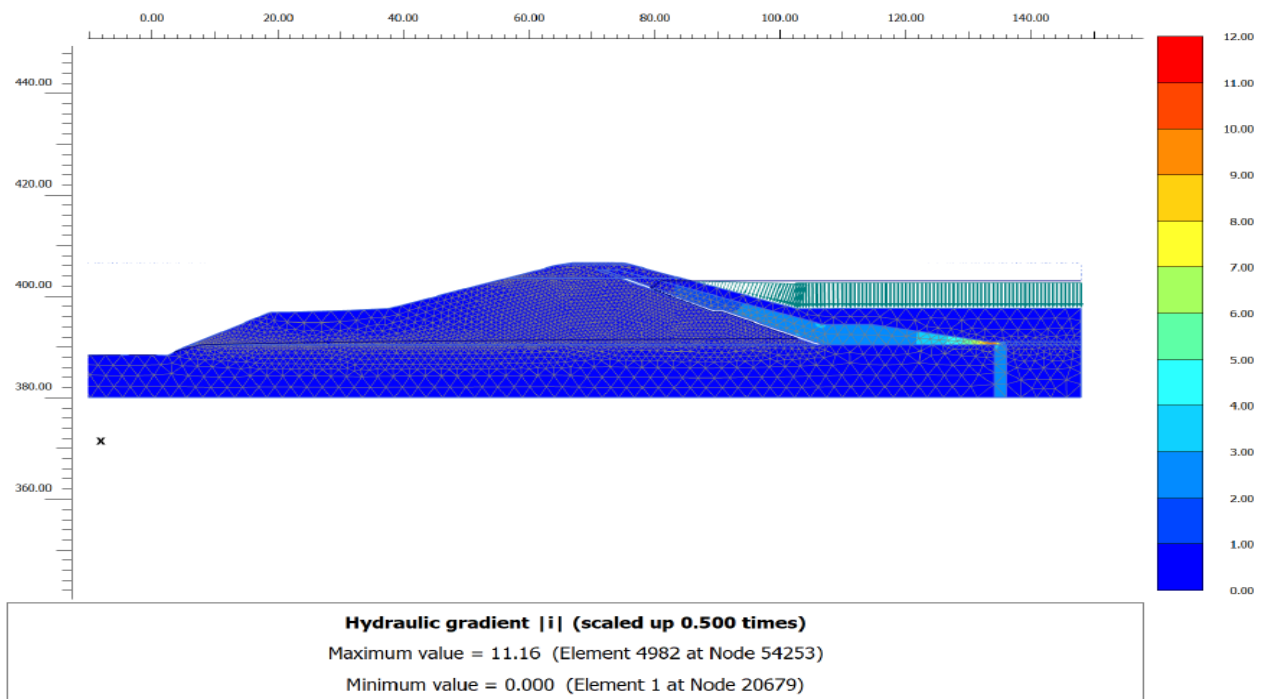
Figure 6 – Hydraulic-gradient field in critical cross-section 5 under the normal operating condition. (author’s materials)
