## IMPROVING THE RELIABILITY AND EFFICIENCY OF OPERATION OF HYDRAULIC STRUCTURES OF THE ASTANA RESERVOIR THROUGH RECONSTRUCTION AND MODERNIZATION

**Abstract.** *This paper examines ways to improve the reliability and operational efficiency of the Astana Reservoir hydraulic structures through reconstruction and modernization. The reservoir, commissioned in 1970, is a key facility for water supply to Astana and irrigation, and its earth dam has a total length of 1,154 m and a maximum height of 32 m. The study is based on the 2023 dam safety declaration and the 2025 verification report on overall stability and seepage strength. Numerical analyses were performed in PLAXIS 2D using the finite element method, the Mohr–Coulomb model, and a strength-reduction approach for five representative cross-sections. The assessment compared the existing condition with two reconstruction scenarios: installation of an anti-filtration screen, and installation of an anti-filtration screen combined with a cement grout curtain. The results showed that, despite a generally satisfactory visual condition, the existing dam configuration has unsafe seepage behavior and critical local instability in the most u

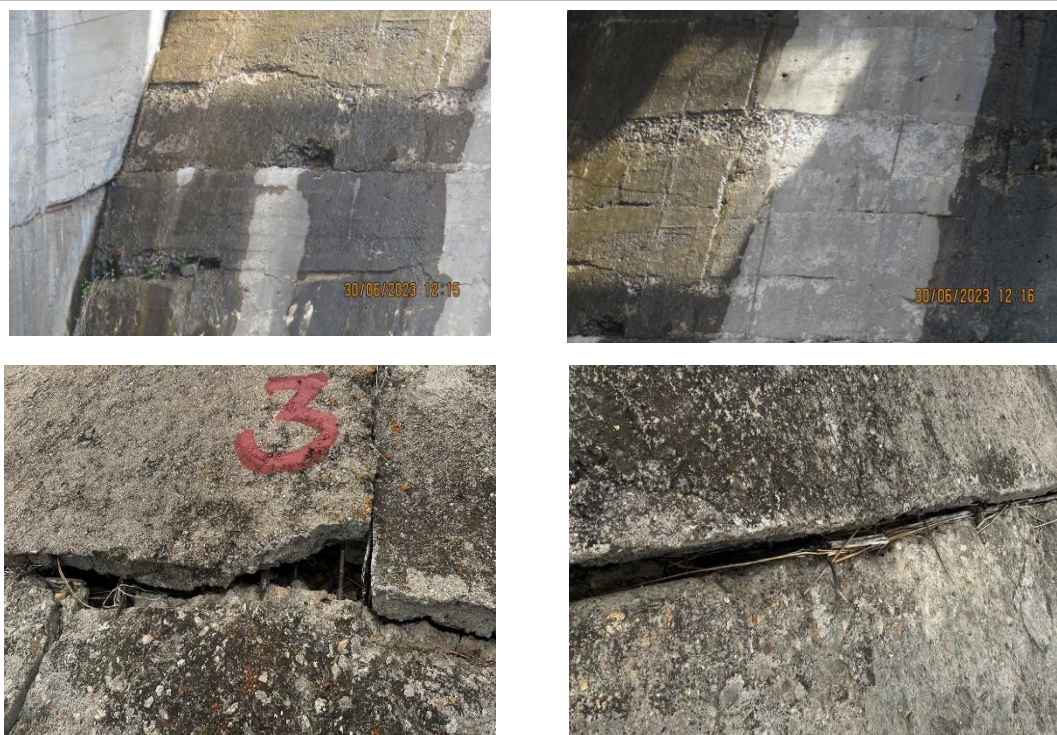
**Figure 2** – Inspection fragments showing cracking and opening of joints in the deteriorated area.  
(author's materials)

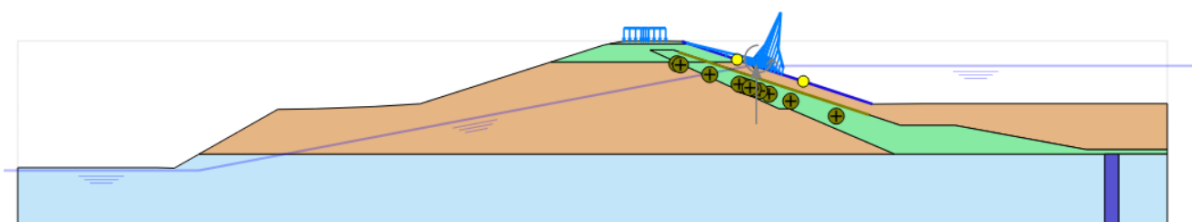
**Figure 3** – Schematic design model of the dam and anti-seepage system used for the numerical assessment.  
(author's materials)

The numerical assessment followed the staged logic of the 2025 verification report. Five representative cross-sections were analysed in plane strain. For each section, the existing configuration was compared with two reconstruction alternatives: (i) restoration of seepage control by means of a clay anti-filtration screen, and (ii) the same screen combined with a cement grout curtain in the foundation. This approach makes it possible to isolate the engineering effect of each anti-seepage measure and to evaluate reconstruction as a measurable change in stability reserve and seepage regime rather than as a generic repair action.

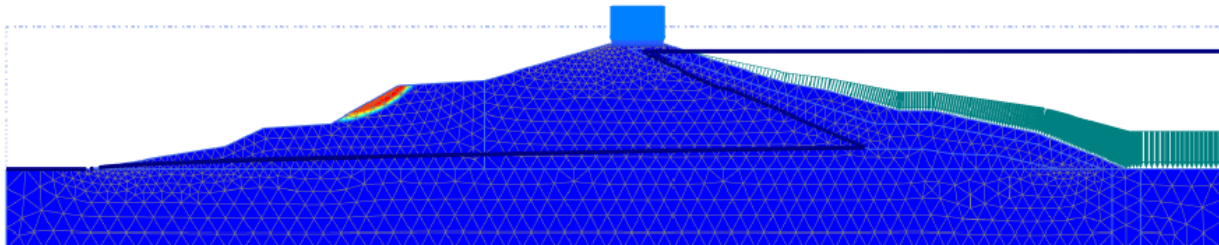
**Figure 4** represents Gate 5 turned out to be the most unfavorable of all the design sections considered. For the existing position of the dam at the NPU, the minimum stability coefficients  $M_{sf} = 0.3166$  for the main design case and  $M_{sf} = 0.1226$  for the special case were obtained, which indicates the unsecured stability of the slope in this alignment. The summary results of the report also show that gate 5 is the most problematic in terms of stability among all five design sections.

**Figure 4** – Gate 5. A general view of the loss of stability during FPU and AK loading. The coefficient of safety margin  $M_{sf} = 1.667$ . Stability is assured. (author's materials)

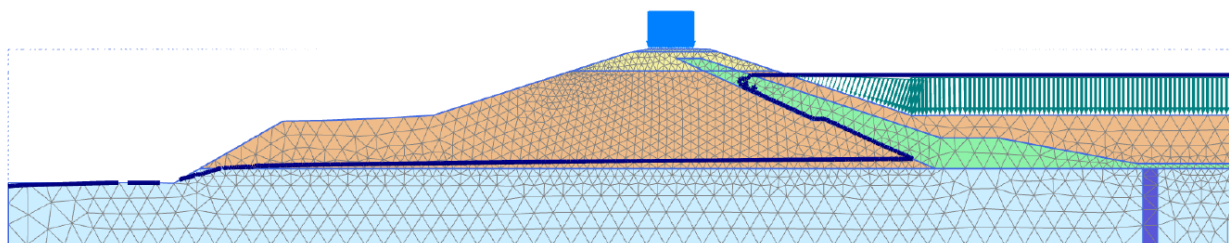
**Figure 5 and 6** shows second result is the clear seepage-related mechanism behind this instability. In cross-section 5, the depression surface remains high within the dam body and exits on the downstream slope rather than penetrating deeper into the foundation. Such a configuration indicates intensive water saturation of the embankment and reduced effective stresses in the lower slope zone. The calculated hydraulic gradient in the same section reached 0.8381 in the main case and

0.9591 in the special case, while filtration velocity in section 5 was about 9.50 m/day and the seepage discharge reached 18.49 m<sup>3</sup>/day per running meter in the main case. Across sections 3 to 5, seepage velocities were approximately 9.5–12.8 m/day and discharge values reached up to 33.94 m<sup>3</sup>/day per running meter. The report therefore concluded that seepage-strength safety was not ensured in four of the five analysed sections. Summary of key results for the critical cross-section and dam behaviour are presented in **Table 2**.

**Figure 5** – Critical cross-section 5: calculated depression curve in the existing condition. (author's materials)

The third result is that reconstruction with a clay anti-filtration screen changes the behaviour of the dam fundamentally. For cross-sections 3 to 5, the minimum stability coefficient increased to 1.680, 1.669, and 1.234 in the main design case and remained above the required level in the special case as well. Seepage velocities decreased to approximately 0.35–0.60 m/day, and the verification report explicitly states that seepage-strength safety became ensured. This is the key engineering argument for reconstruction: the screen does not simply reduce leakage, but transforms the dam from a locally unsafe seepage regime to a controlled and acceptable one (Aniskin et al., 2024; Pianosi et al., 2020).

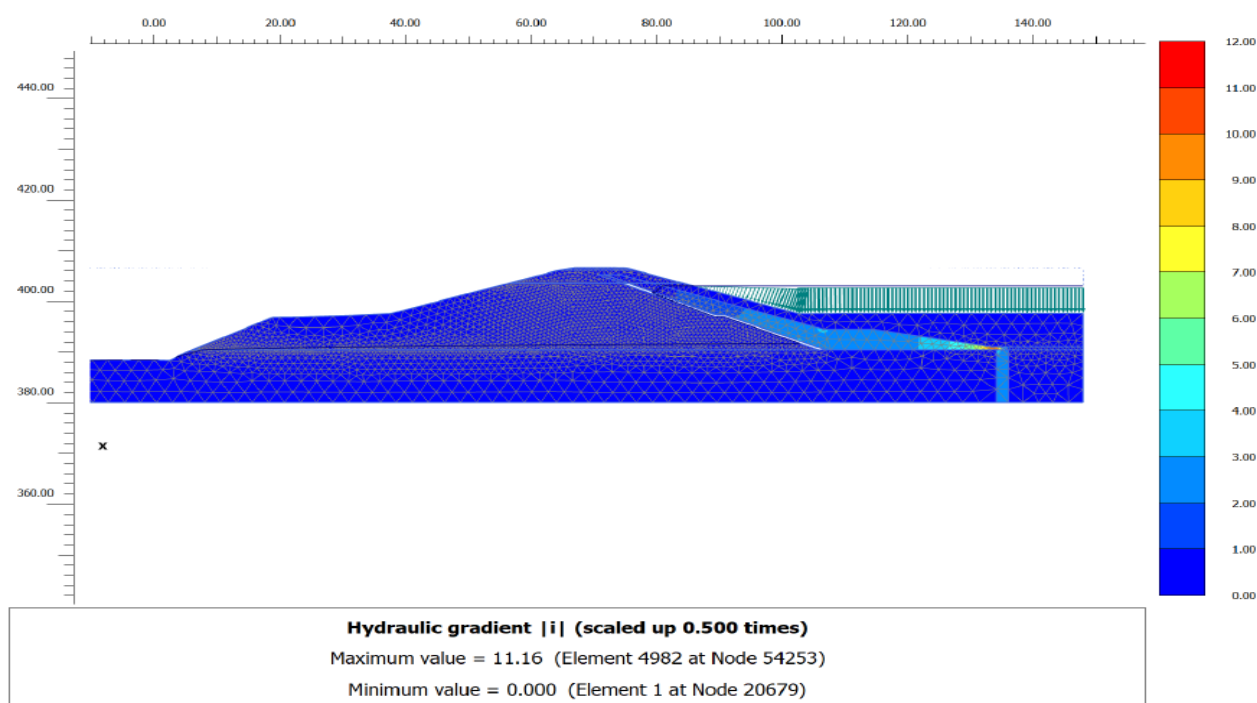
**Figure 6** – Hydraulic-gradient field in critical cross-section 5 under the normal operating condition. (author's materials)
