ASSESSMENT OF THE TECHNICAL CONDITION OF CONCRETE AND REINFORCED CONCRETE HYDRAULIC STRUCTURES USING 3D ULTRASONIC TOMOGRAPHY

Abstract. *The article presents the results of assessing the technical condition of the concrete and reinforced concrete structures of the emergency spillway of the Tasotkel Reservoir using the 3D ultrasonic tomography method based on the Betonoskop SK-1700 3D system. The study is aimed at detecting hidden defects, evaluating the internal structure of concrete, and analyzing deterioration processes under long-term seepage, hydrodynamic, and seismic impacts. During the investigation, spatial ultrasonic scanning of a 10×10 m section was performed with a diagnostic depth of up to 0.60 m. Three-dimensional tomographic models, ultrasonic wave velocity distribution maps, vertical and transverse sections, and engineering interpretations of defect zones were developed. It was established that the average ultrasonic wave velocity was approximately 3280 m/s, while minimum values in critically deteriorated areas decreased to 1680-1850 m/s. More than 35% of the investigated structural volume was found to be in a state of severe and critical deterioration, while the pro

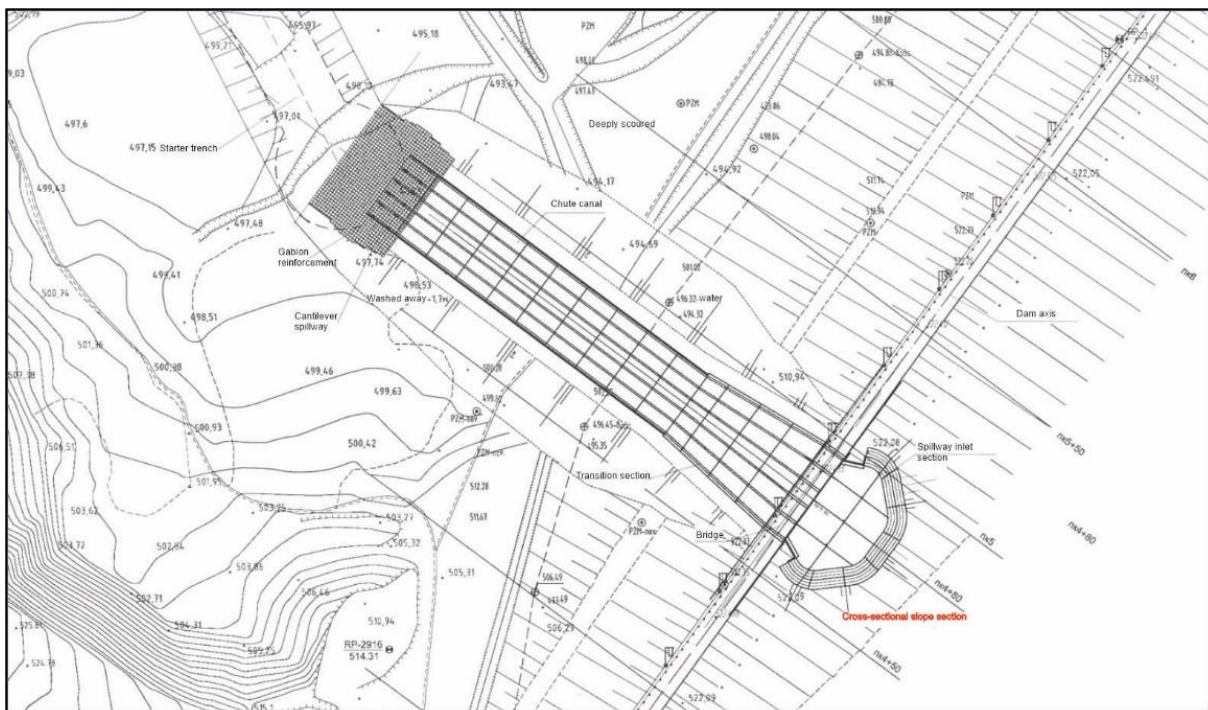
Figure 1 - General view of the emergency spillway of the Tasotkel Reservoir (authors' material)

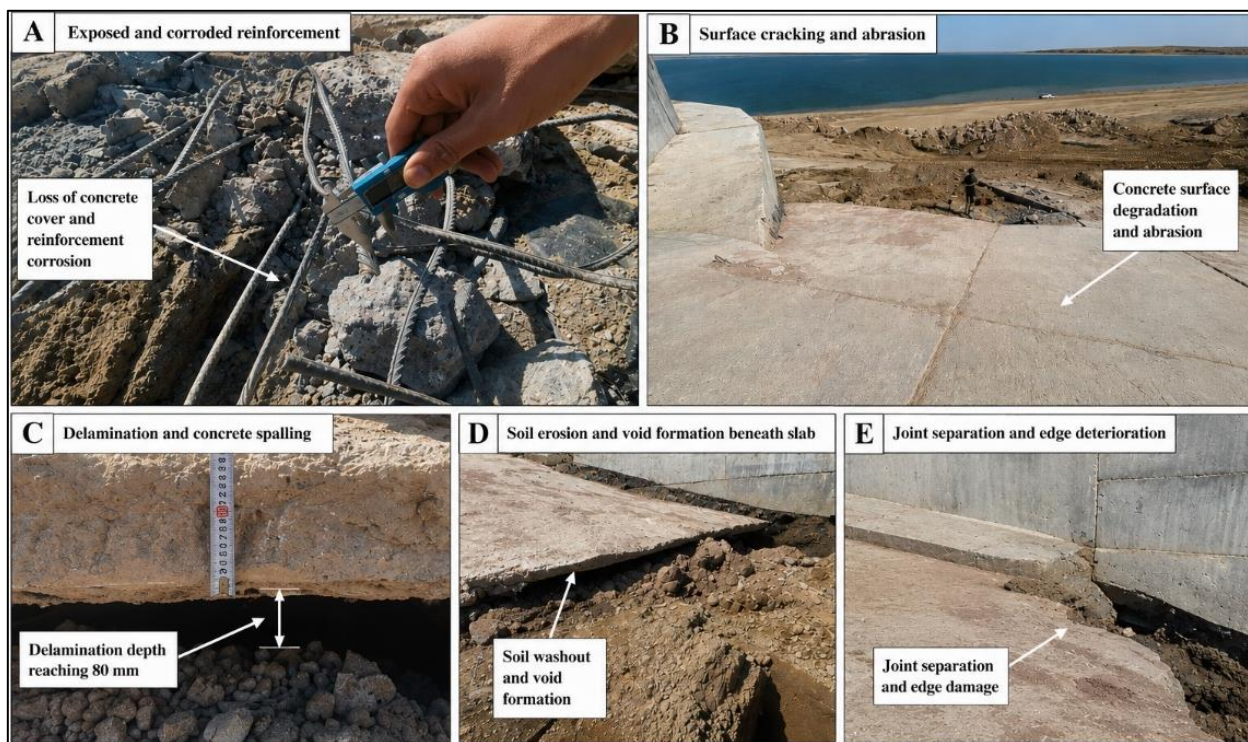
Figure 2 - Typical deterioration defects identified in concrete structures during inspection of the Tasotkel Reservoir emergency spillway: (a) exposed and corroded reinforcement; (b) surface cracking and abrasion; (c) concrete delamination and spalling; (d) soil erosion and void formation beneath slab; (e) joint separation and edge deterioration (authors' material)

The most severe defects were identified in the zones of interaction between structural elements, as well as within the chute canal and cantilever spillway sections, where increased flow velocity and localized hydrodynamic impacts are observed.

The crack opening width varied from 0.08 to 1.60 mm. The depth of local concrete spalling reached up to 45 mm. The area of moisture-affected zones ranged from 0.12 to 2.80 m².

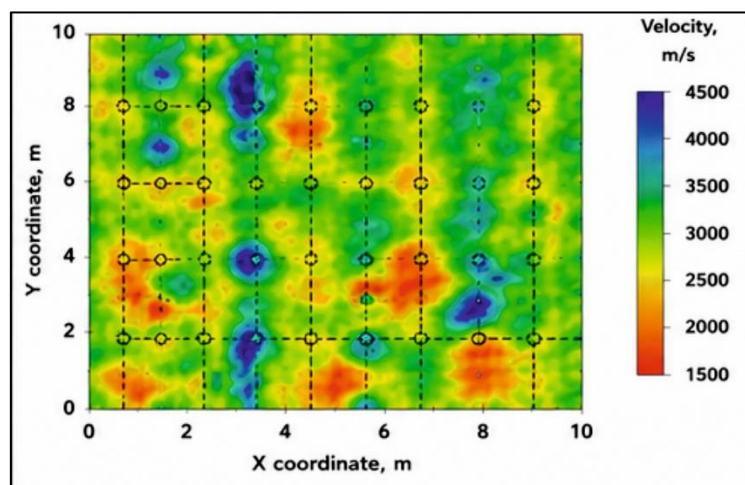
Figure 5 presents the plan-view distribution of ultrasonic wave velocities at a depth of $Z = 0.19$ m. This level corresponds to the upper operational zone of the lining, which is most affected by climatic and operational factors. The average velocity at this level was approximately 3420 m/s. In areas associated with the estimated reinforcement layout, local velocity values of 4100-4450 m/s were recorded. The spacing between such high-velocity zones ranged from 1.8 to 2.2 m, corresponding to the arrangement of structural reinforcement elements and slab joints.

Figure 5 - Plan-view ultrasonic velocity distribution at depth $Z = 0.19$ m (authors' material)

Within the plan-view section, multiple low-velocity anomalies ranging in size from 0.25×0.30 m to 1.10×1.45 m were identified. The largest defect zones were concentrated in the central and lower portions of the investigated area. The average velocity within these anomalous regions ranged from 1950 to 2400 m/s, corresponding to severely deteriorated and locally weakened concrete.

It should be emphasized that the distribution of anomalies exhibited a predominantly elongated geometry aligned with the presumed direction of filtration flow. Such a defect configuration is characteristic of internal filtration erosion and localized moisture accumulation within subsurface structural layers.

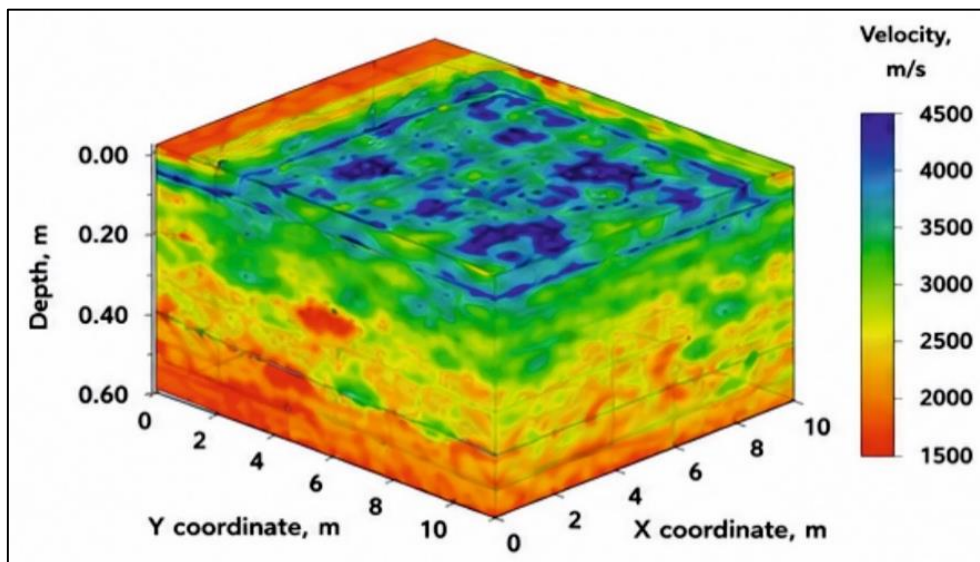
Figure 6 shows the three-dimensional reconstruction of the internal structure of the concrete lining. Analysis of the volumetric model demonstrated that the average ultrasonic wave velocity gradually decreased with increasing depth. Specifically, within the depth range of 0.00-0.15 m, the average velocity varied from 3720 to 3980 m/s, whereas at depths of 0.35-0.60 m, this parameter decreased to 2250-2850 m/s.

A significant increase in the volume fraction of low-velocity zones was observed in the lower portion of the structure. The maximum concentration of defects was identified within the depth interval of 0.32-0.48 m, where the total area of anomalous regions reached 28-34% of the section area. Such distribution patterns indicate the development of internal loosening processes within the foundation layer and deterioration of bonding between the concrete lining and the underlying base.

Figure 6 - 3D ultrasonic tomographic reconstruction of the concrete lining segment (velocity isosurfaces) (authors' material)

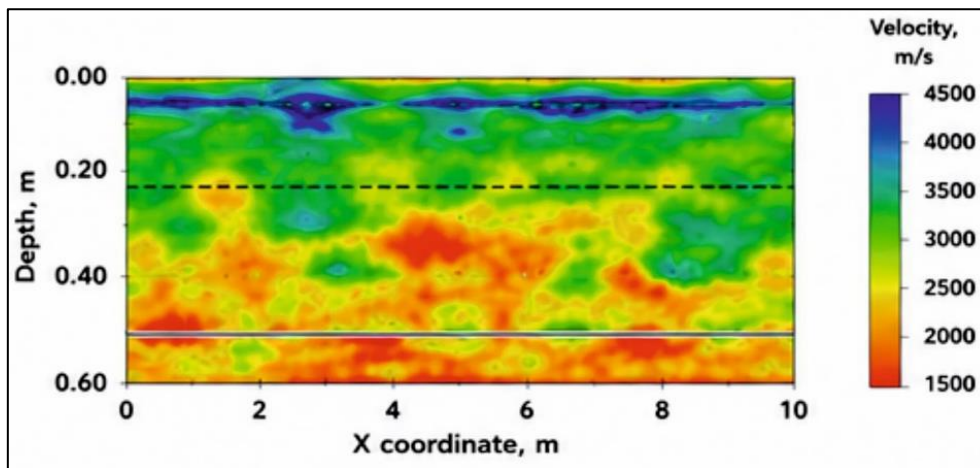
Figure 7 presents the vertical tomographic section (X-Z), allowing assessment of the variation in concrete condition throughout the structural depth. The upper part of the section is characterized by a relatively continuous high-velocity layer with a thickness of approximately 0.08-0.12 m, corresponding to the denser surface layer of the concrete lining and the reinforcement zone. Below this level, a gradual increase in wave-field heterogeneity and a reduction in ultrasonic velocities were observed.

Figure 7 - Vertical tomographic section (X-Z) showing internal heterogeneity and low-velocity zones within the concrete lining (authors' material)

At depths of approximately 0.20-0.25 m, a horizontal zone of increased reflections was identified and interpreted as the estimated reinforcement level. The thickness of this zone ranged from approximately 40 to 60 mm. In the lower part of the section, beginning at depths around 0.35 m, extended regions with velocities ranging from 1800 to 2600 m/s were observed. The amplitudes of reflected signals within these regions decreased by approximately 35-48% compared with relatively intact areas, indicating substantial disruption of material continuity.

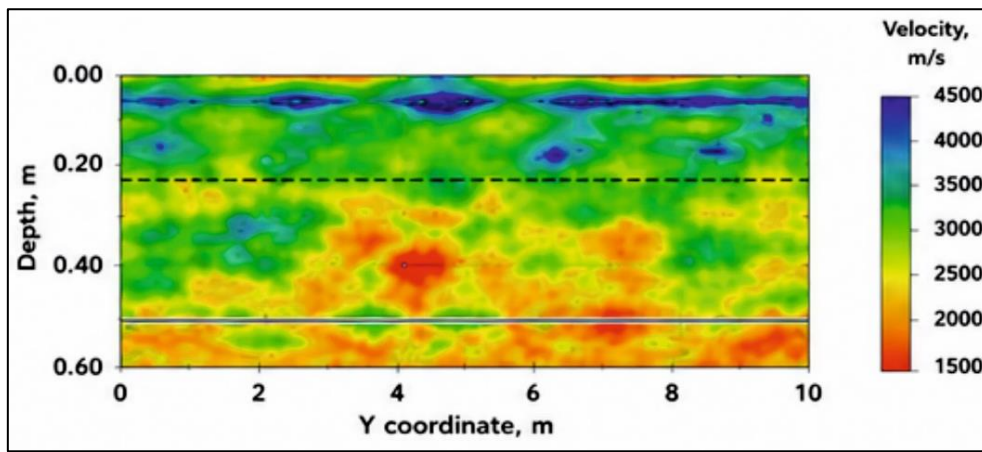
Figure 8 - Transverse tomographic section (Y-Z) illustrating filtration-affected and degraded regions in the concrete structure (authors' material)

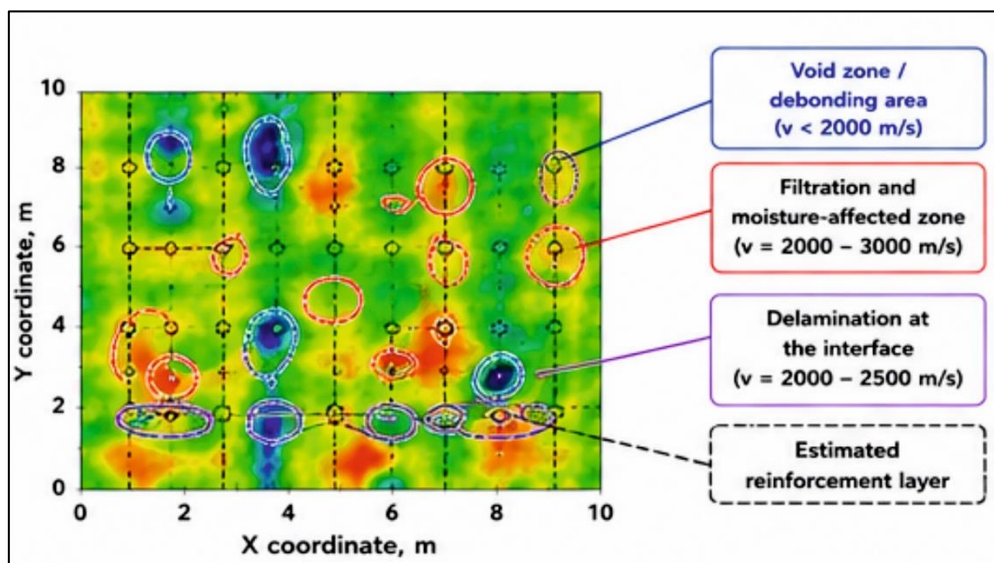
Figure 9 presents the engineering interpretation of the principal defect zones. The total area associated with potential voids and loss of bonding accounted for approximately 6.8-8.5% of the investigated surface. The average depth of these defects reached approximately 0.42-0.55 m. Filtration-affected and moisture-saturated zones occupied approximately 18-22% of the investigated massif. Within these areas, the estimated moisture-related reduction in acoustic properties exceeded average values by approximately 22-35%.

Particularly critical are the delamination zones identified along the concrete lining-foundation interface, whose total extent reached approximately 3.5-4.2 m within the investigated segment. Such defects substantially reduce the composite action of the structure and may accelerate further filtration erosion processes.

Figure 9 - Engineering interpretation of principal defect zones identified in the plan-view ultrasonic tomography (authors' material)

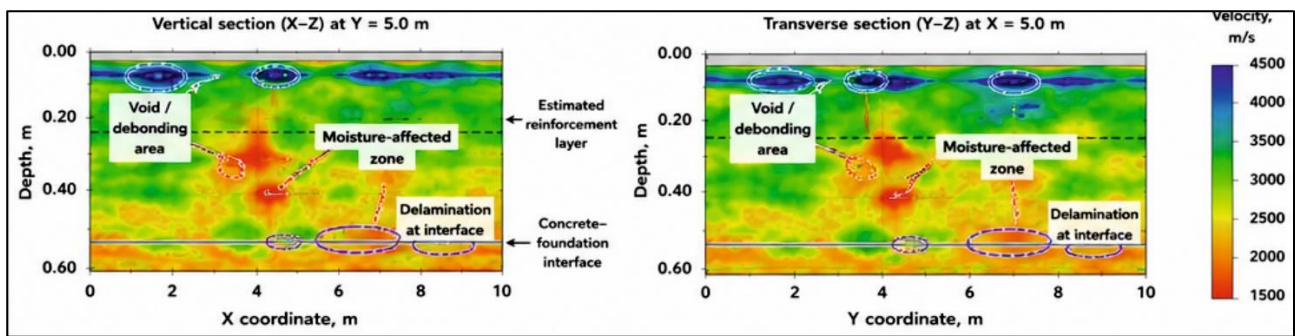
Figure 10 presents the results of the integrated engineering interpretation of vertical and transverse tomographic sections. High-amplitude reflections associated with reinforcement and dense concrete were identified in the upper structural layers. The middle portion of the structure exhibited localized moisture-affected and microstructurally heterogeneous regions. In the lower portion, zones of delamination and loss of bonding between the lining and the foundation were clearly identified.

It should be emphasized that the most critical defects are localized within the concrete lining-foundation interface zone, as these regions create favorable conditions for further filtration erosion, subsurface void development, and progressive slab deformation. Under prolonged operational loading, such processes may result in local slab settlement, joint opening, and a reduction in the overall operational reliability of the hydraulic structure.

Figure 10 - Integrated schematic interpretation of tomographic sections with identification of voids, moisture-affected zones, reinforcement layer, and concrete-foundation interface defects (authors' material)

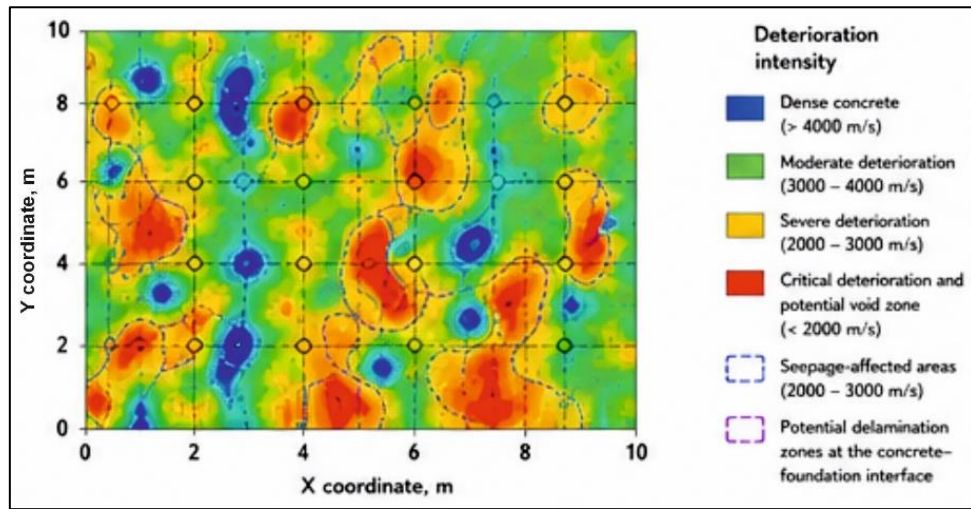
Figure 11 presents the spatial deterioration intensity map of the concrete lining at a depth of $Z = 0.19$ m. This level corresponds to the near-surface operating layer of the lining, where the effects of abrasion, cyclic wetting-drying, temperature gradients, and surface cracking are most pronounced. The map shows that the investigated area is not acoustically homogeneous. Dense concrete zones with velocities above 4000 m/s occupy approximately 14-17% of the investigated surface. Moderate deterioration zones with velocities of 3000-4000 m/s are dominant and account for 41-46% of the area. Severe deterioration zones with velocities of 2000-3000 m/s occupy 20-24%. Critical deterioration and potential void zones with velocities below 2000 m/s account for 6-8%. Filtration-affected zones occupy 18-22%, while delamination-prone interface regions account for 6-9%. This distribution indicates that the deterioration is spatially localized but not isolated. The most critical areas are concentrated along linear and elongated anomaly patterns, which may correspond to slab joints, filtration paths, and zones of weakened concrete-foundation contact.

Figure 11 - Spatial deterioration intensity map of the concrete lining (plan view, Z = 0.19 m), (authors' material)

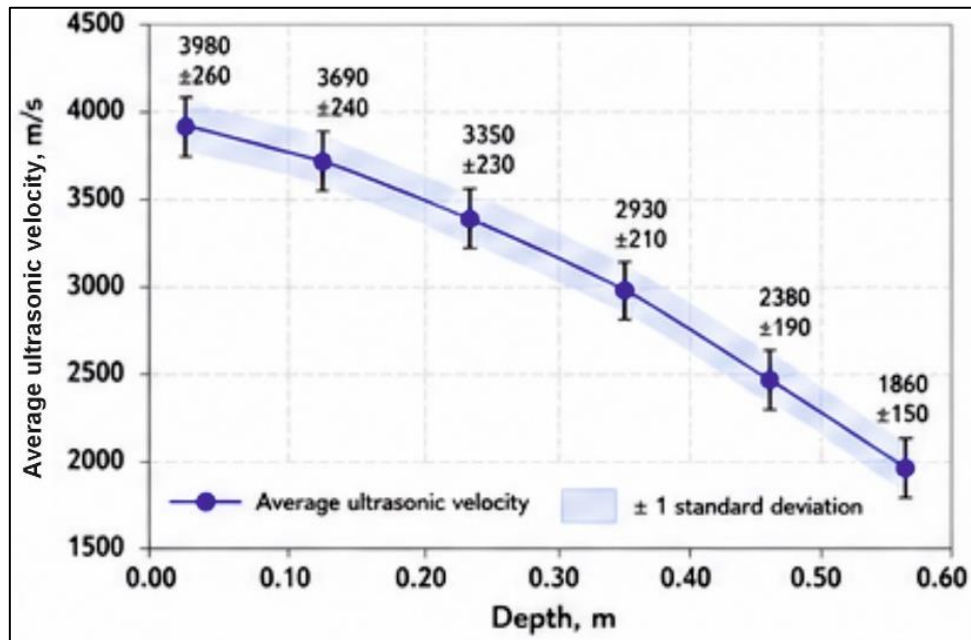
Figure 12 shows the variation in ultrasonic wave velocity with investigation depth. The graph demonstrates a clear depth-dependent reduction in velocity. In the upper layer, within 0.00-0.10 m, the average velocity is approximately 3980 ± 260 m/s. At a depth of 0.10-0.20 m, the velocity decreases to 3690 ± 240 m/s. In the interval of 0.20-0.30 m, the average velocity decreases further to 3350 ± 230 m/s. A more pronounced reduction is observed below 0.35 m, where the average velocity decreases to 2930 ± 210 m/s in the 0.30-0.40 m interval and to 2380 ± 190 m/s in the 0.40-0.50 m interval. At depths of 0.50-0.60 m, the average velocity reaches only 1860 ± 150 m/s. This trend indicates accelerated deterioration below approximately 0.35 m, which is consistent with the expected location of moisture accumulation, debonding, and interface degradation. Therefore, the lower part of the lining and the concrete-foundation contact zone should be considered the most vulnerable structural region.

Figure 12 - Variation in ultrasonic wave velocity with investigation depth (authors' material)

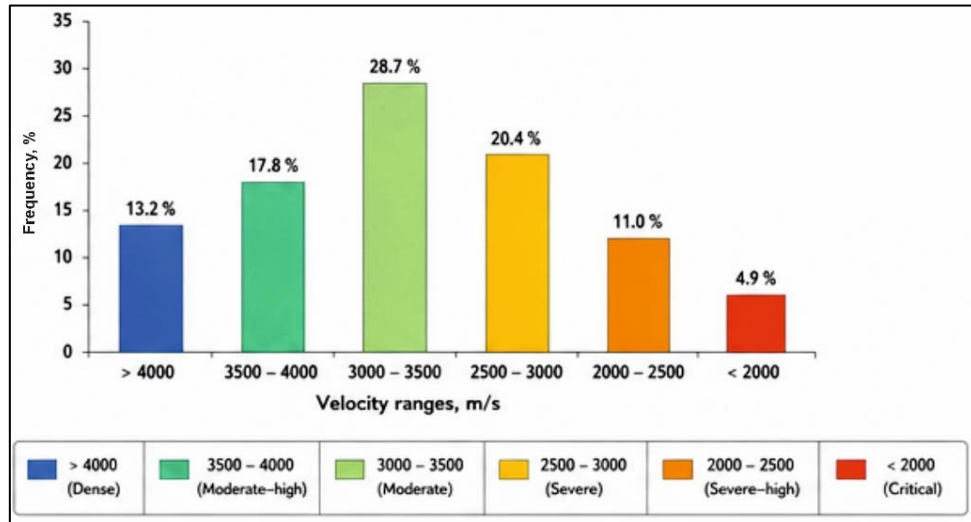
Figure 13 presents the statistical distribution of ultrasonic wave velocities based on 623,061 valid voxels. The mean velocity is 3280 m/s, while the median velocity is 3210 m/s. The standard deviation is 704 m/s, which confirms significant acoustic heterogeneity of the investigated concrete volume. The minimum and maximum recorded velocities are 1680 m/s and 4480 m/s, respectively. The coefficient of variation is 21.4%. The histogram shows that the largest fraction of the investigated volume falls within the 3000-3500 m/s range, accounting for 28.7%. The 3500-4000 m/s range accounts for 17.8%, while the high-velocity range above 4000 m/s accounts for 13.2%. The severe deterioration interval of 2500-3000 m/s accounts for 20.4%, and the 2000-2500 m/s interval accounts for 11.0%. Critical zones with velocities below 2000 m/s account for 4.9%. This distribution confirms that the concrete lining is dominated by moderately deteriorated material, while localized critical defect zones are present and require engineering attention.

Figure 13 - Statistical distribution of ultrasonic wave velocities (authors' material)

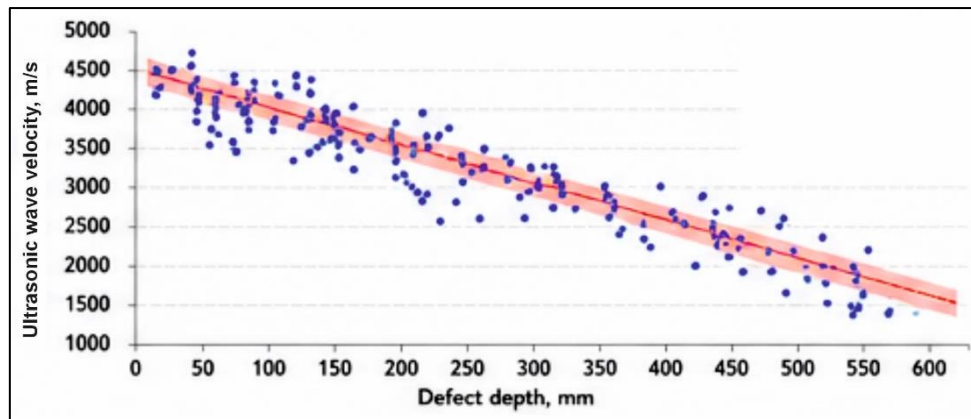
Figure 14 illustrates the correlation between ultrasonic wave velocity and defect depth. The scatter plot demonstrates a distinct negative correlation. The regression equation is expressed as $y = -4.05x + 4240$, with $R^2 = 0.81$ and $N = 152$ measurement points. This means that with increasing defect depth, ultrasonic velocity decreases systematically. Defects with depths of 0-50 mm are

characterized by velocities of approximately 3600-4300 m/s, with a mean value of 3930 m/s. Defects of 50-100 mm correspond to velocities of 3200-3900 m/s, with a mean value of 3560 m/s. For defects of 100-200 mm, velocities decrease to 2500-3400 m/s, with a mean value of 2890 m/s. Defects of 200-300 mm correspond to velocities of 1900-2700 m/s, with a mean value of 2250 m/s. When the defect depth exceeds 300 mm, the velocity drops below 2200 m/s, with an average value of approximately 1830 m/s. These results confirm that deeper defects are associated with stronger internal deterioration, increased porosity, possible void formation, and reduced contact between the concrete lining and the foundation.

Figure 14 - Relationship between ultrasonic wave velocity and defect depth (authors' material)

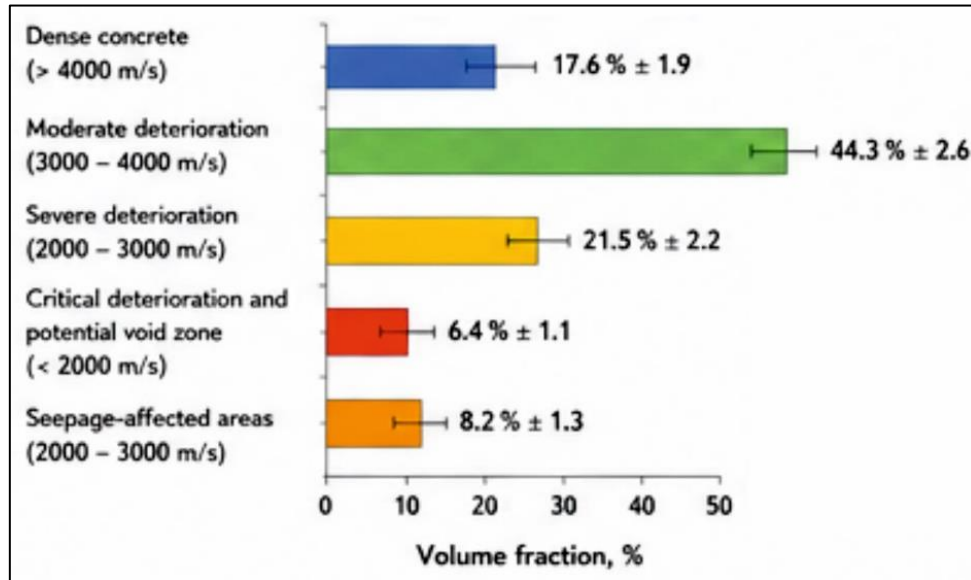
Figure 15 presents the volumetric distribution of structural deterioration zones. Unlike the plan-view map, this figure quantifies the deterioration throughout the entire investigated volume of $10.0 \times 10.0 \times 0.60$ m. Dense concrete zones account for $17.6 \pm 1.9\%$ of the volume. Moderately deteriorated concrete is the dominant class and accounts for $44.3 \pm 2.6\%$. Severe deterioration zones account for $21.5 \pm 2.2\%$. Critical deterioration and potential void zones account for $6.4 \pm 1.1\%$, while moisture-affected zones account for $8.2 \pm 1.3\%$. The total volume with significant deterioration, including severe, critical, and moisture-affected areas, reaches $35.9 \pm 3.1\%$. This value is important from an engineering perspective because it indicates that more than one-third of the investigated concrete lining volume has signs of substantial internal degradation.

Figure 15 - Volumetric distribution of deterioration zones within the concrete lining (authors' material)

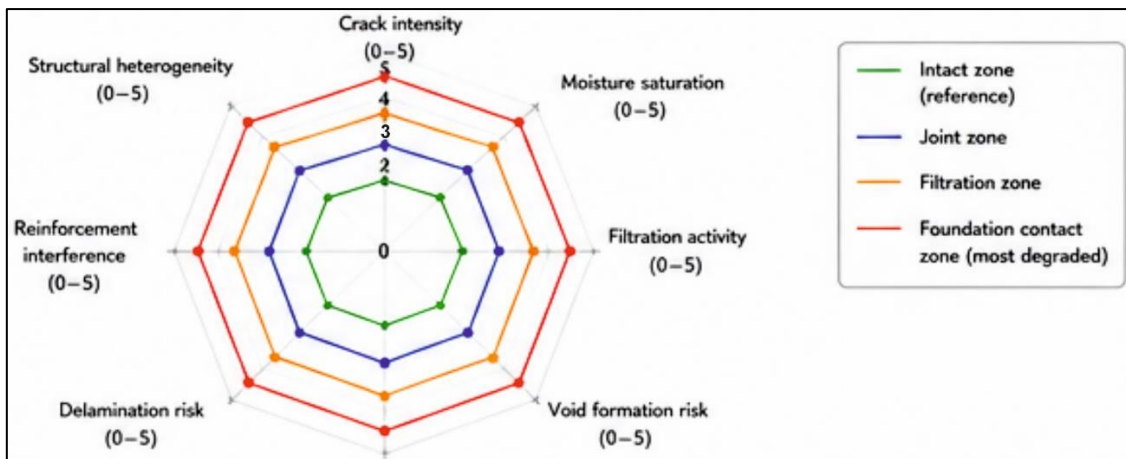
Figure 16 provides a comparative assessment of deterioration indicators in the investigated zones using a radar chart. The evaluated parameters include crack intensity, moisture saturation,

filtration activity, void formation risk, delamination risk, reinforcement interference, and structural heterogeneity. The intact reference zone shows the lowest deterioration indices, generally within 1-2 points on a 0-5 scale. The joint zone shows increased values for crack intensity, moisture saturation, and structural heterogeneity. The filtration zone is characterized by higher moisture saturation, filtration activity, and void formation risk. The foundation contact zone shows the highest overall deterioration level, with values approaching 4-5 points for delamination risk, void formation risk, filtration activity, and structural heterogeneity. This confirms that the concrete-foundation interface is the most critical zone in terms of long-term durability and operational safety.

Figure 16 - Comparative assessment of deterioration indicators in different investigated zones (authors' material)

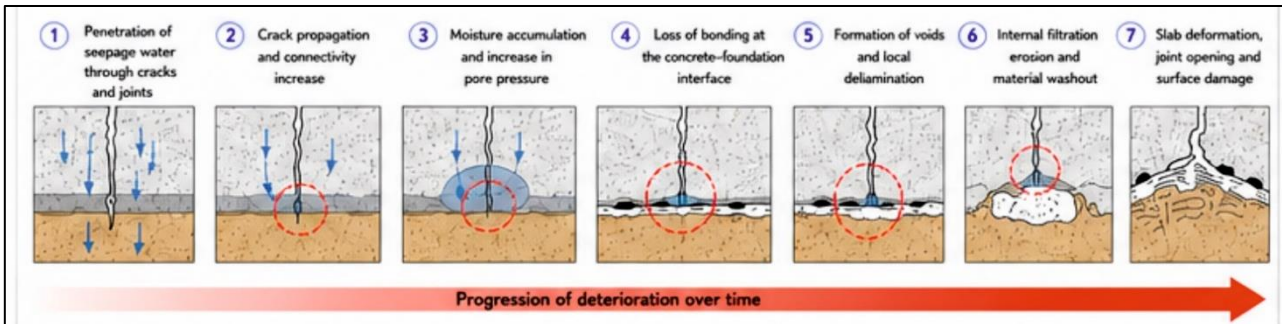
Figure 17 presents the proposed mechanism of filtration-induced deterioration of the concrete lining. The mechanism consists of seven sequential stages. First, seepage water penetrates through cracks and joints. Second, crack propagation and connectivity increase under repeated hydraulic and thermal loading. Third, moisture accumulates within the subsurface zone, causing an increase in pore pressure. Fourth, loss of bonding develops at the concrete-foundation interface. Fifth, local voids and delamination zones are formed. Sixth, internal filtration erosion and material washout occur. Finally, slab deformation, joint opening, and surface damage develop. This mechanism explains the spatial distribution of low-velocity zones observed in the tomographic data. It also links the ultrasonic results with the actual hydraulic deterioration processes typical for concrete linings of spillway structures.

Figure 17 - Proposed mechanism of filtration-induced deterioration of the concrete lining (authors' material)

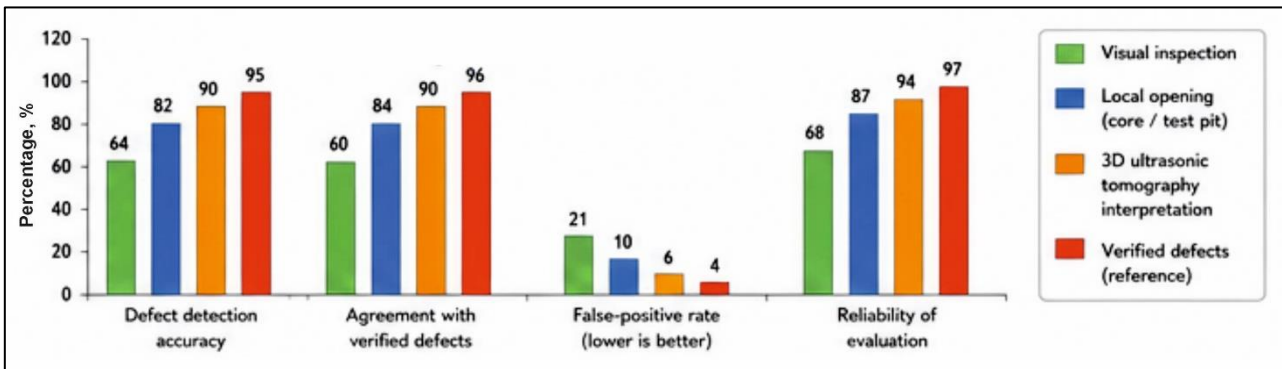
Figure 18 validates the ultrasonic tomography results against field observations. The comparison includes visual inspection, local opening/core or test pit observations, tomography interpretation, and actual detected defects used as reference. The defect detection accuracy of tomography interpretation reaches approximately 90-95%, while visual inspection provides a lower value of about 64%. The agreement with actual defects is 90-96% for tomography-based interpretation and 84-90% for local opening data. The false-positive rate for tomography is approximately 4-7%, which is significantly lower than the uncertainty associated with visual-only inspection. The overall reliability of evaluation based on 3D ultrasonic tomography is estimated at 91-95%. These results confirm that 3D ultrasonic tomography provides a more reliable basis for engineering assessment than visual inspection alone, especially when hidden voids, delamination, and moisture-affected zones are present.

Figure 18 - Validation of 3D ultrasonic tomography results against field observations (authors' material)
