## ASSESSMENT OF THE TECHNICAL CONDITION OF CONCRETE AND REINFORCED CONCRETE HYDRAULIC STRUCTURES USING 3D ULTRASONIC TOMOGRAPHY

**Abstract.** *The article presents the results of assessing the technical condition of the concrete and reinforced concrete structures of the emergency spillway of the Tasotkel Reservoir using the 3D ultrasonic tomography method based on the Betonoskop SK-1700 3D system. The study is aimed at detecting hidden defects, evaluating the internal structure of concrete, and analyzing deterioration processes under long-term seepage, hydrodynamic, and seismic impacts. During the investigation, spatial ultrasonic scanning of a 10×10 m section was performed with a diagnostic depth of up to 0.60 m. Three-dimensional tomographic models, ultrasonic wave velocity distribution maps, vertical and transverse sections, and engineering interpretations of defect zones were developed. It was established that the average ultrasonic wave velocity was approximately 3280 m/s, while minimum values in critically deteriorated areas decreased to 1680-1850 m/s. More than 35% of the investigated structural volume was found to be in a state of severe and critical deterioration, while

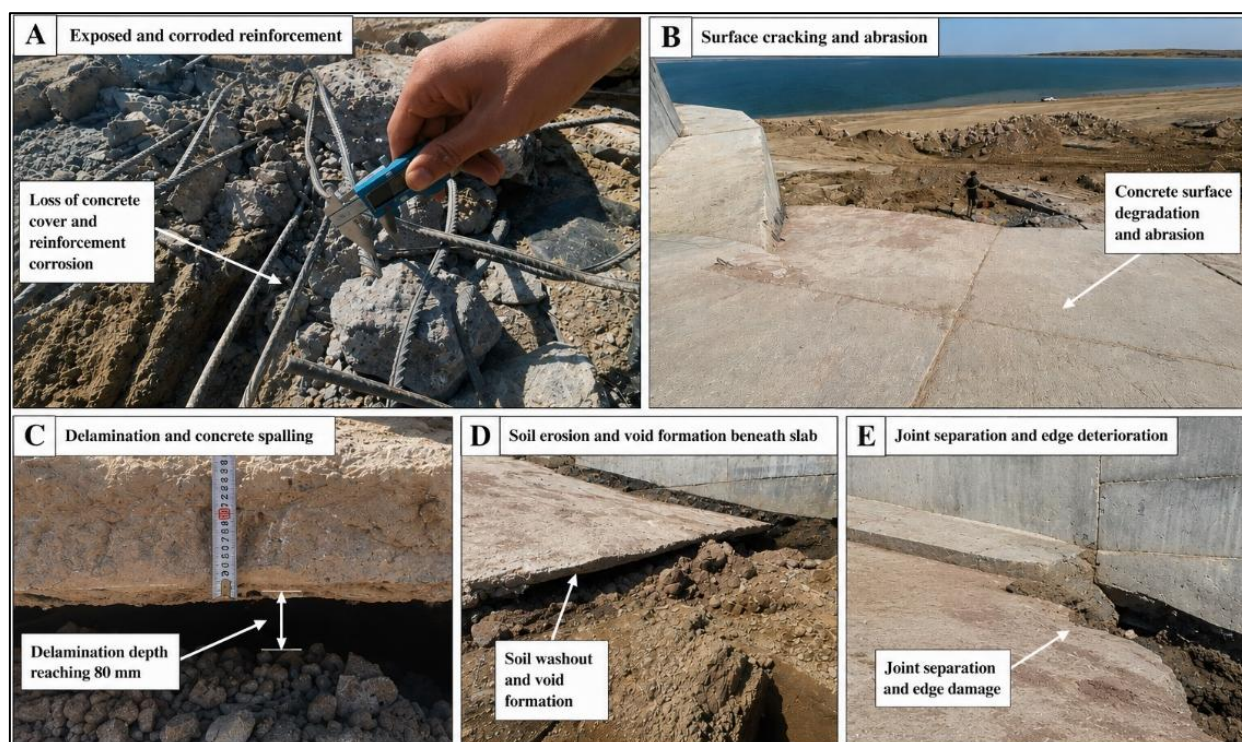
**Figure 2** - Typical deterioration defects identified in concrete structures during inspection of the Tasotkel Reservoir emergency spillway: (a) exposed and corroded reinforcement; (b) surface cracking and abrasion; (c) concrete delamination and spalling; (d) soil erosion and void formation beneath slab; (e) joint separation and edge deterioration (authors' material)

The most severe defects were identified in the zones of interaction between structural elements, as well as within the chute canal and cantilever spillway sections, where increased flow velocity and localized hydrodynamic impacts are observed.

The crack opening width varied from 0.08 to 1.60 mm. The depth of local concrete spalling reached up to 45 mm. The area of moisture-affected zones ranged from 0.12 to 2.80 m<sup>2</sup>.

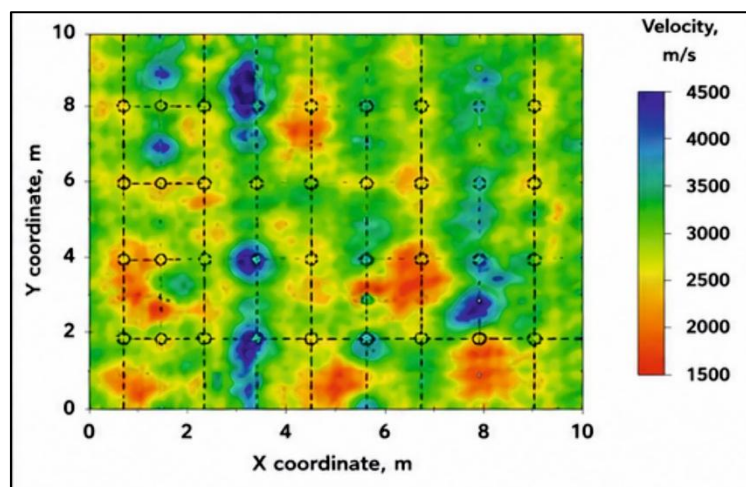
**Figure 5** presents the plan-view distribution of ultrasonic wave velocities at a depth of  $Z = 0.19$  m. This level corresponds to the upper operational zone of the lining, which is most affected by climatic and operational factors. The average velocity at this level was approximately 3420 m/s. In areas associated with the estimated reinforcement layout, local velocity values of 4100-4450 m/s were recorded. The spacing between such high-velocity zones ranged from 1.8 to 2.2 m, corresponding to the arrangement of structural reinforcement elements and slab joints.

**Figure 5** - Plan-view ultrasonic velocity distribution at depth  $Z = 0.19$  m (authors' material)

Within the plan-view section, multiple low-velocity anomalies ranging in size from  $0.25 \times 0.30$  m to  $1.10 \times 1.45$  m were identified. The largest defect zones were concentrated in the central and lower portions of the investigated area. The average velocity within these anomalous regions ranged from 1950 to 2400 m/s, corresponding to severely deteriorated and locally weakened concrete.

It should be emphasized that the distribution of anomalies exhibited a predominantly elongated geometry aligned with the presumed direction of filtration flow. Such a defect configuration is characteristic of internal filtration erosion and localized moisture accumulation within subsurface structural layers.

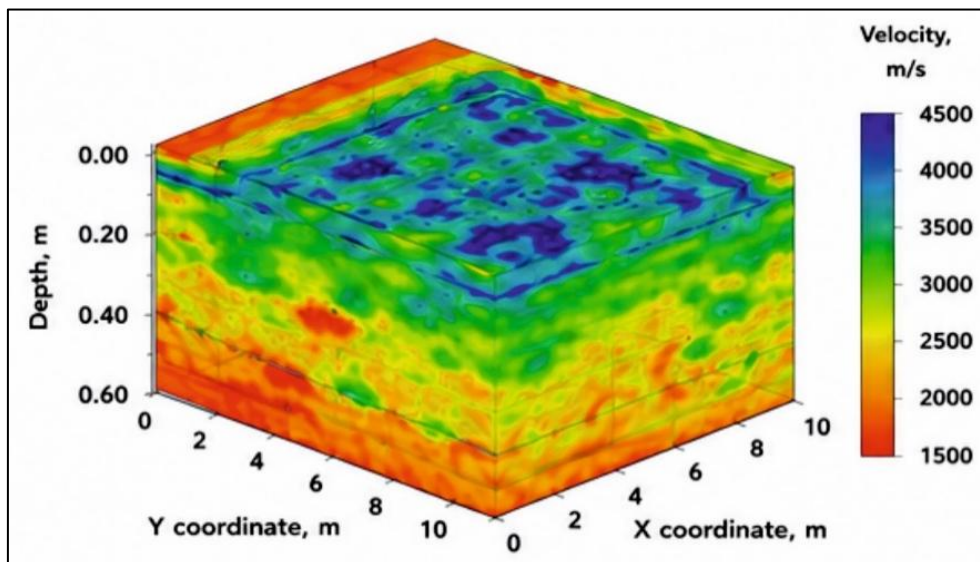
**Figure 6** shows the three-dimensional reconstruction of the internal structure of the concrete lining. Analysis of the volumetric model demonstrated that the average ultrasonic wave velocity gradually decreased with increasing depth. Specifically, within the depth range of 0.00-0.15 m, the average velocity varied from 3720 to 3980 m/s, whereas at depths of 0.35-0.60 m, this parameter decreased to 2250-2850 m/s.

A significant increase in the volume fraction of low-velocity zones was observed in the lower portion of the structure. The maximum concentration of defects was identified within the depth interval of 0.32-0.48 m, where the total area of anomalous regions reached 28-34% of the section area. Such distribution patterns indicate the development of internal loosening processes within the foundation layer and deterioration of bonding between the concrete lining and the underlying base.

**Figure 6** - 3D ultrasonic tomographic reconstruction of the concrete lining segment (velocity isosurfaces)  
(authors' material)

Particular attention should be paid to elongated low-velocity zones oriented along the presumed directions of seepage flow. Similar spatial configurations are typical for internal filtration erosion and the gradual formation of subsurface voids. In several areas, closed anomalous regions with sharp velocity gradients were identified, which may indicate local delamination and hidden cavity formation within the concrete structure.

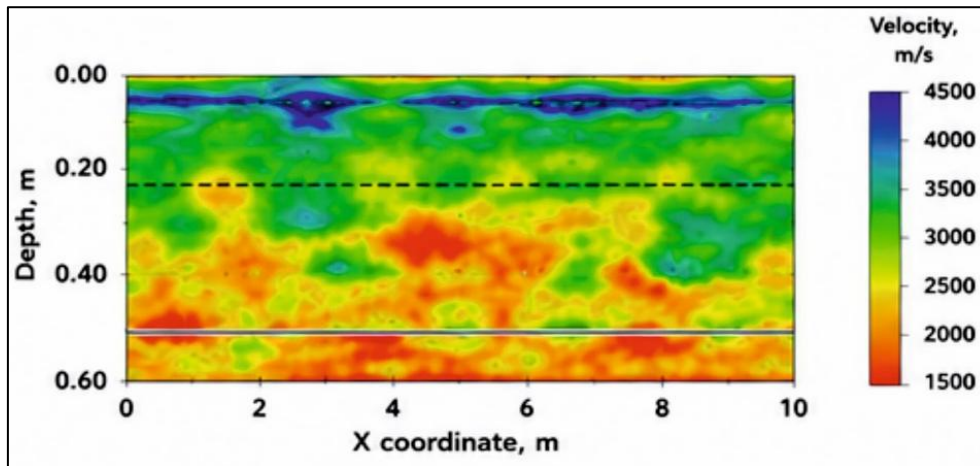
**Figure 7** presents the vertical tomographic section (X-Z), allowing assessment of the variation in concrete condition throughout the structural depth. The upper part of the section is characterized by a relatively continuous high-velocity layer with a thickness of approximately 0.08-0.12 m, corresponding to the denser surface layer of the concrete lining and the reinforcement zone. Below this level, a gradual increase in wave-field heterogeneity and a reduction in ultrasonic velocities were observed.

**Figure 7** - Vertical tomographic section (X-Z) showing internal heterogeneity and low-velocity zones within the concrete lining (authors' material)

At depths of approximately 0.20-0.25 m, a horizontal zone of increased reflections was identified and interpreted as the estimated reinforcement level. The thickness of this zone ranged from approximately 40 to 60 mm. In the lower part of the section, beginning at depths around 0.35 m, extended regions with velocities ranging from 1800 to 2600 m/s were observed. The amplitudes of reflected signals within these regions decreased by approximately 35-48% compared with relatively intact areas, indicating substantial disruption of material continuity.

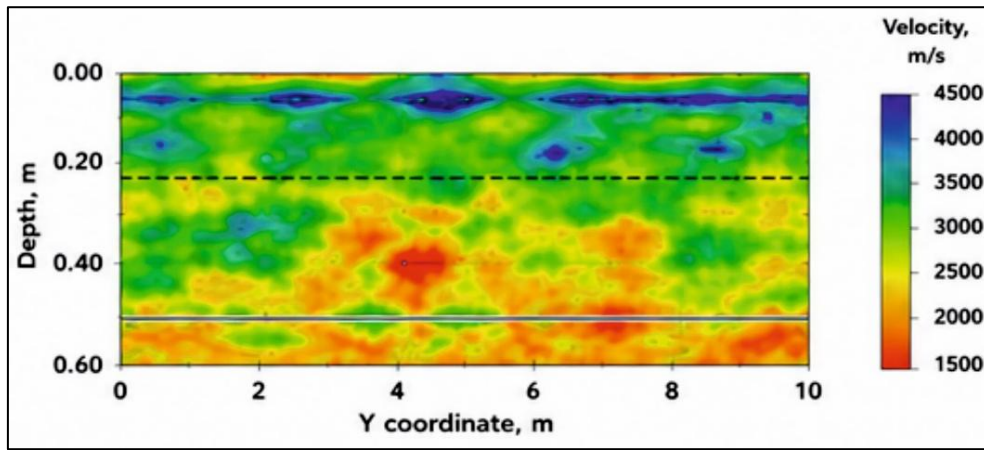
Such a pattern is characteristic of filtration-induced moisture penetration and localized washout of fine-grained particles from the foundation layer. In several areas, discontinuities along the concrete-foundation interface extending over 1.6-2.0 m were identified.

**Figure 8** - Transverse tomographic section (Y-Z) illustrating filtration-affected and degraded regions in the concrete structure (authors' material)

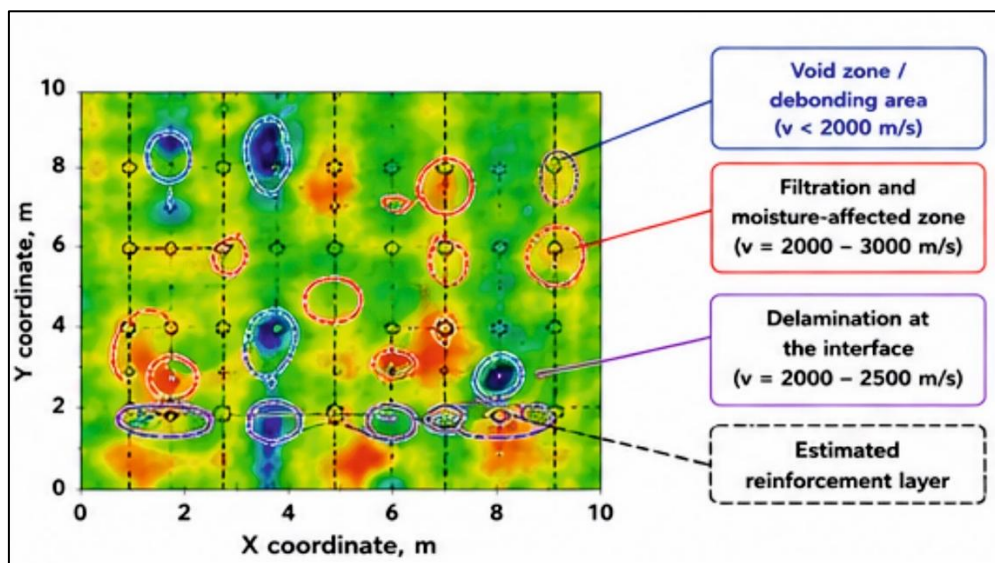
**Figure 9** presents the engineering interpretation of the principal defect zones. The total area associated with potential voids and loss of bonding accounted for approximately 6.8-8.5% of the investigated surface. The average depth of these defects reached approximately 0.42-0.55 m. Filtration-affected and moisture-saturated zones occupied approximately 18-22% of the investigated massif. Within these areas, the estimated moisture-related reduction in acoustic properties exceeded average values by approximately 22-35%.

Particularly critical are the delamination zones identified along the concrete lining-foundation interface, whose total extent reached approximately 3.5-4.2 m within the investigated segment. Such defects substantially reduce the composite action of the structure and may accelerate further filtration erosion processes.

**Figure 9** - Engineering interpretation of principal defect zones identified in the plan-view ultrasonic tomography (authors' material)

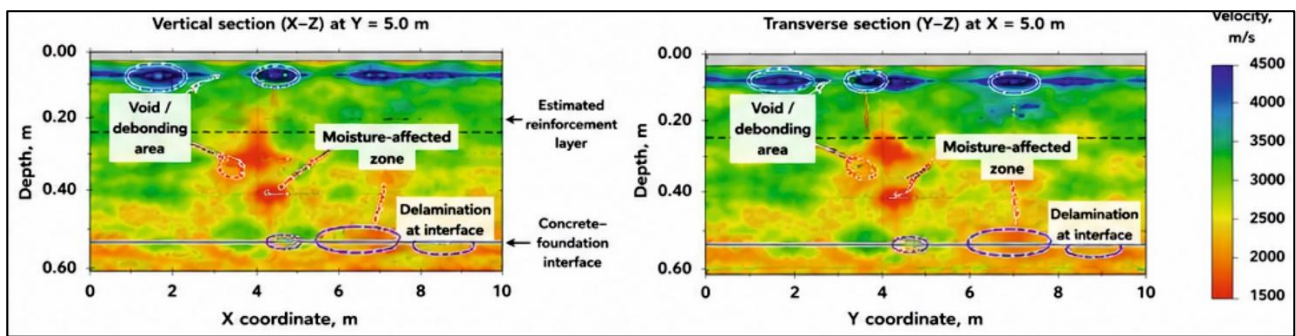
**Figure 10** presents the results of the integrated engineering interpretation of vertical and transverse tomographic sections. High-amplitude reflections associated with reinforcement and dense concrete were identified in the upper structural layers. The middle portion of the structure exhibited localized moisture-affected and microstructurally heterogeneous regions. In the lower portion, zones of delamination and loss of bonding between the lining and the foundation were clearly identified.

It should be emphasized that the most critical defects are localized within the concrete lining-foundation interface zone, as these regions create favorable conditions for further filtration erosion, subsurface void development, and progressive slab deformation. Under prolonged operational loading, such processes may result in local slab settlement, joint opening, and a reduction in the overall operational reliability of the hydraulic structure.

**Figure 10** - Integrated schematic interpretation of tomographic sections with identification of voids, moisture-affected zones, reinforcement layer, and concrete-foundation interface defects (authors' material)

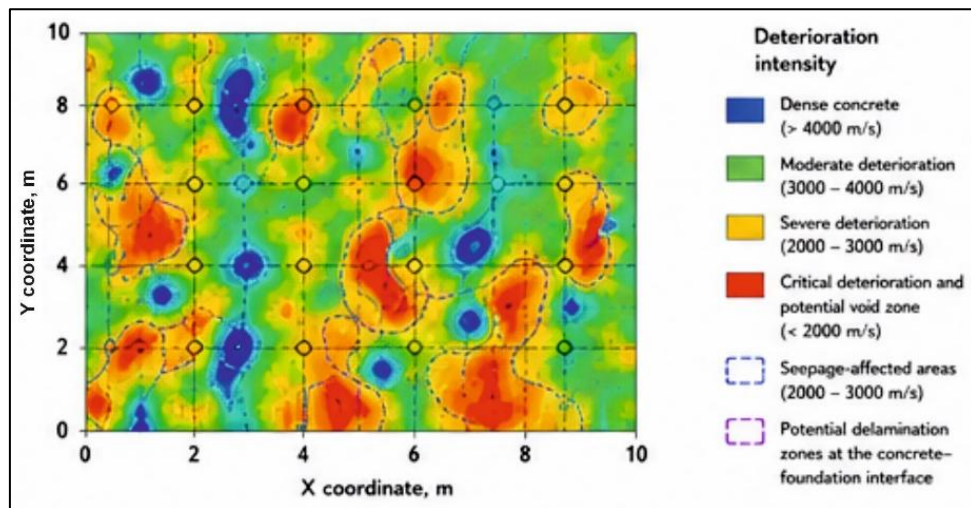
**Figure 11** presents the spatial deterioration intensity map of the concrete lining at a depth of  $Z = 0.19$  m. This level corresponds to the near-surface operating layer of the lining, where the effects of abrasion, cyclic wetting-drying, temperature gradients, and surface cracking are most pronounced. The map shows that the investigated area is not acoustically homogeneous. Dense concrete zones with velocities above 4000 m/s occupy approximately 14-17% of the investigated surface. Moderate deterioration zones with velocities of 3000-4000 m/s are dominant and account for 41-46% of the area. Severe deterioration zones with velocities of 2000-3000 m/s occupy 20-24%. Critical deterioration and potential void zones with velocities below 2000 m/s account for 6-8%. Filtration-affected zones occupy 18-22%, while delamination-prone interface regions account for 6-9%. This distribution indicates that the deterioration is spatially localized but not isolated. The most critical areas are concentrated along linear and elongated anomaly patterns, which may correspond to slab joints, filtration paths, and zones of weakened concrete-foundation contact.

Figure 11 - Spatial deterioration intensity map of the concrete lining (plan view,  $Z = 0.19$  m), (authors' material)

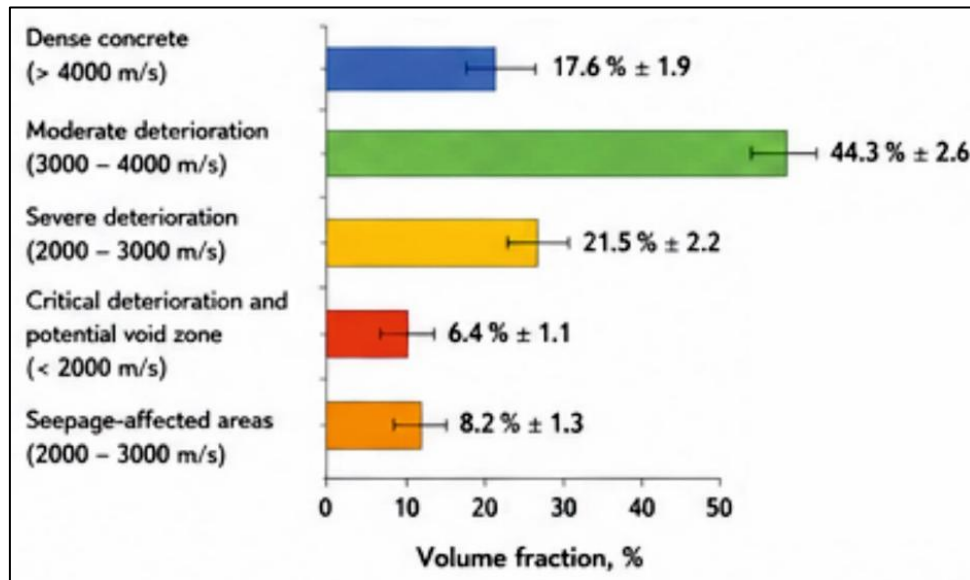
Figure 15 presents the volumetric distribution of structural deterioration zones. Unlike the plan-view map, this figure quantifies the deterioration throughout the entire investigated volume of  $10.0 \times 10.0 \times 0.60$  m. Dense concrete zones account for  $17.6 \pm 1.9\%$  of the volume. Moderately deteriorated concrete is the dominant class and accounts for  $44.3 \pm 2.6\%$ . Severe deterioration zones account for  $21.5 \pm 2.2\%$ . Critical deterioration and potential void zones account for  $6.4 \pm 1.1\%$ , while moisture-affected zones account for  $8.2 \pm 1.3\%$ . The total volume with significant deterioration, including severe, critical, and moisture-affected areas, reaches  $35.9 \pm 3.1\%$ . This value is important from an engineering perspective because it indicates that more than one-third of the investigated concrete lining volume has signs of substantial internal degradation.

Figure 15 - Volumetric distribution of deterioration zones within the concrete lining (authors' material)

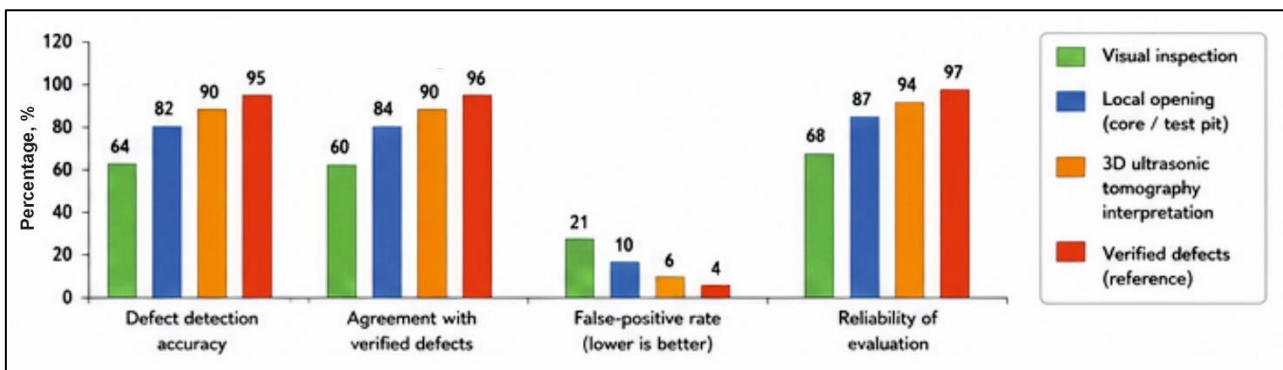
**Figure 18** validates the ultrasonic tomography results against field observations. The comparison includes visual inspection, local opening/core or test pit observations, tomography interpretation, and actual detected defects used as reference. The defect detection accuracy of tomography interpretation reaches approximately 90-95%, while visual inspection provides a lower value of about 64%. The agreement with actual defects is 90-96% for tomography-based interpretation and 84-90% for local opening data. The false-positive rate for tomography is approximately 4-7%, which is significantly lower than the uncertainty associated with visual-only inspection. The overall reliability of evaluation based on 3D ultrasonic tomography is estimated at 91-95%. These results confirm that 3D ultrasonic tomography provides a more reliable basis for engineering assessment than visual inspection alone, especially when hidden voids, delamination, and moisture-affected zones are present.

**Figure 18** - Validation of 3D ultrasonic tomography results against field observations (authors' material)
