## GROUND-PENETRATING RADAR DIAGNOSTICS OF THE TECHNICAL CONDITION OF LOAD-BEARING STRUCTURES OF THE KAPCHAGAY HYDROPOWER PLANT UNDER LONG-TERM OPERATION

**Abstract.** *Hydraulic structures deteriorate during long-term operation. Their soil foundations also change over time. Periodic non-destructive inspection is therefore essential. We applied ground-penetrating radar (GPR) to the Sh. Chokin Kapchagay Hydropower Plant on the Ili River, south-eastern Kazakhstan. The plant has operated for over 50 years in a seismic intensity 8 zone. We acquired 62 records with an OKO-3 system using 150 and 400 MHz antennas. Six structural elements were surveyed: the station-adjacent platform, the tail-race canal lining, the upstream slope protection of the channel and ravine dams, the 220 kV outdoor switchyard platform, and the stoplog storage area. Wave velocities were estimated from diffraction hyperbolas. Where possible, they were calibrated against borehole data. Radargrams were interpreted by radar facies analysis. The reinforced-concrete slope protection and canal lining show continuous slab reflections. No major defects or large voids were detected. However, a 35 m section of the canal lini

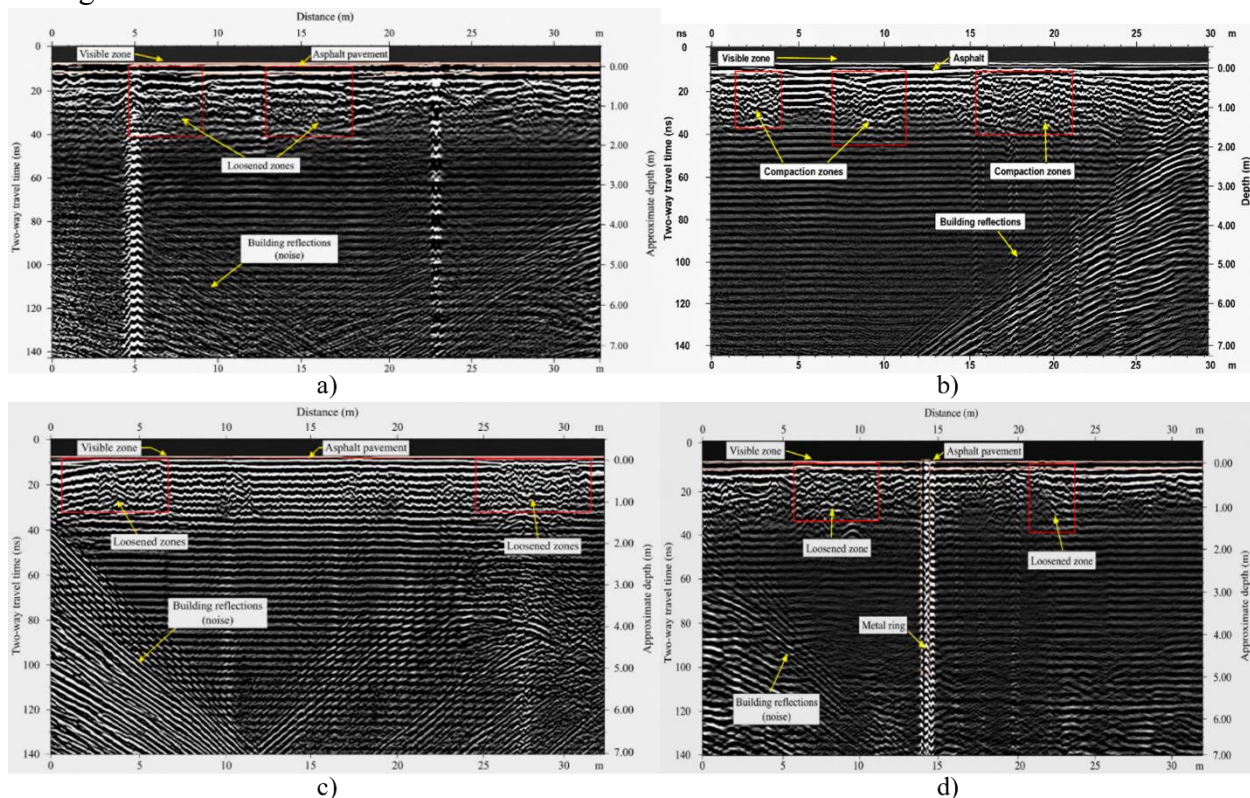
**Figure 7** - (a) GPR radargram - Transverse Profile 0010. (b) GPR radargram - Transverse Profiles 0012-0013. (c) GPR radargram - Transverse Profile 0016. (d) GPR radargram - Transverse Profile 0018 [Author's material]

Radargram No. 10 (Profile 0010, ~32 m; Fig. 7a) is the first transverse profile, oriented perpendicular to the longitudinal lines. It shows two zones of reduced compaction, at 4-8.5 m and ~12.5-17.5 m, extending to ~1.6 m and ~1.5 m depth. Their reflection pattern matches that of the longitudinal profiles. Two narrow vertical ringing bands are also present. The first, at ~4 m, is strong and extends through the full depth of the record. The second, at ~21 m, is weaker and discontinuous and is most distinct in the upper ~3 m. Both resemble the metal-ringing band on Profile 0018 and are attributed to buried metallic objects. The band at ~4 m coincides with the edge of the first zone, so this boundary cannot be located precisely. Building-induced dipping events occupy the lower part of the section, below ~4 m.

| Profile (Fig.) | Length | Compaction-loss zones | Building interference | Notable feature |
|---|---|---|---|---|
| 0012–0013 (Fig. 7 (b)) | ~34,5 m | Three zones, ~2-5, ~8-13 and ~18-24.5 m (to ~1.4, ~1.9 and ~1.6 m depth); ~42% | Right side (>18 m) | Largest share of loosened length and deepest zone (~1.9 m) of the dataset |

The survey was conducted in November, after a period of heavy rainfall. A zone of elevated moisture was recorded at 0.3–1.2 m depth over almost the entire platform. Infiltrated rainwater may therefore have increased the reflection amplitudes within the loosened zones.

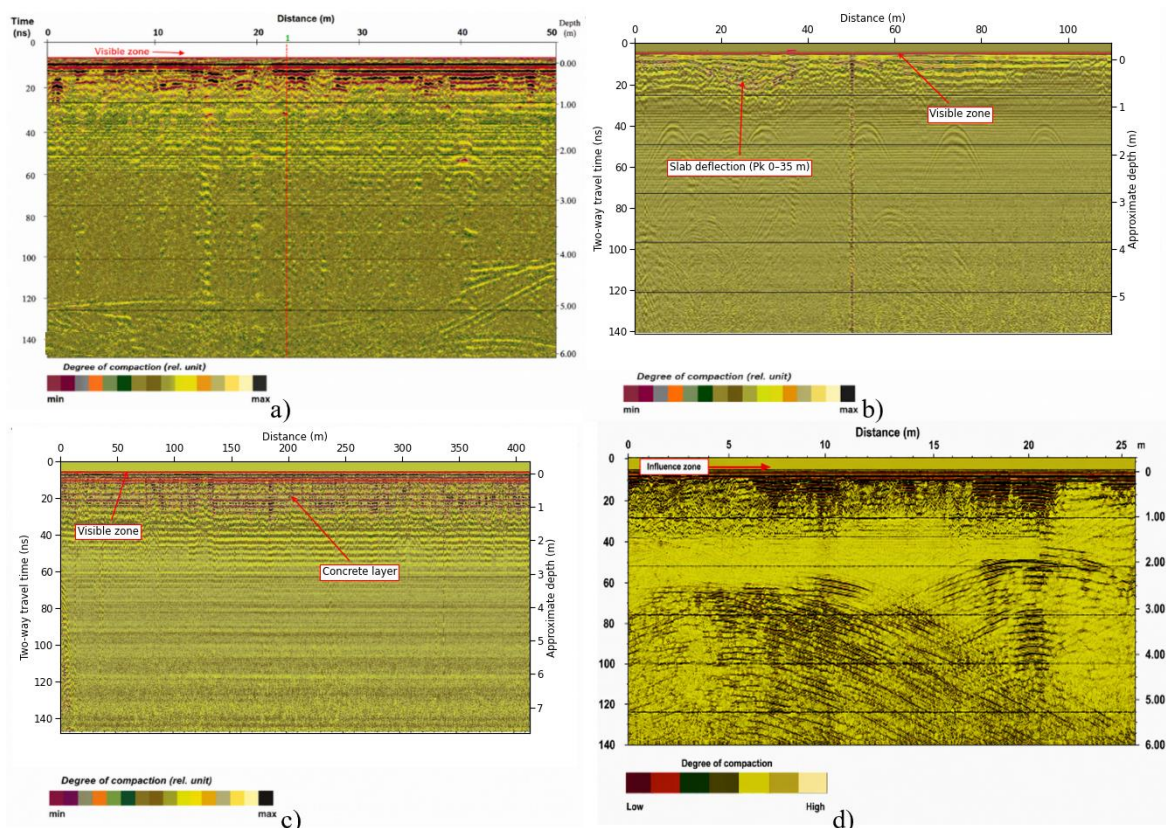
**Figure 8** - (a) Interpretation of Radargram No. 19 (Profile 001), tailrace-channel lining, right bank; (b) Interpretation of Radargram No. 21 (Profile 003), tailrace-channel lining, right bank; (c) Interpretation of Radargram No. 23 (Profile

Profile 003 (tailrace channel lining, 110 m;  $\sim 6$  m; Fig. 8b). At Pk  $\sim 0-35$  m, the lining package ( $\sim 8-20$  ns) is undulating and flexed downward, most clearly at Pk 20-35 m. On the rest of the profile it is planar and laterally continuous. The flexure is interpreted as local differential settlement of the slabs. This agrees with the settlement of the bedding at slab joints and the deformation of the lining surface observed on the right bank of the tailrace channel. The bedding contains isolated diffraction hyperbolae with apexes at  $\sim 40$  ns ( $\sim 1.3$  m). They occur at Pk  $\sim 32$ ,  $\sim 64$  and  $\sim 95$  m, at a regular spacing of  $\sim 30$  m. This regularity suggests periodic structural elements, such as drains or joint details, rather than random inclusions.

| Profile (Fig.) | Length | Facing/lining continuity | Bedding response | Interpretation |
|---|---|---|---|---|
| 001 (Fig. 8 (a)) | 50 m | Continuous package, no major discontinuity | Diffuse, reduced compaction; dipping hyperbolic fan at Pk 38-50 m | Lining without major defects; loosening at 0.8-2.0 m depth |
| 049 (Fig. 8 (c)) | $\sim 400$ m | Uniform amplitude and character along the entire length | Not differentiated at this scale | No slab failure or cavities; minor loosening at 0.9-1.1 m depth |

| 019 (Fig. 8 (d)) | 26 m | Continuous; local contact variation (Pk 5-13 m, 18-21 m) | Broad intersecting hyperbolae with near-air apparent velocity | Above-ground reflections; minor loosening at 0.9-1.5 m depth |

The four records cover the range of conditions observed on the concrete elements (Table 5). On Profiles 001 and 049, the slab reflector is continuous, with no offsets or loss of amplitude. The river-bed dam slope protection (Profile 049) is the more uniform of the two, whereas the tailrace lining (Profile 001) overlies reduced-compaction bedding. Profile 003 is the only record on which the slab reflector itself is deformed, over ~35 m. This indicates settlement of the slabs, not a feature confined to the bedding. On Profile 019, the slab reflector is continuous but shows local amplitude variations, and the deeper events are unrelated to the subgrade. Because the slabs are only 0.20–0.30 m thick, the records confirm the continuity of the slope protection and the absence of large voids beneath it, but cannot exclude thin delaminations.

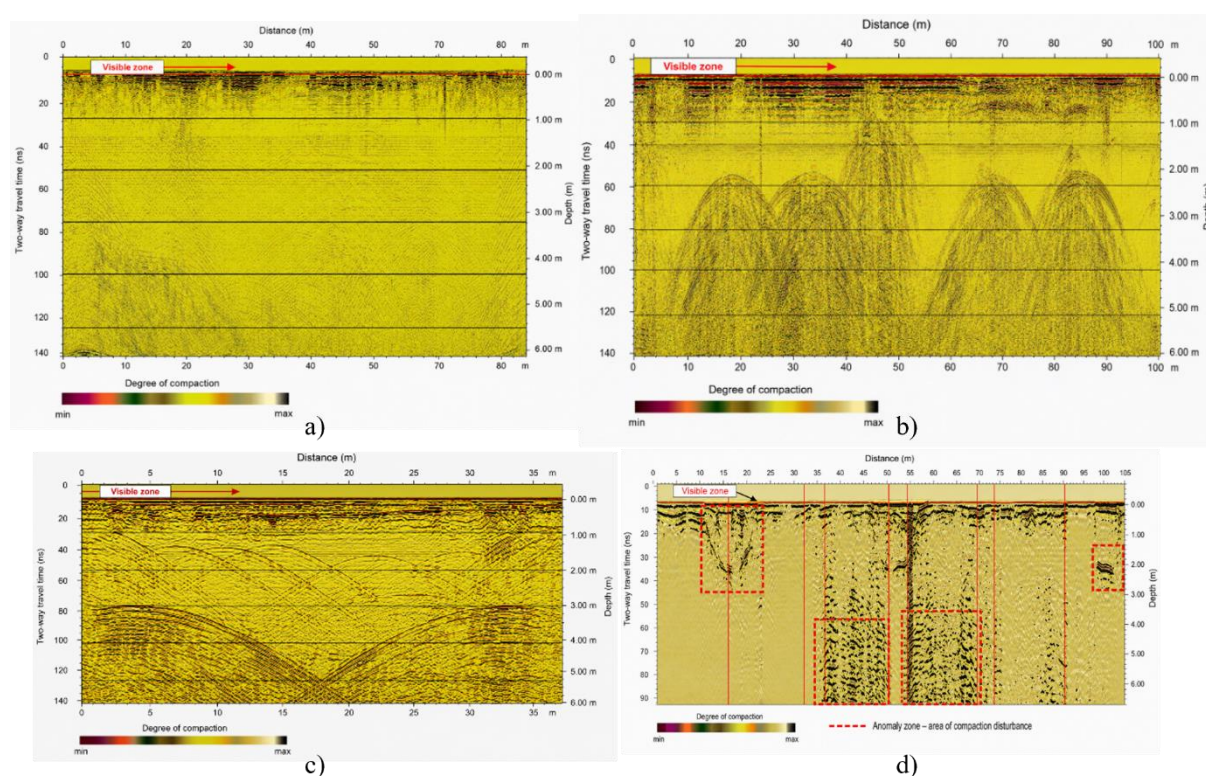
Profile 034 (switchyard platform, 88 m; ~6 m at  $v \approx 0.085$  m/ns; Fig. 9a). Drilling on the platform is prohibited because of the high-voltage equipment, so GPR is the only subsurface method available here. The near-surface reflector package (to ~15-20 ns) is thin and irregular. This is consistent with a graded, compacted pavement and fill rather than a monolithic slab. The upper ~2 m contain only minor local features. The deeper part of the section shows faint, broad hyperbolic arcs and, below ~4 m, sets of dipping events in the lower corners. These events are of the same type as on Profiles 040 and 043 and are attributed to above-ground structures. Field observations indicate fill to 1.5-2.0 m depth over crushed-stone soil and local objects at 0.5-2.0 m depth. No anomalous zones of loosening or settlement were found. A zone of elevated moisture at 0.2-1.5 m depth appears on most switchyard records. It is attributed to rainfall infiltration a few days before the survey. Boreholes Nos. 8 and 9, drilled around the platform in 2010, and borehole No. 12 at its southern boundary found no water-saturated soils.

Radargram No. 60 (Profile 060, stop-log storage area, 105 m; ~0-97 ns, ~6.3 m at  $v \approx 0.14-0.15$  m/ns; Fig. 9d) was recorded along the line of ground disturbance. Four anomalous zones of loosening are outlined on the original record. Zone 1 (Pk ~10-25 m, from the surface to ~2.7 m) is a downward-tapering, funnel-shaped disruption. It is consistent with a local near-surface subsidence feature. Zones 2 and 3 (Pk ~35-50 m and ~54.5-70.5 m, from ~3.5 m to the base of the record at ~6.3 m) are the largest anomalies of the survey. Each shows dense, chaotic, high-amplitude scattering over ~15-16 m. This indicates intense loosening of the ground, and voids cannot be excluded. Both zones reach the base of the record, so their lower boundaries are not resolved. At the western edge of Zone 3 (Pk ~55 m), a narrow vertical band of high-amplitude reflections extends from the surface to the base of the record. It may correspond to the support post or to the vertical cavity observed at the site. Zone 4 (Pk ~96-104 m, ~1.2-2.6 m) is smaller. Surface water from rainfall and snowmelt enters a vertical cavity near a support post. The cavity formed at the contact between the reinforced-concrete and soil cover of the site. Extending the reinforced-concrete cover to the boundary of the storage area and installing a drainage system are recommended.

| Profile (Fig.) | Signature | Geometry | Interpreted origin | Recommended action |
|---|---|---|---|---|
| 034 (Fig. 9 (a)) | Minor local features in the upper ~2 m; faint broad arcs and dipping events below ~4 m | Deeper events of the same type as on Profiles 040 and 043 | Graded, compacted fill without loosening; deeper events from above-ground structures | Correlate with as-built switchyard drawings |
| 060 (Fig. 9 (d)) | Four zones: funnel-shaped subsidence, two chaotic scattering zones, smaller shallow zone | Irregular, high-amplitude; up to ~16 m wide; ~3.5 m to the base of the record (~6.3 m) | Intense loosening of the ground; voids not excluded | Highest priority: test pits or probing; drainage and cover extension |

These four records show how the geometry of an anomaly indicates its origin (Table 6). Compact reflections in the upper ~2 m (Profile 040, Pk ~86 m) indicate local buried objects. Broad hyperbolae with apparent velocities of ~0.2-0.3 m/ns (Profiles 034, 040 and 043) are too wide for the ground velocity. They are reflections from above-ground structures and must be excluded from the subsurface interpretation. Chaotic, high-amplitude scattering over 15 m or more (Radargram No. 60) indicates intense loosening of the ground. Comparing the apparent velocity of each hyperbola with the velocity of the medium is therefore a simple safeguard. It prevents reflections from the dense above-ground infrastructure of a hydropower site from being misinterpreted as subsurface features..

6. The investigated structures show no evidence of widespread subsurface deterioration. The stop-log storage area should be investigated first by test pits or probing. To stop further loosening there, the reinforced-concrete cover should be extended to the boundary of the storage area and a drainage system installed. Repeated GPR surveys along the same profiles are needed to establish whether the settlement of the tailrace channel lining is stable or progressive.
