## GROUND-PENETRATING RADAR DIAGNOSTICS OF THE TECHNICAL CONDITION OF LOAD-BEARING STRUCTURES OF THE KAPCHAGAY HYDROPOWER PLANT UNDER LONG-TERM OPERATION

**Abstract.** *Hydraulic structures deteriorate during long-term operation. Their soil foundations also change over time. Periodic non-destructive inspection is therefore essential. We applied ground-penetrating radar (GPR) to the Sh. Chokin Kapchagay Hydropower Plant on the Ili River, south-eastern Kazakhstan. The plant has operated for over 50 years in a seismic intensity 8 zone. We acquired 62 records with an OKO-3 system using 150 and 400 MHz antennas. Six structural elements were surveyed: the station-adjacent platform, the tailrace canal lining, the upstream slope protection of the channel and ravine dams, the 220 kV outdoor switchyard platform, and the stoplog storage area. Wave velocities were estimated from diffraction hyperbolas. Where possible, they were calibrated against borehole data. Radargrams were interpreted by radar facies analysis. The reinforced-concrete slope protection and canal lining show continuous slab reflections. No major defects or large voids were detected. However, a 35 m section of the canal linin

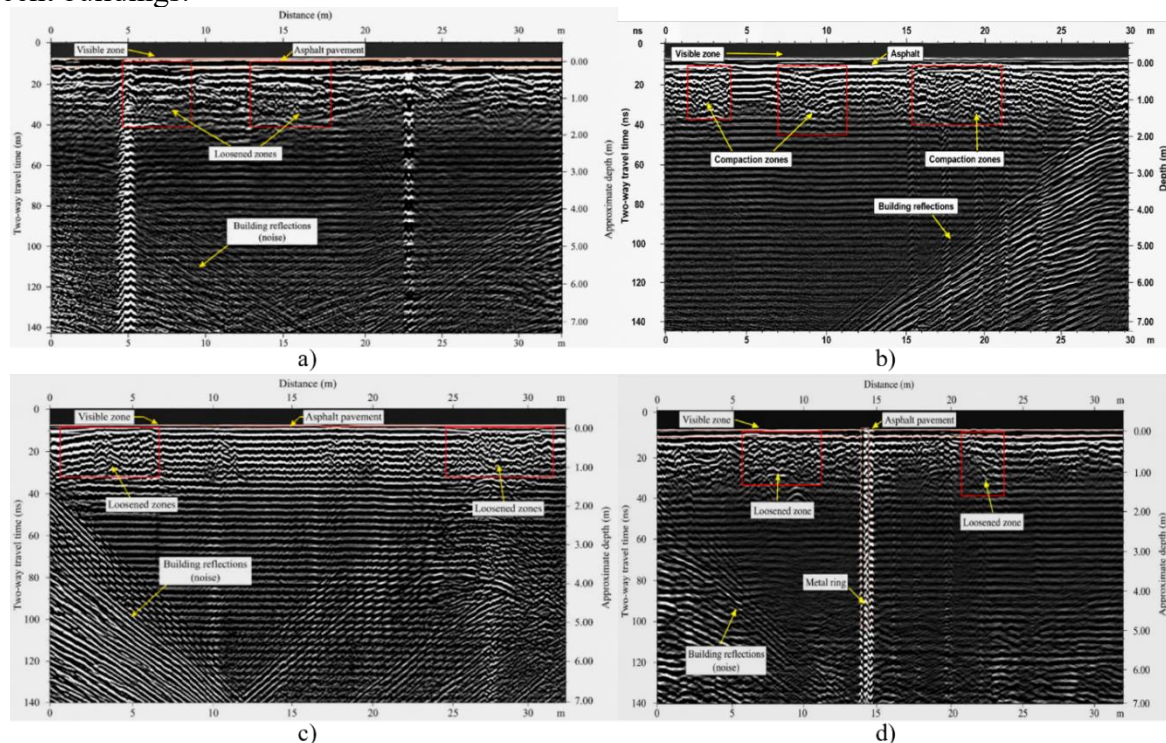
**Figure 7** - (a) GPR radargram - Transverse Profile 0010. (b) GPR radargram - Transverse Profiles 0012-0013. (c) GPR radargram - Transverse Profile 0016. (d) GPR radargram - Transverse Profile 0018 [Author's material]

Radargram No. 10 (Profile 0010, ~32 m; Fig. 7a) is the first transverse profile, oriented perpendicular to the longitudinal lines. It shows two zones of reduced compaction, at 4-8.5 m and ~12.5-17.5 m, extending to ~1.6 m and ~1.5 m depth. Their reflection pattern matches that of the longitudinal profiles. Two narrow vertical ringing bands are also present. The first, at ~4 m, is strong and extends through the full depth of the record. The second, at ~21 m, is weaker and discontinuous and is most distinct in the upper ~3 m. Both resemble the metal-ringing band on Profile 0018 and are attributed to buried metallic objects. The band at ~4 m coincides with the edge of the first zone, so this boundary cannot be located precisely. Building-induced dipping events occupy the lower part of the section, below ~4 m.

| Profile (Fig.) | Length | Compaction-loss zones | Building interference | Notable feature |
|---|---|---|---|---|
| 0012–0013 (Fig. 7 (b)) | ~34,5 m | Three zones, ~2-5, ~8-13 and ~18-24.5 m (to ~1.4, ~1.9 and ~1.6 m depth); ~42% | Right side (>18 m) | Largest share of loosened length and deepest zone (~1.9 m) of the dataset |

The zones appear on both orthogonal sets of lines and are therefore distributed across the entire platform. They do not, however, form a continuous layer. On every profile, they alternate with intervals of undisturbed reflections and extend no deeper than ~1.1-1.9 m. This agrees with the field survey, which found weakly consolidated man-made fill at 0.5-1.5 m depth, locally to 2-2.5 m, and no loosening associated with concentrated seepage. The deeper part of this range (2-2.5 m) was not observed on the profiles analysed here.

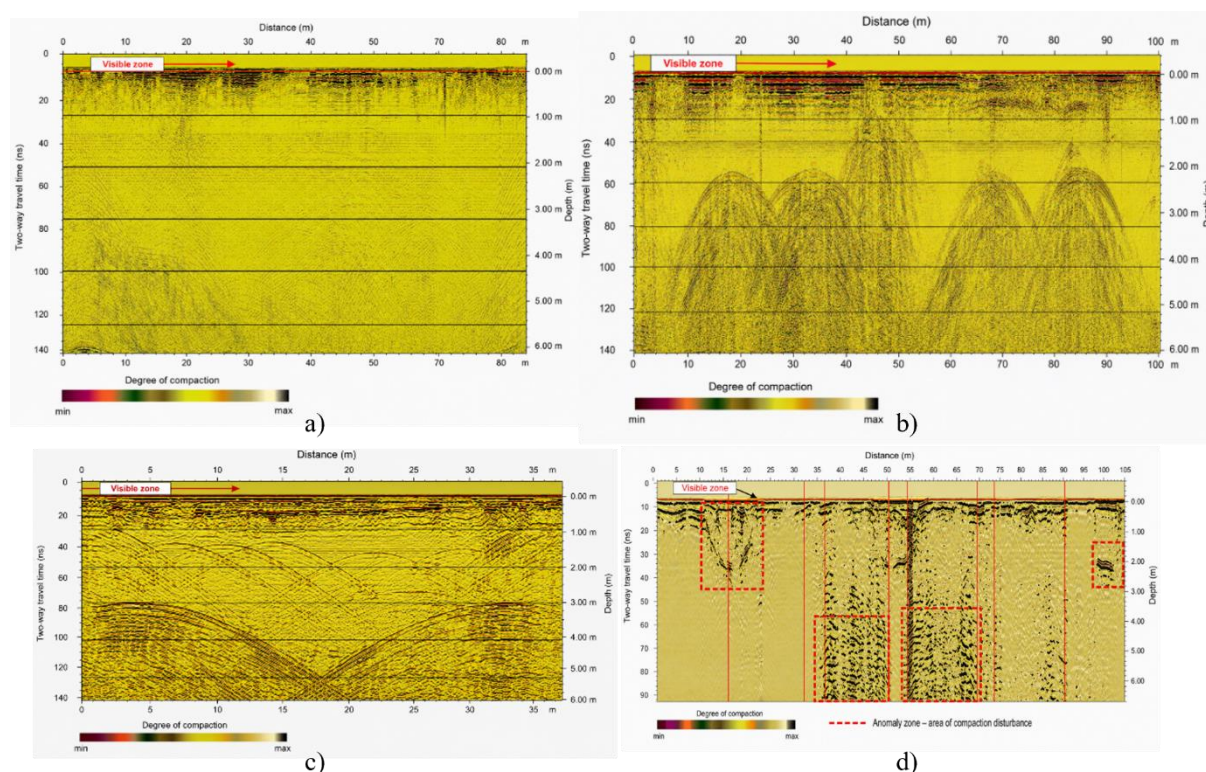
Profile 034 (switchyard platform, 88 m; ~6 m at  $v \approx 0.085$  m/ns; Fig. 9a). Drilling on the platform is prohibited because of the high-voltage equipment, so GPR is the only subsurface method available here. The near-surface reflector package (to ~15-20 ns) is thin and irregular. This is consistent with a graded, compacted pavement and fill rather than a monolithic slab. The upper ~2 m contain only minor local features. The deeper part of the section shows faint, broad hyperbolic arcs and, below ~4 m, sets of dipping events in the lower corners. These events are of the same type as on Profiles 040 and 043 and are attributed to above-ground structures. Field observations indicate fill to 1.5-2.0 m depth over crushed-stone soil and local objects at 0.5-2.0 m depth. No anomalous zones of loosening or settlement were found. A zone of elevated moisture at 0.2-1.5 m depth appears on most switchyard records. It is attributed to rainfall infiltration a few days before the survey. Boreholes Nos. 8 and 9, drilled around the platform in 2010, and borehole No. 12 at its southern boundary found no water-saturated soils.

against the as-built layout of the switchyard. A small, compact reflection at Pk ~86 m and ~40 ns (~1.4 m) is consistent with the local buried objects observed at 0.5-2.0 m depth.

Radargram No. 60 (Profile 060, stop-log storage area, 105 m; ~0-97 ns, ~6.3 m at  $v \approx 0.14-0.15$  m/ns; Fig. 9d) was recorded along the line of ground disturbance. Four anomalous zones of loosening are outlined on the original record. Zone 1 (Pk ~10-25 m, from the surface to ~2.7 m) is a downward-tapering, funnel-shaped disruption. It is consistent with a local near-surface subsidence feature. Zones 2 and 3 (Pk ~35-50 m and ~54.5-70.5 m, from ~3.5 m to the base of the record at ~6.3 m) are the largest anomalies of the survey. Each shows dense, chaotic, high-amplitude scattering over ~15-16 m. This indicates intense loosening of the ground, and voids cannot be excluded. Both zones reach the base of the record, so their lower boundaries are not resolved. At the western edge of Zone 3 (Pk ~55 m), a narrow vertical band of high-amplitude reflections extends from the surface to the base of the record. It may correspond to the support post or to the vertical cavity observed at the site. Zone 4 (Pk ~96-104 m, ~1.2-2.6 m) is smaller. Surface water from rainfall and snowmelt enters a vertical cavity near a support post. The cavity formed at the contact between the reinforced-concrete and soil cover of the site. Extending the reinforced-concrete cover to the boundary of the storage area and installing a drainage system are recommended.

| Profile (Fig.) | Signature | Geometry | Interpreted origin | Recommended action |
|---|---|---|---|---|
| 034 (Fig. 9 (a)) | Minor local features in the upper ~2 m; faint broad arcs and dipping events below ~4 m | Deeper events of the same type as on Profiles 040 and 043 | Graded, compacted fill without loosening; deeper events from above-ground structures | Correlate with as-built switchyard drawings |
| 060 (Fig. 9 (d)) | Four zones: funnel-shaped subsidence, two chaotic scattering zones, smaller shallow zone | Irregular, high-amplitude; up to ~16 m wide; ~3.5 m to the base of the record (~6.3 m) | Intense loosening of the ground; voids not excluded | Highest priority: test pits or probing; drainage and cover extension |

4. The most significant anomalies occur in the stop-log storage area (Profile 060). A near-surface funnel-shaped subsidence feature extends to about 2.7 m depth. Two zones of chaotic, high-amplitude scattering, 15-16 m wide, extend from about 3.5 m to the base of the record. They indicate intense loosening of the ground, and voids cannot be excluded. The loosening is related to surface water entering a vertical cavity near a support post.

6. The investigated structures show no evidence of widespread subsurface deterioration. The stop-log storage area should be investigated first by test pits or probing. To stop further loosening there, the reinforced-concrete cover should be extended to the boundary of the storage area and a drainage system installed. Repeated GPR surveys along the same profiles are needed to establish whether the settlement of the tailrace channel lining is stable or progressive.
