## GROUND-PENETRATING RADAR DIAGNOSTICS OF THE TECHNICAL CONDITION OF LOAD-BEARING STRUCTURES OF THE KAPCHAGAY HYDROPOWER PLANT UNDER LONG-TERM OPERATION

**Abstract.** *Hydraulic structures deteriorate during long-term operation. Their soil foundations also change over time. Periodic non-destructive inspection is therefore essential. We applied ground-penetrating radar (GPR) to the Sh. Chokin Kapchagay Hydropower Plant on the Ili River, south-eastern Kazakhstan. The plant has operated for over 50 years in a seismic intensity 8 zone. We acquired 62 records with an OKO-3 system using 150 and 400 MHz antennas. Six structural elements were surveyed: the station-adjacent platform, the tailrace canal lining, the upstream slope protection of the channel and ravine dams, the 220 kV outdoor switchyard platform, and the stoplog storage area. Wave velocities were estimated from diffraction hyperbolas. Where possible, they were calibrated against borehole data. Radargrams were interpreted by radar facies analysis. The reinforced-concrete slope protection and canal lining show continuous slab reflections. No major defects or large voids were detected. However, a 35 m section of the canal linin

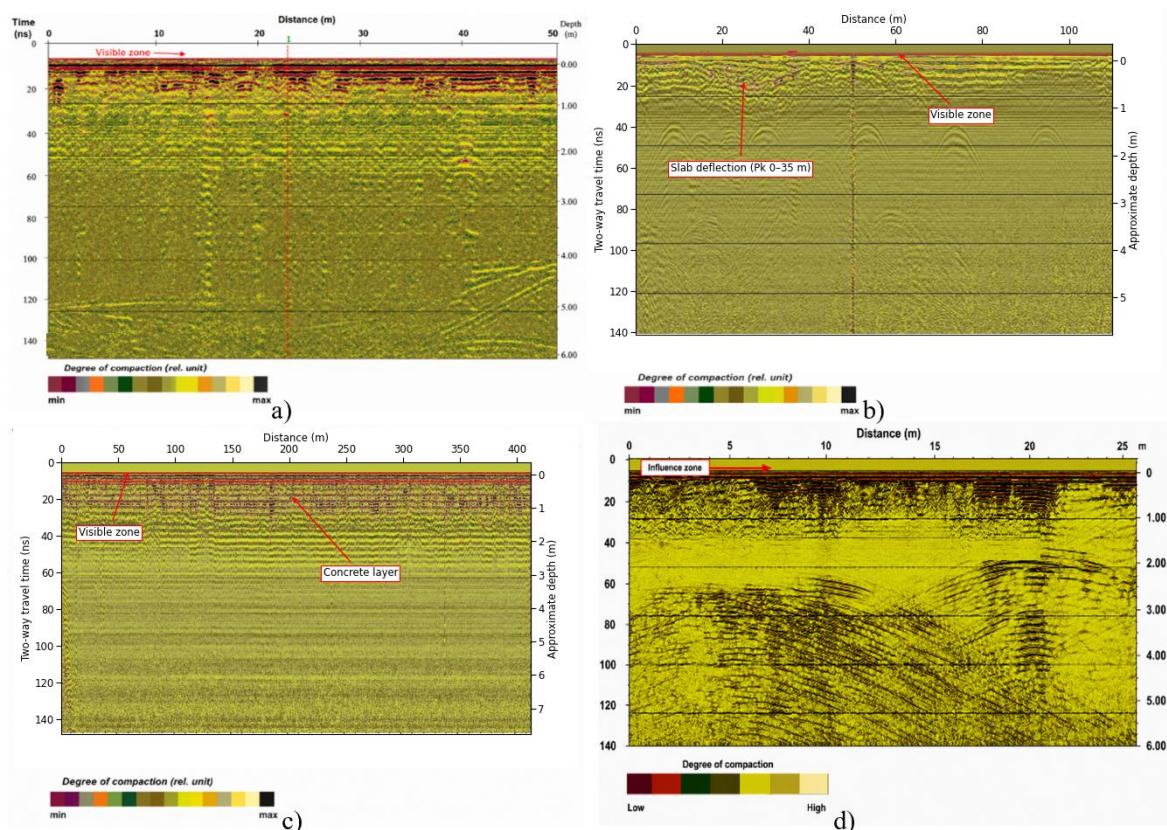
Profile 001 (tailrace channel lining, 50 m; ~6 m at  $v \approx 0.085$  m/ns; Fig. 8a). Below the direct-wave zone (~0-8 ns), a laterally continuous, high-amplitude reflector package occurs at ~8-25 ns. It represents the 0.20 m slab together with reverberation from its reinforcement mesh. The slab thickness

is close to the vertical resolution of the antenna. The continuity of the package therefore rules out major discontinuities, but it cannot resolve thin delaminations. Below the package (~25-150 ns), the bedding shows a diffuse, low-coherence texture consistent with reduced-compaction backfill. Field observations located loosened soil beneath the right-bank lining at 0.8-2.0 m depth and elevated moisture at 1.0-2.5 m depth. A set of dipping reflections occurs at Pk ~38-50 m (~100-150 ns; ~4-6 m) and continues to the end of the profile. It is attributed to a buried linear feature or to lateral reflection from an adjacent structure.

Profile 003 (tailrace channel lining, 110 m; ~6 m; Fig. 8b). At Pk ~0-35 m, the lining package (~8-20 ns) is undulating and flexed downward, most clearly at Pk 20-35 m. On the rest of the profile it is planar and laterally continuous. The flexure is interpreted as local differential settlement of the slabs. This agrees with the settlement of the bedding at slab joints and the deformation of the lining surface observed on the right bank of the tailrace channel. The bedding contains isolated diffraction hyperbolae with apexes at ~40 ns (~1.3 m). They occur at Pk ~32, ~64 and ~95 m, at a regular spacing of ~30 m. This regularity suggests periodic structural elements, such as drains or joint details, rather than random inclusions.

| Profile (Fig.) | Length | Facing/lining continuity | Bedding response | Interpretation |
|---|---|---|---|---|
| 001 (Fig. 8 (a)) | 50 m | Continuous package, no major discontinuity | Diffuse, reduced compaction; dipping hyperbolic fan at Pk 38-50 m | Lining without major defects; loosening at 0.8-2.0 m depth |
| 049 (Fig. 8 (c)) | ~400 m | Uniform amplitude and character along the entire length | Not differentiated at this scale | No slab failure or cavities; minor loosening at 0.9-1.1 m depth |
| 019 (Fig. 8 (d)) | 26 m | Continuous; local contact variation (Pk 5-13 m, 18-21 m) | Broad intersecting hyperbolae with near-air apparent velocity | Above-ground reflections; minor loosening at 0.9-1.5 m depth |

The four records cover the range of conditions observed on the concrete elements (Table 5). On Profiles 001 and 049, the slab reflector is continuous, with no offsets or loss of amplitude. The river-bed dam slope protection (Profile 049) is the more uniform of the two, whereas the tailrace lining

(Profile 001) overlies reduced-compaction bedding. Profile 003 is the only record on which the slab reflector itself is deformed, over ~35 m. This indicates settlement of the slabs, not a feature confined to the bedding. On Profile 019, the slab reflector is continuous but shows local amplitude variations, and the deeper events are unrelated to the subgrade. Because the slabs are only 0.20–0.30 m thick, the records confirm the continuity of the slope protection and the absence of large voids beneath it, but cannot exclude thin delaminations.

1. The reinforced-concrete slope protection of the river-bed dam and the tailrace channel lining show continuous slab reflectors. No major discontinuities or large voids beneath the slabs were found. Because the slabs are only 0.20-0.30 m thick, thin delaminations cannot be excluded at the frequencies used. The tailrace channel lining shows local differential settlement of the slabs over about 35 m (Profile 003).

2. Loosened soil occurs beneath the tailrace channel lining at 0.8-2.0 m depth and beneath the ravine dam slope protection at 0.9-1.5 m depth.
