## GROUND-PENETRATING RADAR DIAGNOSTICS OF THE TECHNICAL CONDITION OF LOAD-BEARING STRUCTURES OF THE KAPCHAGAY HYDROPOWER PLANT UNDER LONG-TERM OPERATION

**Abstract.** *Hydraulic structures deteriorate during long-term operation. Their soil foundations also change over time. Periodic non-destructive inspection is therefore essential. We applied ground-penetrating radar (GPR) to the Sh. Chokin Kapchagay Hydropower Plant on the Ili River, south-eastern Kazakhstan. The plant has operated for over 50 years in a seismic intensity 8 zone. We acquired 62 records with an OKO-3 system using 150 and 400 MHz antennas. Six structural elements were surveyed: the station-adjacent platform, the tailrace canal lining, the upstream slope protection of the channel and ravine dams, the 220 kV outdoor switchyard platform, and the stoplog storage area. Wave velocities were estimated from diffraction hyperbolas. Where possible, they were calibrated against borehole data. Radargrams were interpreted by radar facies analysis. The reinforced-concrete slope protection and canal lining show continuous slab reflections. No major defects or large voids were detected. However, a 35 m section of the canal linin

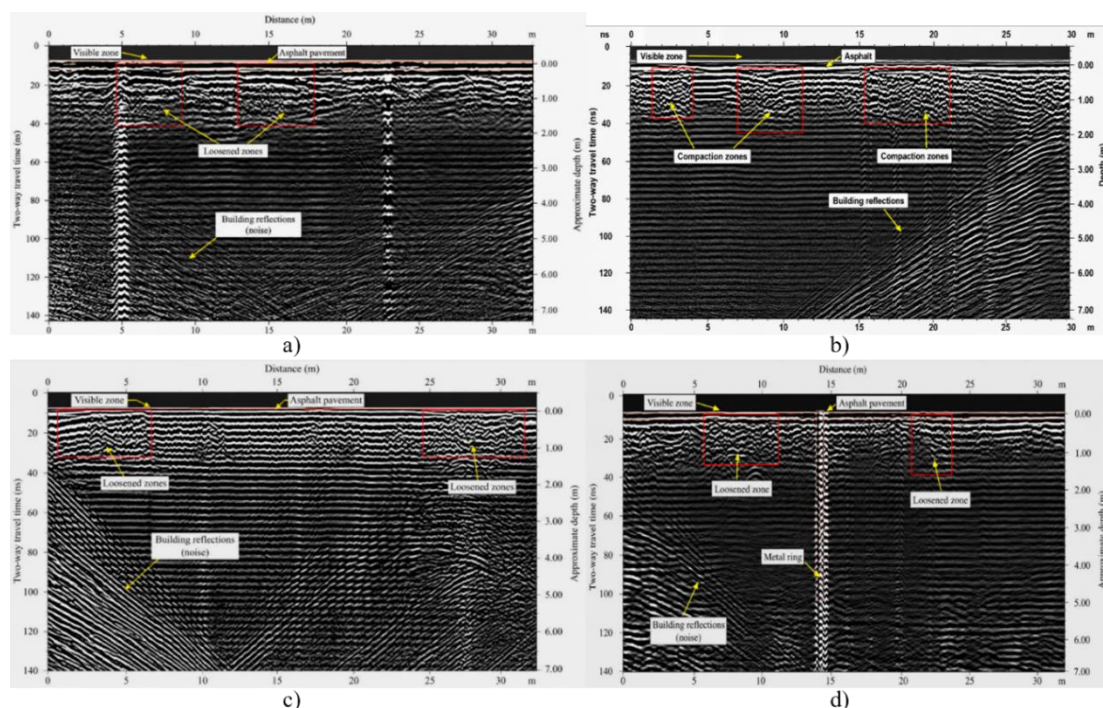
**Figure 7** - (a) GPR radargram - Transverse Profile 0010. (b) GPR radargram - Transverse Profiles 0012-0013. (c) GPR radargram - Transverse Profile 0016. (d) GPR radargram - Transverse Profile 0018 [Author's material]

Radargram No. 10 (Profile 0010, ~32 m; Fig. 7a) is the first transverse profile, oriented perpendicular to the longitudinal lines. It shows two zones of reduced compaction, at 4-8.5 m and ~12.5-17.5 m, extending to ~1.6 m and ~1.5 m depth. Their reflection pattern matches that of the longitudinal profiles. Two narrow vertical ringing bands are also present. The first, at ~4 m, is strong and extends through the full depth of the record. The second, at ~21 m, is weaker and discontinuous and is most distinct in the upper ~3 m. Both resemble the metal-ringing band on Profile 0018 and are attributed to buried metallic objects. The band at ~4 m coincides with the edge of the first zone, so this boundary cannot be located precisely. Building-induced dipping events occupy the lower part of the section, below ~4 m.

| Profile (Fig.) | Length | Compaction-loss zones | Building interference | Notable feature |
|---|---|---|---|---|
| 0012–0013 (Fig. 7 (b)) | ~34,5 m | Three zones, ~2-5, ~8-13 and ~18-24.5 m (to ~1.4, ~1.9 and ~1.6 m depth); ~42% | Right side (>18 m) | Largest share of loosened length and deepest zone (~1.9 m) of the dataset |

The zones appear on both orthogonal sets of lines and are therefore distributed across the entire platform. They do not, however, form a continuous layer. On every profile, they alternate with intervals of undisturbed reflections and extend no deeper than ~1.1-1.9 m. This agrees with the field survey, which found weakly consolidated man-made fill at 0.5-1.5 m depth, locally to 2-2.5 m, and no loosening associated with concentrated seepage. The deeper part of this range (2-2.5 m) was not observed on the profiles analysed here.

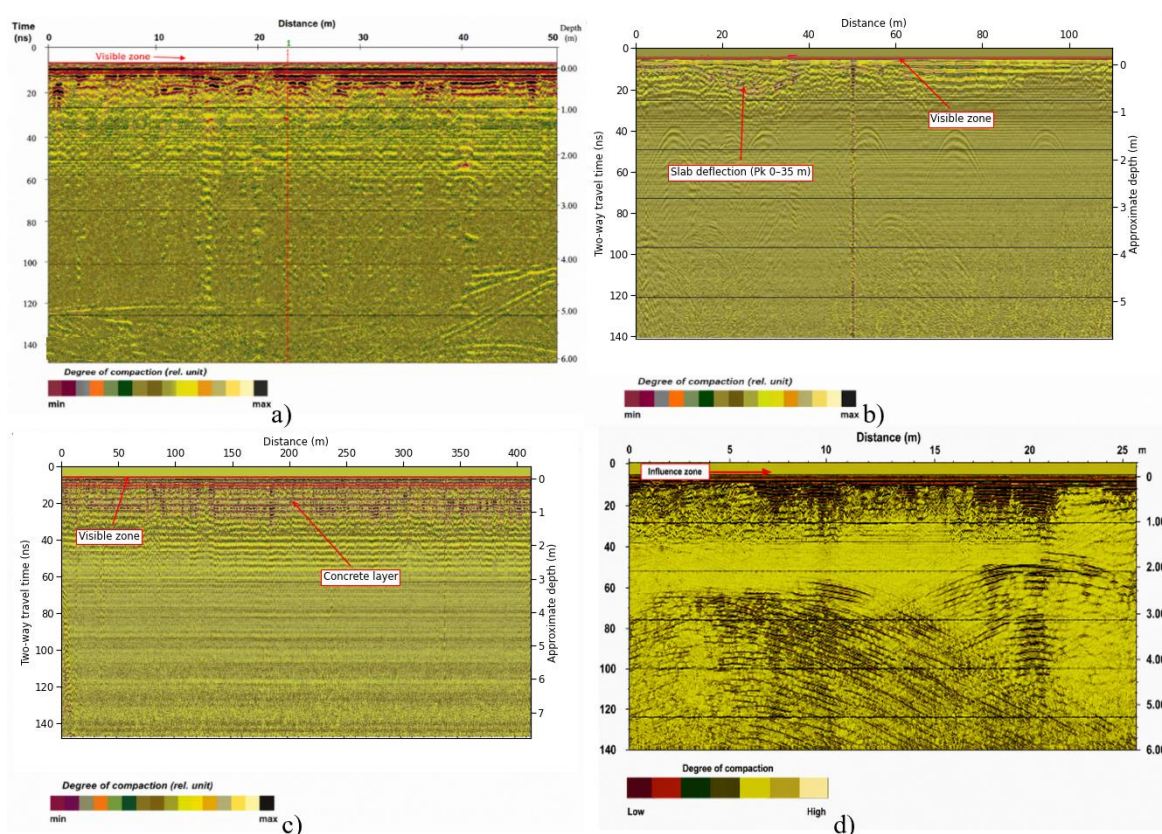
**Figure 8** - (a) Interpretation of Radargram No. 19 (Profile 001), tailrace-channel lining, right bank; (b) Interpretation of Radargram No. 21 (Profile 003), tailrace-channel lining, right bank; (c) Interpretation of Radargram No. 23 (Profile 049), river-bed dam, upstream slope; (d) Interpretation of Radargram No. 31 (Profile 019), the ravine dam, upstream slope [Author's material]

Profile 001 (tailrace channel lining, 50 m; ~6 m at  $v \approx 0.085$  m/ns; Fig. 8a). Below the direct-wave zone (~0-8 ns), a laterally continuous, high-amplitude reflector package occurs at ~8-25 ns. It represents the 0.20 m slab together with reverberation from its reinforcement mesh. The slab thickness

is close to the vertical resolution of the antenna. The continuity of the package therefore rules out major discontinuities, but it cannot resolve thin delaminations. Below the package (~25-150 ns), the bedding shows a diffuse, low-coherence texture consistent with reduced-compaction backfill. Field observations located loosened soil beneath the right-bank lining at 0.8-2.0 m depth and elevated moisture at 1.0-2.5 m depth. A set of dipping reflections occurs at Pk ~38-50 m (~100-150 ns; ~4-6 m) and continues to the end of the profile. It is attributed to a buried linear feature or to lateral reflection from an adjacent structure.

Profile 003 (tailrace channel lining, 110 m; ~6 m; Fig. 8b). At Pk ~0-35 m, the lining package (~8-20 ns) is undulating and flexed downward, most clearly at Pk 20-35 m. On the rest of the profile it is planar and laterally continuous. The flexure is interpreted as local differential settlement of the slabs. This agrees with the settlement of the bedding at slab joints and the deformation of the lining surface observed on the right bank of the tailrace channel. The bedding contains isolated diffraction hyperbolae with apexes at ~40 ns (~1.3 m). They occur at Pk ~32, ~64 and ~95 m, at a regular spacing of ~30 m. This regularity suggests periodic structural elements, such as drains or joint details, rather than random inclusions.

| Profile (Fig.) | Length | Facing/lining continuity | Bedding response | Interpretation |
|---|---|---|---|---|
| 001 (Fig. 8 (a)) | 50 m | Continuous package, no major discontinuity | Diffuse, reduced compaction; dipping hyperbolic fan at Pk 38-50 m | Lining without major defects; loosening at 0.8-2.0 m depth |
| 049 (Fig. 8 (c)) | ~400 m | Uniform amplitude and character along the entire length | Not differentiated at this scale | No slab failure or cavities; minor loosening at 0.9-1.1 m depth |
| 019 (Fig. 8 (d)) | 26 m | Continuous; local contact variation (Pk 5-13 m, 18-21 m) | Broad intersecting hyperbolae with near-air apparent velocity | Above-ground reflections; minor loosening at 0.9-1.5 m depth |

The four records cover the range of conditions observed on the concrete elements (Table 5). On Profiles 001 and 049, the slab reflector is continuous, with no offsets or loss of amplitude. The river-bed dam slope protection (Profile 049) is the more uniform of the two, whereas the tailrace lining

(Profile 001) overlies reduced-compaction bedding. Profile 003 is the only record on which the slab reflector itself is deformed, over ~35 m. This indicates settlement of the slabs, not a feature confined to the bedding. On Profile 019, the slab reflector is continuous but shows local amplitude variations, and the deeper events are unrelated to the subgrade. Because the slabs are only 0.20–0.30 m thick, the records confirm the continuity of the slope protection and the absence of large voids beneath it, but cannot exclude thin delaminations.

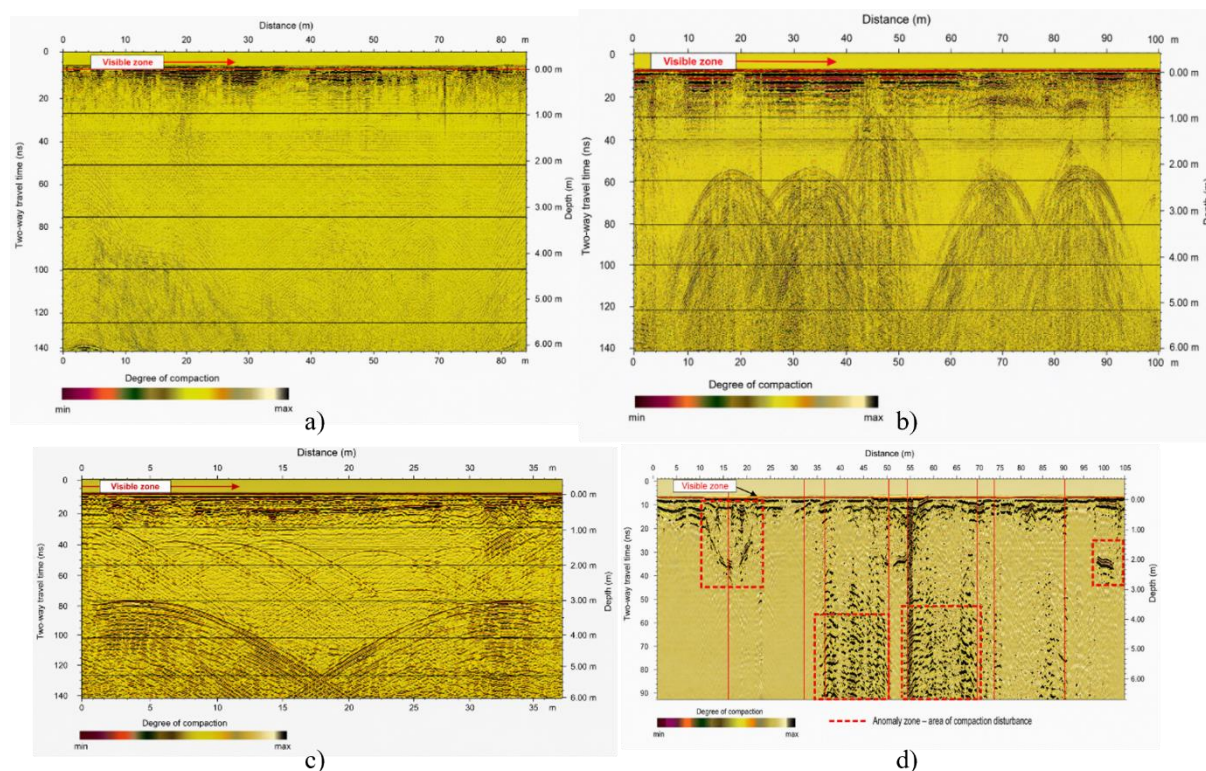
**Figure 9** - (a) Interpretation of Radargram No. 46 (Profile 034), 220 kV switchyard platform; (b) Interpretation of Radargram No. 52 (Profile 040), 220 kV switchyard platform; (c) Interpretation of Radargram No. 54 (Profile 043), 220 kV switchyard platform; (d) Interpretation of Radargram No. 60 (Profile 060), stop-log storage area, along the line of observed ground disturbance [Author's material]

Profile 034 (switchyard platform, 88 m; ~6 m at  $v \approx 0.085$  m/ns; Fig. 9a). Drilling on the platform is prohibited because of the high-voltage equipment, so GPR is the only subsurface method available here. The near-surface reflector package (to ~15-20 ns) is thin and irregular. This is consistent with a graded, compacted pavement and fill rather than a monolithic slab. The upper ~2 m contain only minor local features. The deeper part of the section shows faint, broad hyperbolic arcs and, below ~4 m, sets of dipping events in the lower corners. These events are of the same type as on Profiles 040 and 043 and are attributed to above-ground structures. Field observations indicate fill to 1.5-2.0 m depth over crushed-stone soil and local objects at 0.5-2.0 m depth. No anomalous zones of loosening or settlement were found. A zone of elevated moisture at 0.2-1.5 m depth appears on most switchyard records. It is attributed to rainfall infiltration a few days before the survey. Boreholes Nos. 8 and 9, drilled around the platform in 2010, and borehole No. 12 at its southern boundary found no water-saturated soils.

against the as-built layout of the switchyard. A small, compact reflection at Pk ~86 m and ~40 ns (~1.4 m) is consistent with the local buried objects observed at 0.5-2.0 m depth.

Radargram No. 60 (Profile 060, stop-log storage area, 105 m; ~0-97 ns, ~6.3 m at  $v \approx 0.14-0.15$  m/ns; Fig. 9d) was recorded along the line of ground disturbance. Four anomalous zones of loosening are outlined on the original record. Zone 1 (Pk ~10-25 m, from the surface to ~2.7 m) is a downward-tapering, funnel-shaped disruption. It is consistent with a local near-surface subsidence feature. Zones 2 and 3 (Pk ~35-50 m and ~54.5-70.5 m, from ~3.5 m to the base of the record at ~6.3 m) are the largest anomalies of the survey. Each shows dense, chaotic, high-amplitude scattering over ~15-16 m. This indicates intense loosening of the ground, and voids cannot be excluded. Both zones reach the base of the record, so their lower boundaries are not resolved. At the western edge of Zone 3 (Pk ~55 m), a narrow vertical band of high-amplitude reflections extends from the surface to the base of the record. It may correspond to the support post or to the vertical cavity observed at the site. Zone 4 (Pk ~96-104 m, ~1.2-2.6 m) is smaller. Surface water from rainfall and snowmelt enters a vertical cavity near a support post. The cavity formed at the contact between the reinforced-concrete and soil cover of the site. Extending the reinforced-concrete cover to the boundary of the storage area and installing a drainage system are recommended.

| Profile (Fig.) | Signature | Geometry | Interpreted origin | Recommended action |
|---|---|---|---|---|
| 034 (Fig. 9 (a)) | Minor local features in the upper ~2 m; faint broad arcs and dipping events below ~4 m | Deeper events of the same type as on Profiles 040 and 043 | Graded, compacted fill without loosening; deeper events from above-ground structures | Correlate with as-built switchyard drawings |
| 060 (Fig. 9 (d)) | Four zones: funnel-shaped subsidence, two chaotic scattering zones, smaller shallow zone | Irregular, high-amplitude; up to ~16 m wide; ~3.5 m to the base of the record (~6.3 m) | Intense loosening of the ground; voids not excluded | Highest priority: test pits or probing; drainage and cover extension |

4. The most significant anomalies occur in the stop-log storage area (Profile 060). A near-surface funnel-shaped subsidence feature extends to about 2.7 m depth. Two zones of chaotic, high-amplitude scattering, 15-16 m wide, extend from about 3.5 m to the base of the record. They indicate intense loosening of the ground, and voids cannot be excluded. The loosening is related to surface water entering a vertical cavity near a support post.

6. The investigated structures show no evidence of widespread subsurface deterioration. The stop-log storage area should be investigated first by test pits or probing. To stop further loosening there, the reinforced-concrete cover should be extended to the boundary of the storage area and a drainage system installed. Repeated GPR surveys along the same profiles are needed to establish whether the settlement of the tailrace channel lining is stable or progressive.
