## GROUND-PENETRATING RADAR DIAGNOSTICS OF THE TECHNICAL CONDITION OF LOAD-BEARING STRUCTURES OF THE KAPCHAGAY HYDROPOWER PLANT UNDER LONG-TERM OPERATION

This study presents a GPR assessment of six structural elements of one hydropower complex that includes two Class I earthfill dams. Five of these elements are surveyed by GPR within the annual

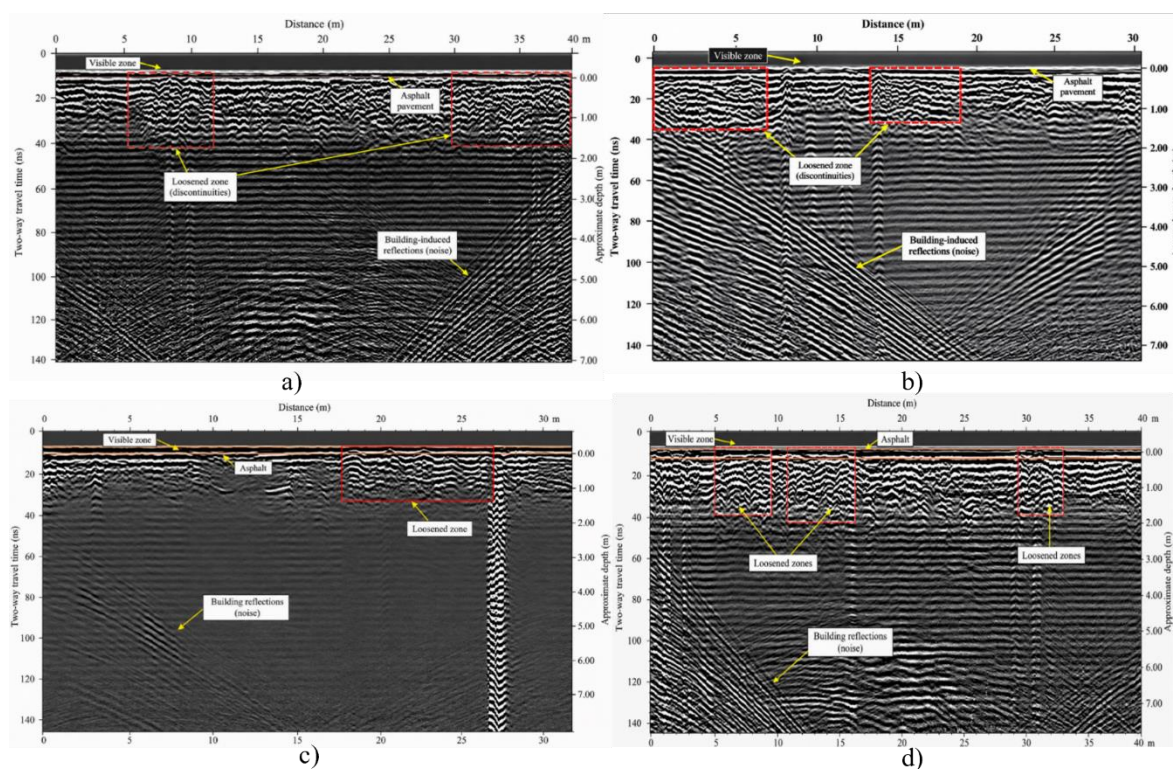
**Figure 6** - (a) GPR radargram - Longitudinal Profile 001. (b) GPR radargram - Longitudinal Profile 002. (c) GPR radargram - Longitudinal Profile 004. (d) GPR radargram - Longitudinal Profile 006 [Author's material]

Radargram No. 1 (Profile 001, ~40 m; Fig. 6a) is described in the most detail and serves as the reference for the other profiles. A continuous high-amplitude reflector marks the asphalt along the entire line. Two zones of reduced compaction occur at ~6-12.5 m and from ~31 m to the end of the line. They extend to ~1.7 m and ~1.6 m depth, respectively. The second zone reaches the end of the profile and may continue beyond it. Building-induced dipping events are strongest in the lower right part of the section (beyond ~29 m, below ~3 m). A weaker set appears in the lower left corner (0-8 m, below ~5 m).

| Profile (Fig.) | Length | Compaction-loss zones | Building interference | Notable feature |
|---|---|---|---|---|
| 006 (Fig. 6 (d)) | 41 m | Three zones, ~5-10, ~11.5-17.5 and ~30-34 m (to ~1.7, ~1.8 and ~1.5 m depth); ~37% | Both sides: strong on the left (0-10 m), weak in the lower right corner (>35 m) | First two zones, ~1.5 m apart, may form one disturbance |

All four longitudinal profiles show the same signature of compaction loss: a chaotic, discontinuous, high-amplitude pattern within the upper ~1.1-1.8 m (Table 3). This anomaly type is consistent across the platform and is not confined to individual profiles. The number of zones varies from one on Profile 004 to three on Profile 006. In total, zones of reduced compaction occupy ~36% of the longitudinal profile length (~51 of ~141 m). The share ranges from ~30% on Profile 004 to ~39% on Profile 001. Building-induced interference dominates on the right on Profile 001 and on the left on Profiles 002, 004 and 006. This pattern reflects the position of each survey line relative to the adjacent buildings.

The survey was conducted in November, after a period of heavy rainfall. A zone of elevated moisture was recorded at 0.3-1.2 m depth over almost the entire platform. Infiltrated rainwater may therefore have increased the reflection amplitudes within the loosened zones.

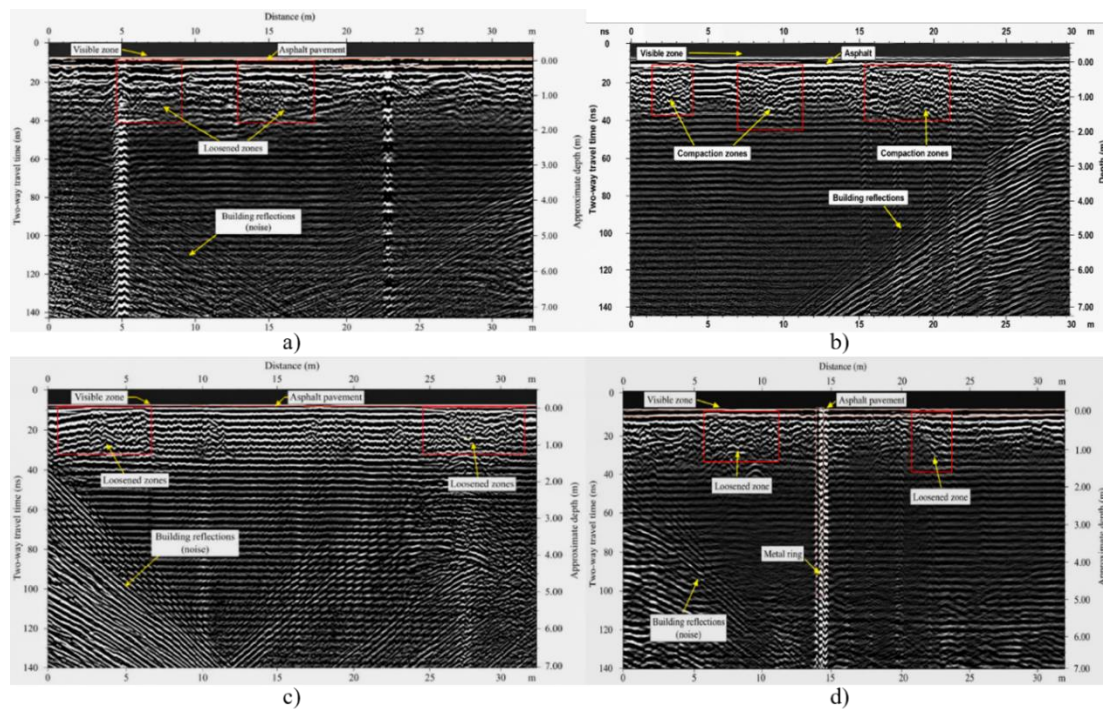
**Figure 7** - (a) GPR radargram - Transverse Profile 0010. (b) GPR radargram - Transverse Profiles 0012-0013. (c) GPR radargram - Transverse Profile 0016. (d) GPR radargram - Transverse Profile 0018 [Author's material]

Radargram No. 10 (Profile 0010, ~32 m; Fig. 7a) is the first transverse profile, oriented perpendicular to the longitudinal lines. It shows two zones of reduced compaction, at 4-8.5 m and ~12.5-17.5 m, extending to ~1.6 m and ~1.5 m depth. Their reflection pattern matches that of the longitudinal profiles. Two narrow vertical ringing bands are also present. The first, at ~4 m, is strong and extends through the full depth of the record. The second, at ~21 m, is weaker and discontinuous and is most distinct in the upper ~3 m. Both resemble the metal-ringing band on Profile 0018 and are attributed to buried metallic objects. The band at ~4 m coincides with the edge of the first zone, so this boundary cannot be located precisely. Building-induced dipping events occupy the lower part of the section, below ~4 m.

| 0012–0013 (Fig. 7 (b)) | ~34,5 m | Three zones, ~2-5, ~8-13 and ~18-24.5 m (to ~1.4, ~1.9 and ~1.6 m depth); ~42% | Right side (>18 m) | Largest share of loosened length and deepest zone (~1.9 m) of the dataset |

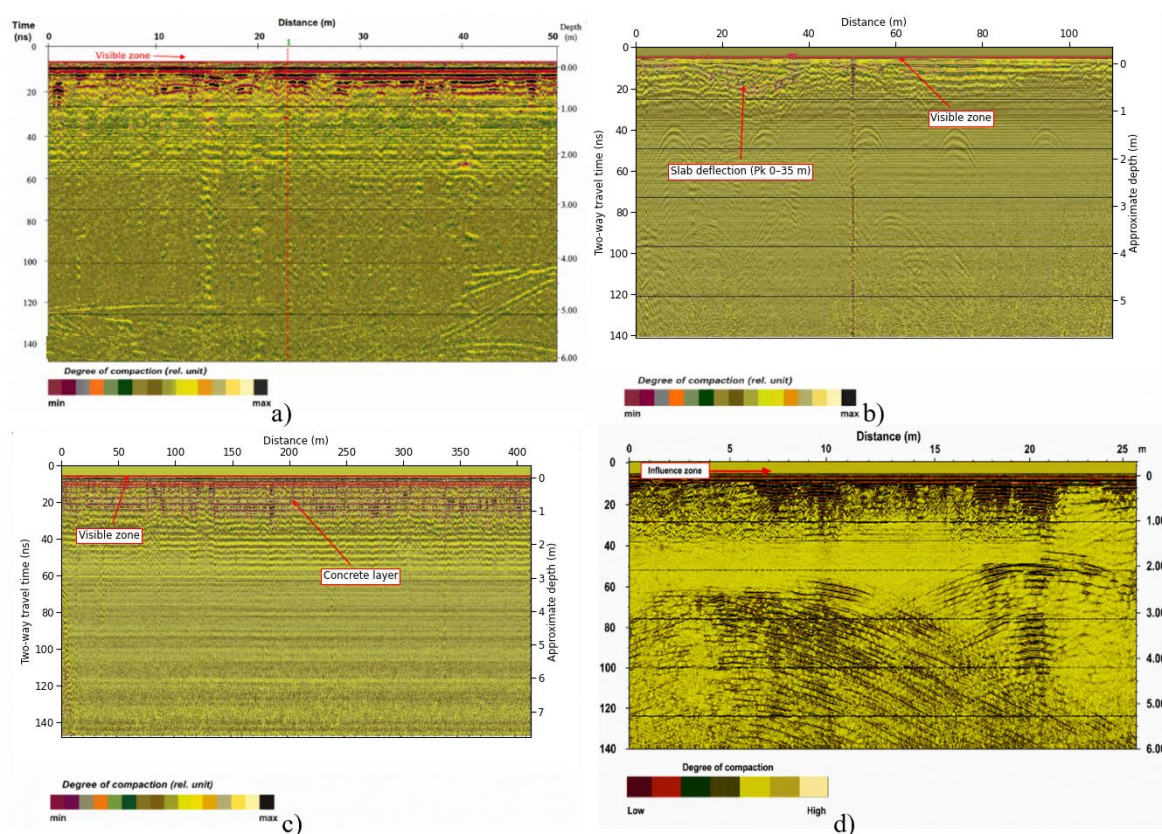
**Figure 8** - (a) Interpretation of Radargram No. 19 (Profile 001), tailrace-channel lining, right bank; (b) Interpretation of Radargram No. 21 (Profile 003), tailrace-channel lining, right bank; (c) Interpretation of Radargram No. 23 (Profile 049), river-bed dam, upstream slope; (d) Interpretation of Radargram No. 31 (Profile 019), the ravine dam, upstream slope [Author's material]

Profile 001 (tailrace channel lining, 50 m;  $\sim 6$  m at  $v \approx 0.085$  m/ns; Fig. 8a). Below the direct-wave zone ( $\sim 0-8$  ns), a laterally continuous, high-amplitude reflector package occurs at  $\sim 8-25$  ns. It represents the 0.20 m slab together with reverberation from its reinforcement mesh. The slab thickness is close to the vertical resolution of the antenna. The continuity of the package therefore rules out major discontinuities, but it cannot resolve thin delaminations. Below the package ( $\sim 25-150$  ns), the bedding shows a diffuse, low-coherence texture consistent with reduced-compaction backfill. Field observations located loosened soil beneath the right-bank lining at 0.8-2.0 m depth and elevated moisture at 1.0-2.5 m depth. A set of dipping reflections occurs at Pk  $\sim 38-50$  m ( $\sim 100-150$  ns;  $\sim 4-6$  m) and continues to the end of the profile. It is attributed to a buried linear feature or to lateral reflection from an adjacent structure.

Profile 003 (tailrace channel lining, 110 m;  $\sim 6$  m; Fig. 8b). At Pk  $\sim 0-35$  m, the lining package ( $\sim 8-20$  ns) is undulating and flexed downward, most clearly at Pk 20-35 m. On the rest of the profile it is planar and laterally continuous. The flexure is interpreted as local differential settlement of the slabs. This agrees with the settlement of the bedding at slab joints and the deformation of the lining surface observed on the right bank of the tailrace channel. The bedding contains isolated diffraction hyperbolae with apexes at  $\sim 40$  ns ( $\sim 1.3$  m). They occur at Pk  $\sim 32$ ,  $\sim 64$  and  $\sim 95$  m, at a regular spacing of  $\sim 30$  m. This regularity suggests periodic structural elements, such as drains or joint details, rather than random inclusions.

| Profile (Fig.) | Length | Facing/lining continuity | Bedding response | Interpretation |
|---|---|---|---|---|
| 001 (Fig. 8 (a)) | 50 m | Continuous package, no major discontinuity | Diffuse, reduced compaction; dipping hyperbolic fan at Pk 38-50 m | Lining without major defects; loosening at 0.8-2.0 m depth |
| 049 (Fig. 8 (c)) | $\approx 400$ m | Uniform amplitude and character along the entire length | Not differentiated at this scale | No slab failure or cavities; minor loosening at 0.9-1.1 m depth |
| 019 (Fig. 8 (d)) | 26 m | Continuous; local contact variation (Pk 5-13 m, 18-21 m) | Broad intersecting hyperbolae with near-air apparent velocity | Above-ground reflections; minor loosening at 0.9-1.5 m depth |

The four records cover the range of conditions observed on the concrete elements (Table 5). On Profiles 001 and 049, the slab reflector is continuous, with no offsets or loss of amplitude. The river-bed dam slope protection (Profile 049) is the more uniform of the two, whereas the tailrace lining (Profile 001) overlies reduced-compaction bedding. Profile 003 is the only record on which the slab reflector itself is deformed, over  $\sim 35$  m. This indicates settlement of the slabs, not a feature confined to the bedding. On Profile 019, the slab reflector is continuous but shows local amplitude variations, and the deeper events are unrelated to the subgrade. Because the slabs are only 0.20–0.30 m thick, the records confirm the continuity of the slope protection and the absence of large voids beneath it, but cannot exclude thin delaminations.

1. The reinforced-concrete slope protection of the river-bed dam and the tailrace channel lining show continuous slab reflectors. No major discontinuities or large voids beneath the slabs were found. Because the slabs are only 0.20-0.30 m thick, thin delaminations cannot be excluded at the frequencies used. The tailrace channel lining shows local differential settlement of the slabs over about 35 m (Profile 003).

2. Loosened soil occurs beneath the tailrace channel lining at 0.8-2.0 m depth and beneath the ravine dam slope protection at 0.9-1.5 m depth.

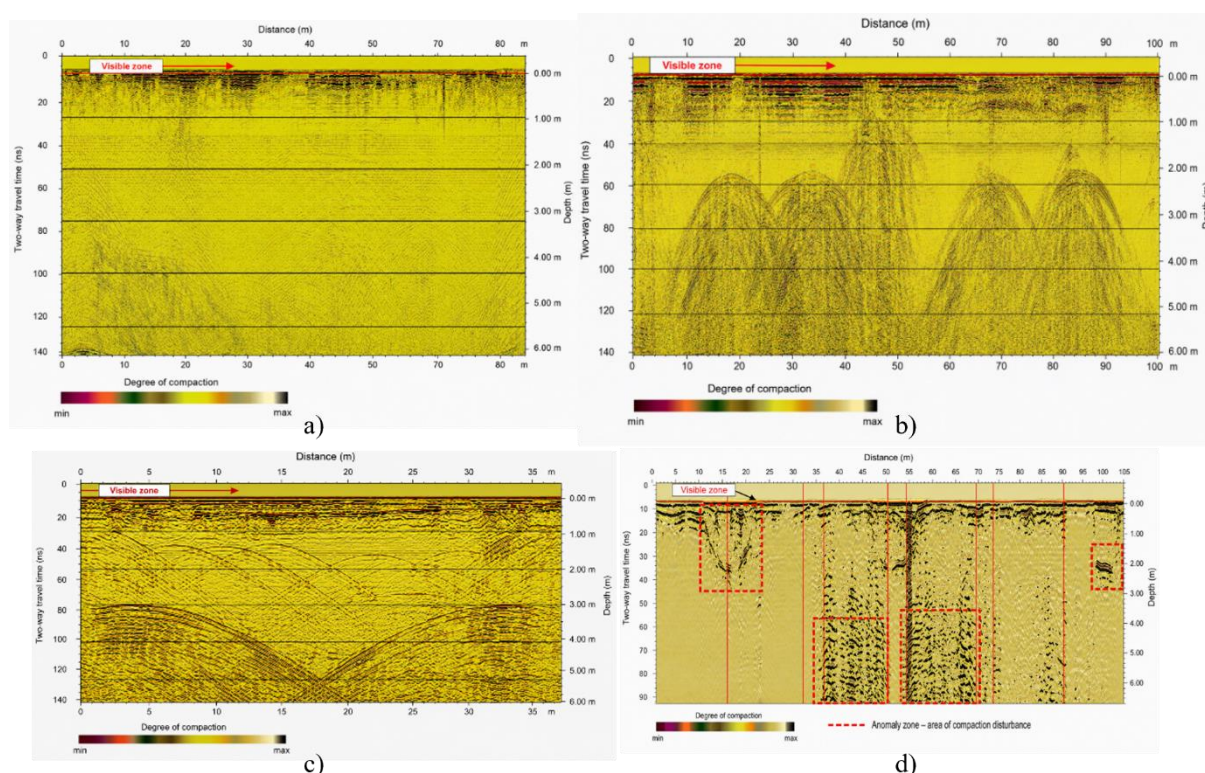
**Figure 9** - (a) Interpretation of Radargram No. 46 (Profile 034), 220 kV switchyard platform; (b) Interpretation of Radargram No. 52 (Profile 040), 220 kV switchyard platform; (c) Interpretation of Radargram No. 54 (Profile 043), 220 kV switchyard platform; (d) Interpretation of Radargram No. 60 (Profile 060), stop-log storage area, along the line of observed ground disturbance [Author's material]

Profile 034 (switchyard platform, 88 m;  $\sim 6$  m at  $v \approx 0.085$  m/ns; Fig. 9a). Drilling on the platform is prohibited because of the high-voltage equipment, so GPR is the only subsurface method available here. The near-surface reflector package (to  $\sim 15$ -20 ns) is thin and irregular. This is consistent with a graded, compacted pavement and fill rather than a monolithic slab. The upper  $\sim 2$  m contain only minor local features. The deeper part of the section shows faint, broad hyperbolic arcs and, below  $\sim 4$  m, sets of dipping events in the lower corners. These events are of the same type as on Profiles 040 and 043 and are attributed to above-ground structures. Field observations indicate fill to 1.5-2.0 m depth over crushed-stone soil and local objects at 0.5-2.0 m depth. No anomalous zones of loosening or settlement were found. A zone of elevated moisture at 0.2-1.5 m depth appears on most switchyard records. It is attributed to rainfall infiltration a few days before the survey. Boreholes Nos. 8 and 9, drilled around the platform in 2010, and borehole No. 12 at its southern boundary found no water-saturated soils.

Radargram No. 60 (Profile 060, stop-log storage area, 105 m; ~0-97 ns, ~6.3 m at  $v \approx 0.14$ -0.15 m/ns; Fig. 9d) was recorded along the line of ground disturbance. Four anomalous zones of loosening are outlined on the original record. Zone 1 (Pk ~10-25 m, from the surface to ~2.7 m) is a downward-tapering, funnel-shaped disruption. It is consistent with a local near-surface subsidence feature. Zones 2 and 3 (Pk ~35-50 m and ~54.5-70.5 m, from ~3.5 m to the base of the record at ~6.3 m) are the largest anomalies of the survey. Each shows dense, chaotic, high-amplitude scattering over ~15-16 m. This indicates intense loosening of the ground, and voids cannot be excluded. Both zones reach the base of the record, so their lower boundaries are not resolved. At the western edge of Zone 3 (Pk ~55 m), a narrow vertical band of high-amplitude reflections extends from the surface to the base of the record. It may correspond to the support post or to the vertical cavity observed at the site. Zone 4 (Pk ~96-104 m, ~1.2-2.6 m) is smaller. Surface water from rainfall and snowmelt enters a vertical cavity near a support post. The cavity formed at the contact between the reinforced-concrete and soil cover of the site. Extending the reinforced-concrete cover to the boundary of the storage area and installing a drainage system are recommended.

| Profile (Fig.) | Signature | Geometry | Interpreted origin | Recommended action |
|---|---|---|---|---|
| 034 (Fig. 9 (a)) | Minor local features in the upper ~2 m; faint broad arcs and dipping events below ~4 m | Deeper events of the same type as on Profiles 040 and 043 | Graded, compacted fill without loosening; deeper events from above-ground structures | Correlate with as-built switchyard drawings |
| 060 (Fig. 9 (d)) | Four zones: funnel-shaped subsidence, two chaotic scattering zones, smaller shallow zone | Irregular, high-amplitude; up to ~16 m wide; ~3.5 m to the base of the record (~6.3 m) | Intense loosening of the ground; voids not excluded | Highest priority: test pits or probing; drainage and cover extension |

These four records show how the geometry of an anomaly indicates its origin (Table 6). Compact reflections in the upper ~2 m (Profile 040, Pk ~86 m) indicate local buried objects. Broad hyperbolae with apparent velocities of ~0.2-0.3 m/ns (Profiles 034, 040 and 043) are too wide for the ground velocity. They are reflections from above-ground structures and must be excluded from the subsurface interpretation. Chaotic, high-amplitude scattering over 15 m or more (Radargram No. 60) indicates intense loosening of the ground. Comparing the apparent velocity of each hyperbola with the velocity of the medium is therefore a simple safeguard. It prevents reflections from the dense above-ground infrastructure of a hydropower site from being misinterpreted as subsurface features..

4. The most significant anomalies occur in the stop-log storage area (Profile 060). A near-surface funnel-shaped subsidence feature extends to about 2.7 m depth. Two zones of chaotic, high-amplitude scattering, 15-16 m wide, extend from about 3.5 m to the base of the record. They indicate intense loosening of the ground, and voids cannot be excluded. The loosening is related to surface water entering a vertical cavity near a support post.

5. Comparing the apparent velocity of diffraction hyperbolae with the velocity of the ground separates buried objects from reflections from above-ground structures. The large hyperbolae on the switchyard profiles (040 and 043) have apparent velocities of 0.2-0.3 m/ns and are caused by above-ground structures. Compact reflections in the upper 2 m indicate local buried objects.

6. The investigated structures show no evidence of widespread subsurface deterioration. The stop-log storage area should be investigated first by test pits or probing. To stop further loosening there, the reinforced-concrete cover should be extended to the boundary of the storage area and a drainage system installed. Repeated GPR surveys along the same profiles are needed to establish whether the settlement of the tailrace channel lining is stable or progressive.
