## NON-DESTRUCTIVE GROUND PENETRATING RADAR INSPECTION OF HYDRAULIC STRUCTURES USING THE OKO-3 GEORADAR FOR DETECTION OF HIDDEN DEFECTS AND ASSESSMENT OF TECHNICAL CONDITION

**Abstract.** *This paper presents the results of a Ground Penetrating Radar (GPR) survey of the earth-fill dam of the Tasotkel Reservoir located in the Zhambyl Region of the Republic of Kazakhstan. The relevance of the study is associated with the need to improve the reliability and safety of hydraulic structures operating under long-term service conditions and seismic activity. The aim of the study is to evaluate the effectiveness of the GPR method for detecting hidden defects, moisture-rich zones, and local heterogeneities within the dam body and foundation. The investigations were carried out using the OKO-3 Ground Penetrating Radar system equipped with 250, 400, and 900 MHz antennas. A comprehensive inspection algorithm was developed and validated, including collection of initial data, field measurements along longitudinal and transverse survey profiles, digital signal processing, and engineering interpretation of radargrams. Data processing involved dewow filtering, band-pass filtering, signal gain corre

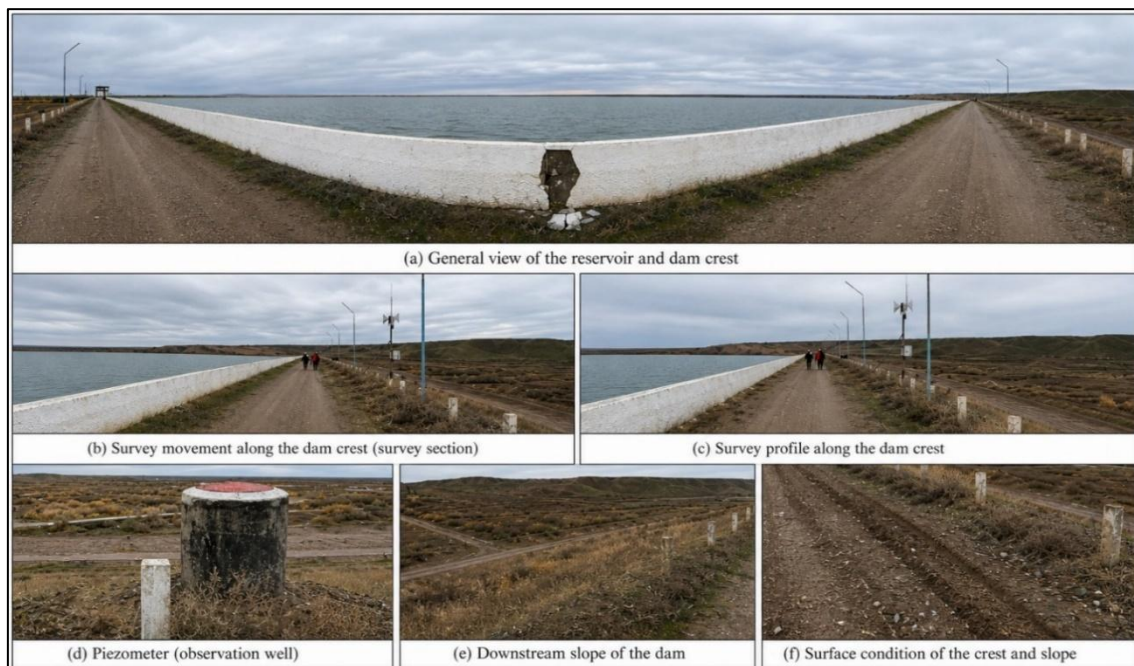
**Figure 3** - Field conditions of the Tasotkel dam and the GPR survey environment: (a) general view of the reservoir and dam crest; (b-c) survey movement and profile layout along the crest; (d) piezometer (observation well); (e-f) downstream slope and surface condition of the embankment (author's materials)

The Tasotkel Reservoir, located in the Zhambyl Region of the Republic of Kazakhstan, was selected as the research object (Figure 3). The reservoir was commissioned in 1974 and represents an important component of the regional water management system. Its operation is carried out in accordance with current regulatory documents, particularly the Reservoir Operation Rules developed in 2001 by the Kazyuzhgirovodkhoz Design and Survey Institute (Moldamuratov et. all., 2025).

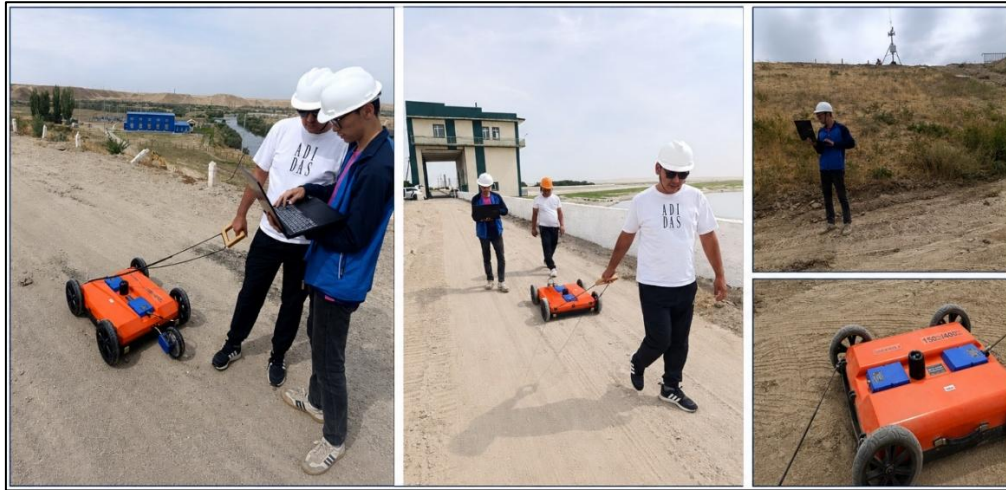
**Figure 7** - Field GPR Measurements (author's materials)
