UDC 699.841  
IRSTI 67.07.11  
RESEARCH ARTICLE

## THE SEISMIC EVENT ON JANUARY 23, 2024 AND THE ANALYSIS OF THE CONSEQUENCES FOR THE BUILDINGS OF THE ALMATY

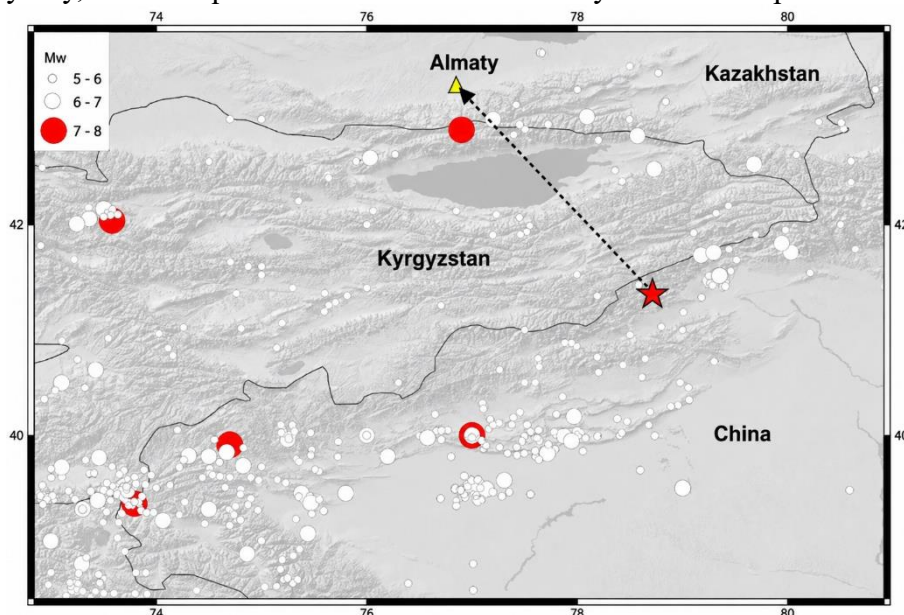
The coordinates of the epicenter are 41.23 degrees north latitude, 78.59 degrees east longitude. Magnitude  $M_b=7.27$ . The earthquake occurred 260 km south-east of Almaty city. The depth is 13 km (Figure 1).

**Figure 1** - Location of the earthquake on January 23, 2024 (according to the Data Center of the IGR NNC RK [https://kndc.kz/index.php/home-ru/kndcnews/227-operativnaya-informatsiya-o-proizoshedshem-zemletryasenii-23-01-2024-g])

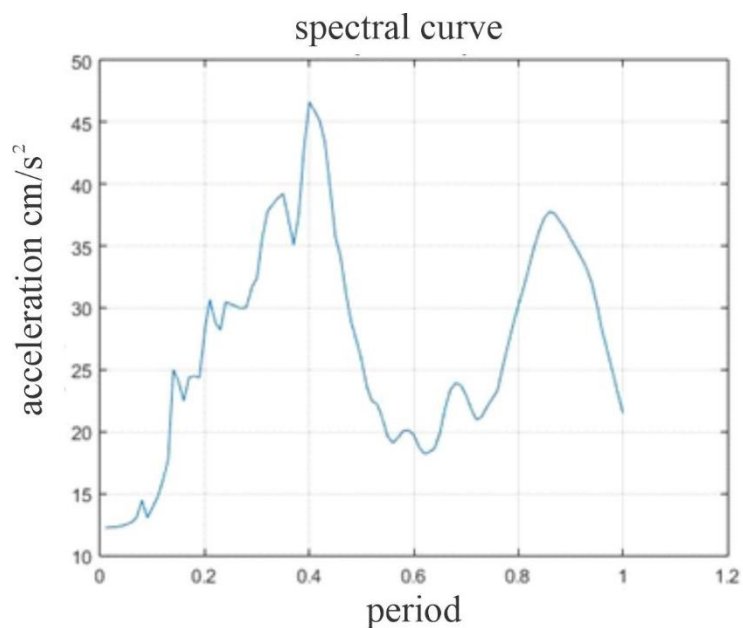
**Figure 2-** Spectral curve of the accelerogram at the No. 1 “INSTITUTE” station, OX, basement [Author's material]

The values of PGA accelerations in the basement parts of the building characterize the intensity of the seismic impact. Figure 2-4 shows spectral curves for accelerograms of the “INSTITUTE” station. The spectral curves were calculated using the SCILAB mathematical system based on the explicit Runge-Kutta method of 4-5 orders of accuracy.

The values of the vertical components of the impact in the basement parts of the building practically coincide and do not exceed the values of the horizontal components of the seismic impact, which corresponds to global patterns (Figure 2,3).

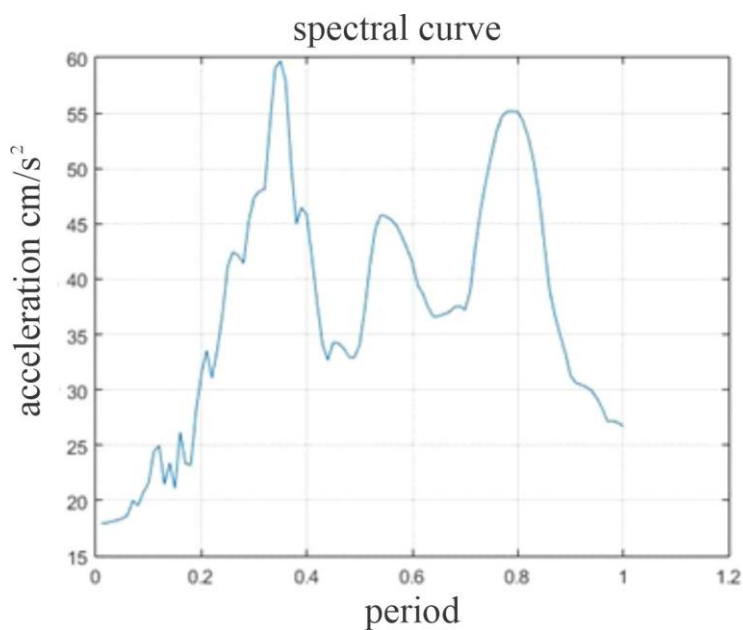
**Figure 3 -** Spectral curve of the accelerogram at the No. 1 “INSTITUTE” station, OY, basement [Author's material]
