UDC 699.841  
IRSTI 67.07.11  
RESEARCH ARTICLE

## THE SEISMIC EVENT ON JANUARY 23, 2024 AND THE ANALYSIS OF THE CONSEQUENCES FOR THE BUILDINGS OF THE ALMATY

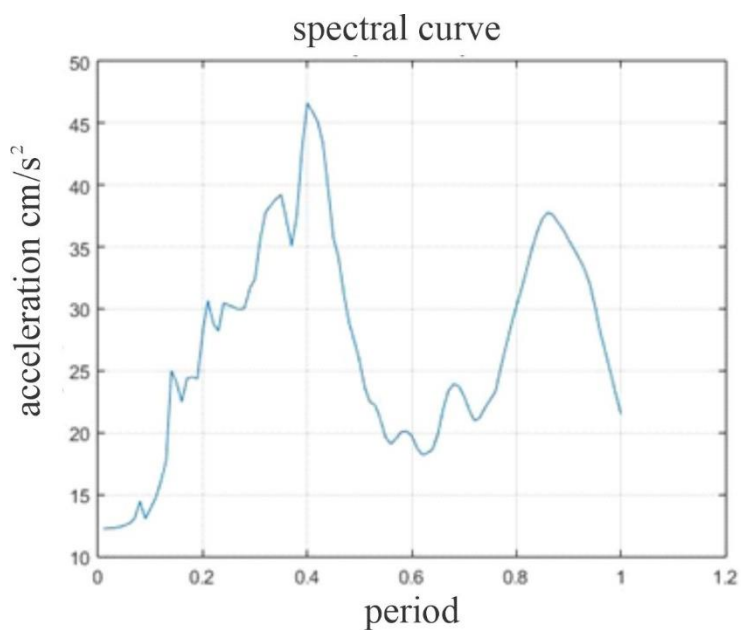
**Figure 2-** Spectral curve of the accelerogram at the No. 1 “INSTITUTE” station, OX, basement [Author's material]

The values of PGA accelerations in the basement parts of the building characterize the intensity of the seismic impact. Figure 2-4 shows spectral curves for accelerograms of the “INSTITUTE” station. The spectral curves were calculated using the SCILAB mathematical system based on the explicit Runge-Kutta method of 4-5 orders of accuracy.

The values of the vertical components of the impact in the basement parts of the building practically coincide and do not exceed the values of the horizontal components of the seismic impact, which corresponds to global patterns (Figure 2,3).

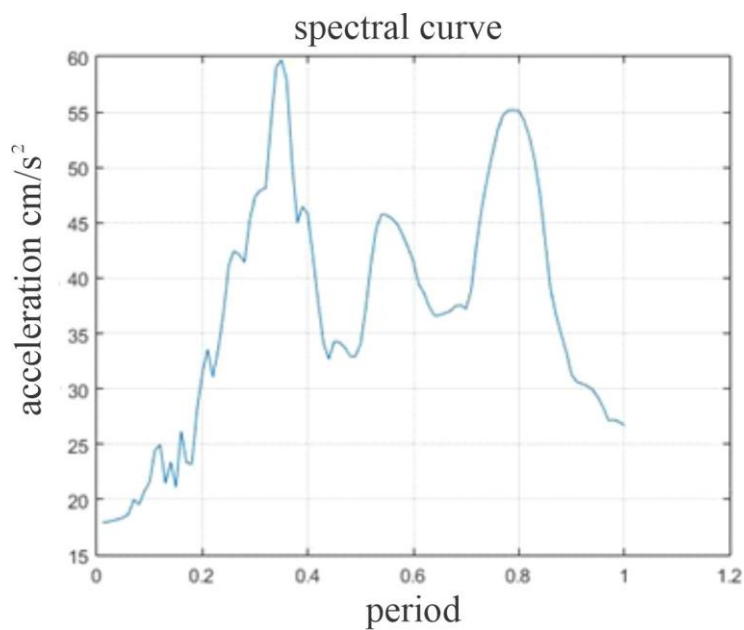
**Figure 3 -** Spectral curve of the accelerogram at the No. 1 “INSTITUTE” station, OY, basement [Author's material]
