## THE SEISMIC EVENT ON JANUARY 23, 2024 AND THE ANALYSIS OF THE CONSEQUENCES FOR THE BUILDINGS OF THE ALMATY

**Abstract.** *On January 23, 2024, an earthquake of magnitude  $M_b = 7.27$  occurred in China. In Almaty city, it was registered by stations of the engineering and seismometric service of “KazRDICA” JSC and seismic stations of the National Scientific Center for Seismological Observations and Research. What is new is the analysis of instrumental data from seismic stations and the consequences for city buildings based on the results of sample surveys of 188 construction sites. It is established that the intensity of the seismic impact is not less than 5 points. There is no discernible effect of the presence of tectonic faults on the instrumental characteristics of seismic motion in the basement of the building (stations No. 17 ‘Novaya Ploshchad’ and No. 16 ‘Hotel’). At Station No. 3 “School”, abnormally high acceleration values of 88.46 cm/s<sup>2</sup> and 81.89 cm/s<sup>2</sup> were recorded at floor level. It was found that the horizontal components of the seismic response have a significant long-period component. There is a peak in the spectral curve at a period of app

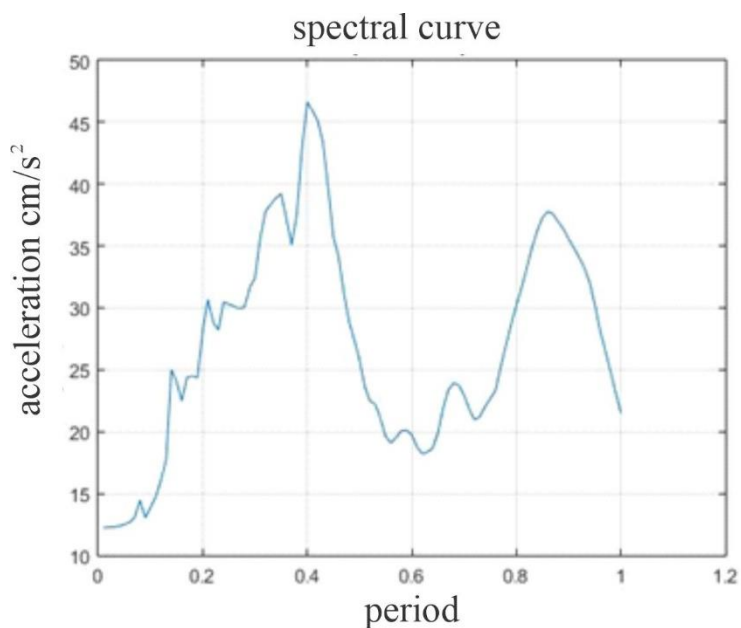
**Figure 2-** Spectral curve of the accelerogram at the No. 1 “INSTITUTE” station, OX, basement [Author's material]

The values of PGA accelerations in the basement parts of the building characterize the intensity of the seismic impact. Figure 2-4 shows spectral curves for accelerograms of the “INSTITUTE” station. The spectral curves were calculated using the SCILAB mathematical system based on the explicit Runge-Kutta method of 4-5 orders of accuracy.

The values of the vertical components of the impact in the basement parts of the building practically coincide and do not exceed the values of the horizontal components of the seismic impact, which corresponds to global patterns (Figure 2,3).
