UDC 699.841  
IRSTI 67.07.11  
RESEARCH ARTICLE

## THE SEISMIC EVENT ON JANUARY 23, 2024 AND THE ANALYSIS OF THE CONSEQUENCES FOR THE BUILDINGS OF THE ALMATY

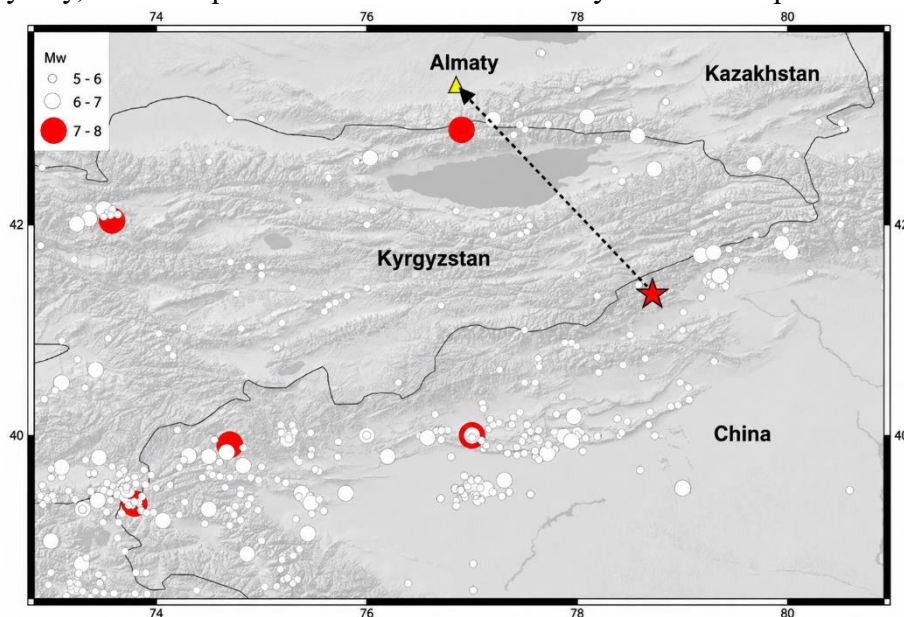
**Figure 1** - Location of the earthquake on January 23, 2024 (according to the Data Center of the IGR NNC RK [https://kndc.kz/index.php/home-ru/kndcnews/227-operativnaya-informatsiya-o-proizoshedshem-zemletryasenii-23-01-2024-g])

The coordinates of the epicenter are 41.23 degrees north latitude, 78.59 degrees east longitude. Magnitude  $M_b=7.27$ . The earthquake occurred 260 km south-east of Almaty city. The depth is 13 km (Figure 1).

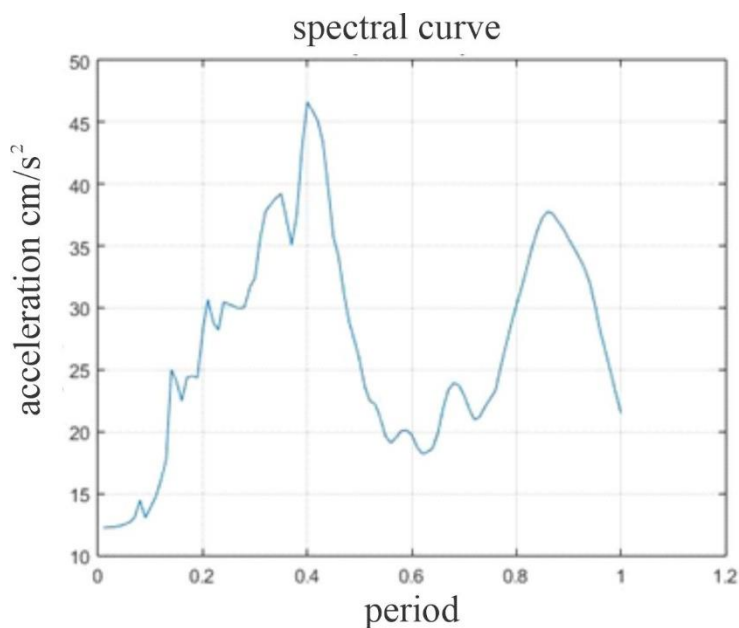
**Figure 2-** Spectral curve of the accelerogram at the No. 1 “INSTITUTE” station, OX, basement [Author's material]

The values of PGA accelerations in the basement parts of the building characterize the intensity of the seismic impact. Figure 2-4 shows spectral curves for accelerograms of the “INSTITUTE” station. The spectral curves were calculated using the SCILAB mathematical system based on the explicit Runge-Kutta method of 4-5 orders of accuracy.

The values of the vertical components of the impact in the basement parts of the building practically coincide and do not exceed the values of the horizontal components of the seismic impact, which corresponds to global patterns (Figure 2,3).

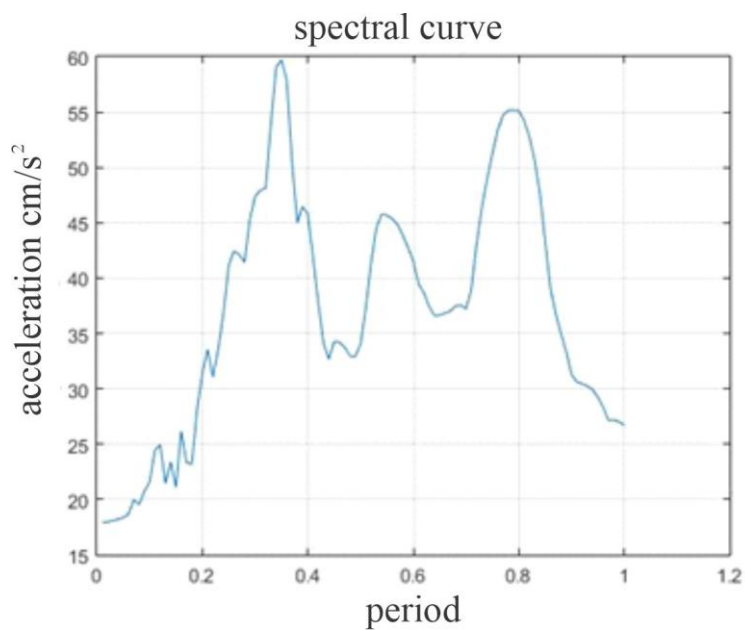
**Figure 3 -** Spectral curve of the accelerogram at the No. 1 “INSTITUTE” station, OY, basement [Author's material]

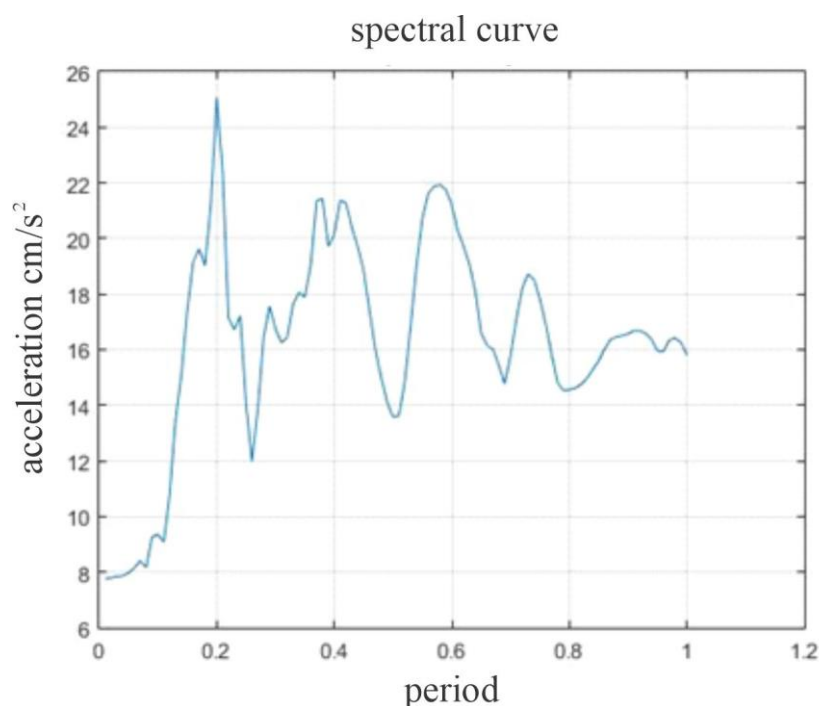
**Figure 4** - Spectral curve of the accelerogram at the No. 1 “INSTITUTE” station, OZ, basement [Author's material]
