## MULTIFACTOR ASSESSMENT OF HYDRAULIC STRUCTURES IN SEISMICALLY ACTIVE ZONES: A CASE STUDY OF THE TASOTKEL RESERVOIR, REPUBLIC OF KAZAKHSTAN

**Abstract.** *This article presents a multifactor assessment of the technical condition of the Tasotkel Dam, located in the seismically active zone of southern Kazakhstan. With the increasing frequency and intensity of earthquakes in the region - including the March 28, 2025, earthquake near the village of Merke in the Zhambyl region - there is a growing need for a systematic approach to evaluating the seismic safety of hydraulic structures. The investigation employed a range of modern techniques, including visual inspection, instrumental monitoring, geodetic surveying, non-destructive testing of concrete structures, as well as laboratory and in-situ analysis of the physical and mechanical properties of the dam body and its foundation soils. The assessment revealed localized defects in the facing, signs of erosion, reduced piezometric levels compared to design values, and high filtration activity of the foundation. Geodetic data confirmed the absence of critical deformations but identified areas of potential instability. Based on the collec

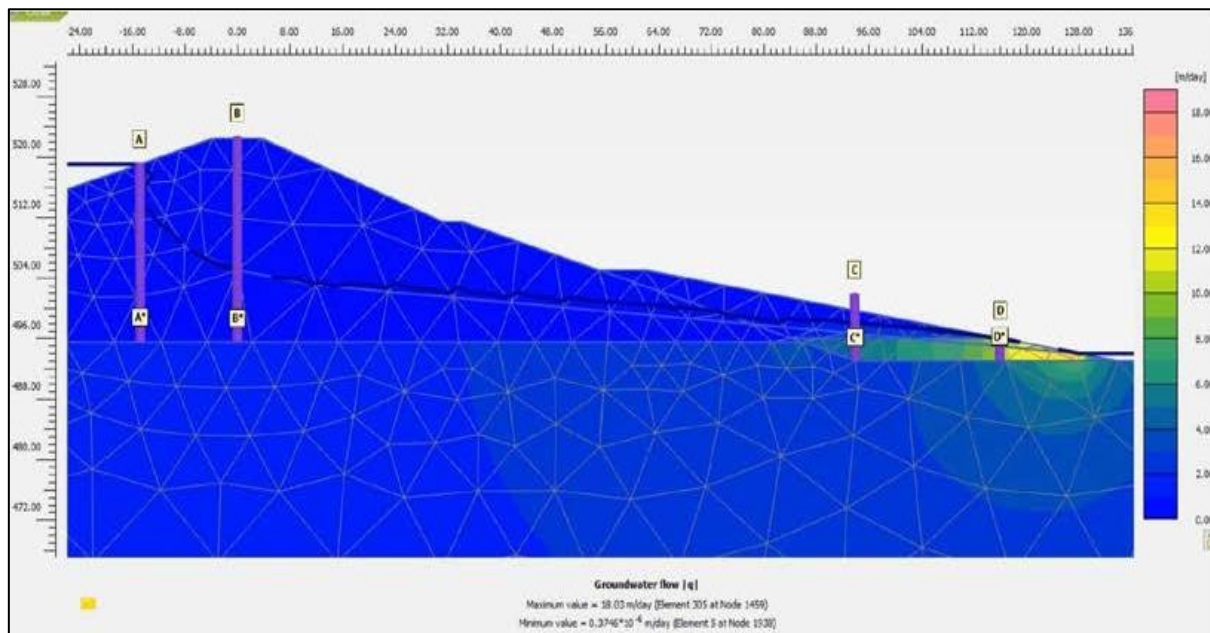
Figure 12 – Water Flow within the Dam Body at PK 05+00

**Figure 12** visualizes the seepage flow field within the dam body at PK 5+00. Flow vectors illustrate the direction and magnitude of water movement, allowing the identification of zones with concentrated seepage pressure and potential internal erosion.

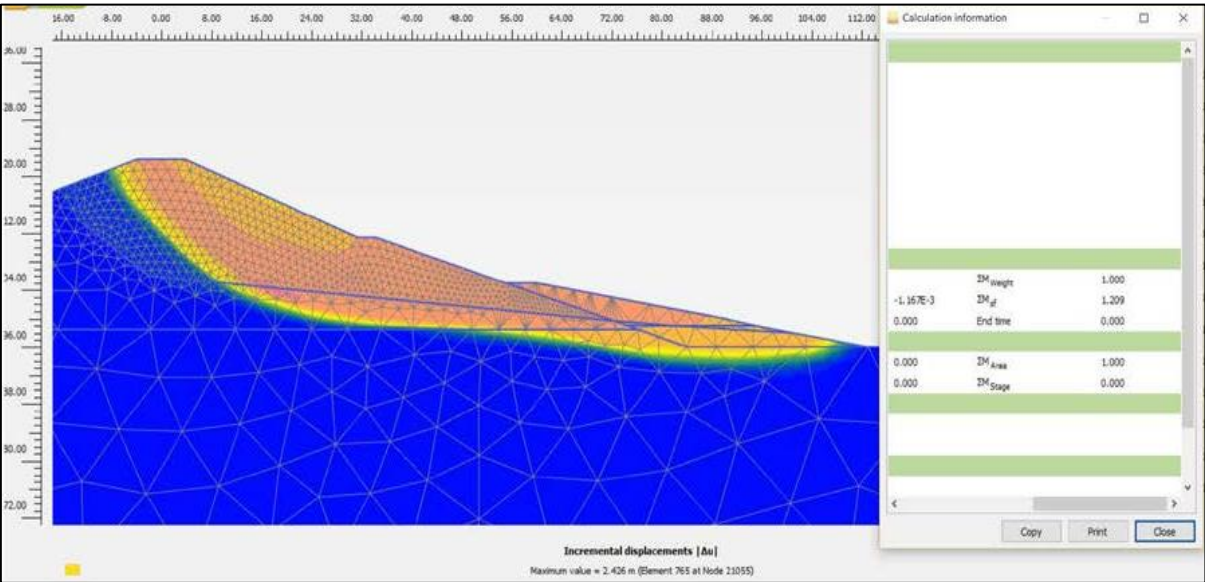
Figure 15 – Special Case 1: Potential Failure Surface of the Downstream Slope and Safety Factor

**Figure 14** displays the phreatic surface for PK 12+00 at an upstream water level of 519 m. The results highlight specific features of the seepage regime and help evaluate the performance of drainage elements in this section. **Figures 15, 16, and 17** illustrate additional special seismic load cases at PK 12+00. Each model varies the saturation and seismic intensity parameters to simulate structural behavior under critical combinations of loads. The results identify areas of potential local instability, providing a foundation for future strengthening measures.
