IMPROVING THE RELIABILITY AND EFFICIENCY OF OPERATION OF HYDRAULIC STRUCTURES OF THE ASTANA RESERVOIR THROUGH RECONSTRUCTION AND MODERNIZATION

Abstract. *This paper examines ways to improve the reliability and operational efficiency of the Astana Reservoir hydraulic structures through reconstruction and modernization. The reservoir, commissioned in 1970, is a key facility for water supply to Astana and irrigation, and its earth dam has a total length of 1,154 m and a maximum height of 32 m. The study is based on the 2023 dam safety declaration and the 2025 verification report on overall stability and seepage strength. Numerical analyses were performed in PLAXIS 2D using the finite element method, the Mohr–Coulomb model, and a strength-reduction approach for five representative cross-sections. The assessment compared the existing condition with two reconstruction scenarios: installation of an anti-filtration screen, and installation of an anti-filtration screen combined with a cement grout curtain. The results showed that, despite a generally satisfactory visual condition, the existing dam configuration has unsafe seepage behavior and critical local instability in the most unfavora

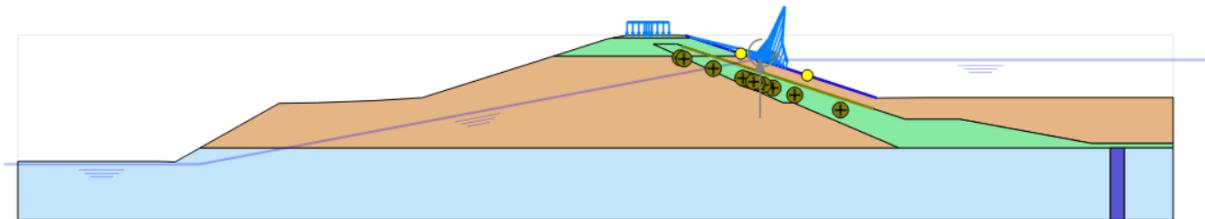
The numerical analysis in **Figure 3** in the 2025 report was performed in PLAXIS 2D using the finite element method. The model employed the Mohr-Coulomb constitutive law and the strength-reduction technique to evaluate slope stability. Five representative cross-sections were selected along the dam. The verification program considered three scenarios: the existing condition without confirmed anti-seepage elements, a reconstructed case with a clay anti-filtration screen, and a reconstructed case with both the anti-filtration screen and a cement grout curtain in the rock foundation. Main source data and modelling framework are presented in **Table 1**.

Figure 3 – Schematic design model of the dam and anti-seepage system used for the numerical assessment. (author’s materials)

Reconstruction scenarios	Scenario 1 – existing condition; Scenario 2 – clay anti-filtration screen; Scenario 3 – clay screen + cement grout curtain in the foundation.
Output indicators	Safety factor, position of the depression surface, hydraulic gradient, seepage velocity, and seepage discharge.
