IMPROVING THE RELIABILITY AND EFFICIENCY OF OPERATION OF HYDRAULIC STRUCTURES OF THE ASTANA RESERVOIR THROUGH RECONSTRUCTION AND MODERNIZATION

Abstract. *This paper examines ways to improve the reliability and operational efficiency of the Astana Reservoir hydraulic structures through reconstruction and modernization. The reservoir, commissioned in 1970, is a key facility for water supply to Astana and irrigation, and its earth dam has a total length of 1,154 m and a maximum height of 32 m. The study is based on the 2023 dam safety declaration and the 2025 verification report on overall stability and seepage strength. Numerical analyses were performed in PLAXIS 2D using the finite element method, the Mohr–Coulomb model, and a strength-reduction approach for five representative cross-sections. The assessment compared the existing condition with two reconstruction scenarios: installation of an anti-filtration screen, and installation of an anti-filtration screen combined with a cement grout curtain. The results showed that, despite a generally satisfactory visual condition, the existing dam configuration has unsafe seepage behavior and critical local instability in the most unfavora

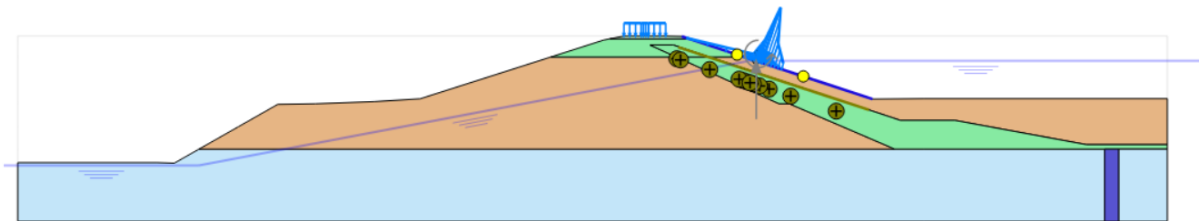
The numerical analysis in **Figure 3** in the 2025 report was performed in PLAXIS 2D using the finite element method. The model employed the Mohr-Coulomb constitutive law and the strength-reduction technique to evaluate slope stability. Five representative cross-sections were selected along the dam. The verification program considered three scenarios: the existing condition without confirmed anti-seepage elements, a reconstructed case with a clay anti-filtration screen, and a reconstructed case with both the anti-filtration screen and a cement grout curtain in the rock foundation. Main source data and modelling framework are presented in **Table 1**.

Figure 3 – Schematic design model of the dam and anti-seepage system used for the numerical assessment. (author’s materials)

The numerical assessment followed the staged logic of the 2025 verification report. Five representative cross-sections were analysed in plane strain. For each section, the existing configuration was compared with two reconstruction alternatives: (i) restoration of seepage control by means of a clay anti-filtration screen, and (ii) the same screen combined with a cement grout curtain in the foundation. This approach makes it possible to isolate the engineering effect of each anti-seepage measure and to evaluate reconstruction as a measurable change in stability reserve and seepage regime rather than as a generic repair action.

Reconstruction scenarios	Scenario 1 – existing condition; Scenario 2 – clay anti-filtration screen; Scenario 3 – clay screen + cement grout curtain in the foundation.
Output indicators	Safety factor, position of the depression surface, hydraulic gradient, seepage velocity, and seepage discharge.
