ASSESSMENT OF THE TECHNICAL CONDITION OF CONCRETE AND REINFORCED CONCRETE HYDRAULIC STRUCTURES USING 3D ULTRASONIC TOMOGRAPHY

Abstract. *The article presents the results of assessing the technical condition of the concrete and reinforced concrete structures of the emergency spillway of the Tasotkel Reservoir using the 3D ultrasonic tomography method based on the Betonoskop SK-1700 3D system. The study is aimed at detecting hidden defects, evaluating the internal structure of concrete, and analyzing deterioration processes under long-term seepage, hydrodynamic, and seismic impacts. During the investigation, spatial ultrasonic scanning of a 10×10 m section was performed with a diagnostic depth of up to 0.60 m. Three-dimensional tomographic models, ultrasonic wave velocity distribution maps, vertical and transverse sections, and engineering interpretations of defect zones were developed. It was established that the average ultrasonic wave velocity was approximately 3280 m/s, while minimum values in critically deteriorated areas decreased to 1680-1850 m/s. More than 35% of the investigated structural volume was found to be in a state of severe and critical deterioration, while the pro

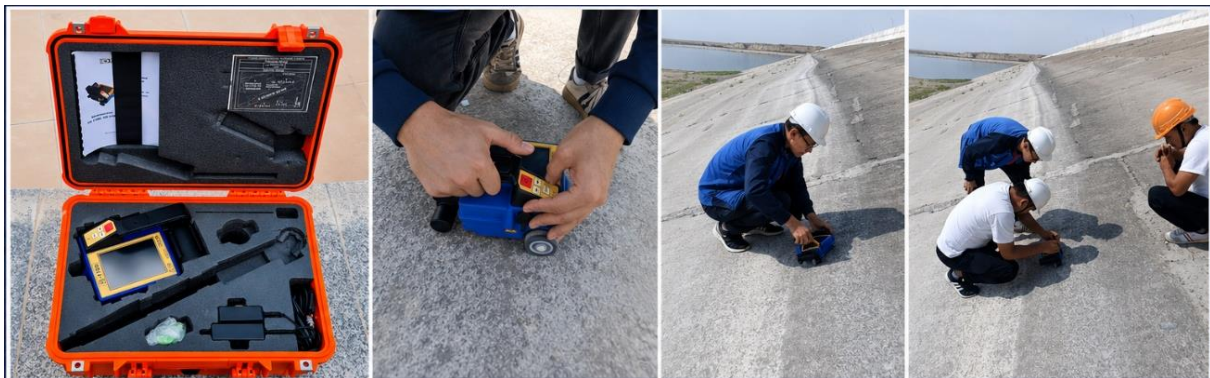
Figure 3 - Field application of the CK-1700 3D ultrasonic tomography system during inspection of concrete structures at the Tasotkel Reservoir emergency spillway (authors' material)

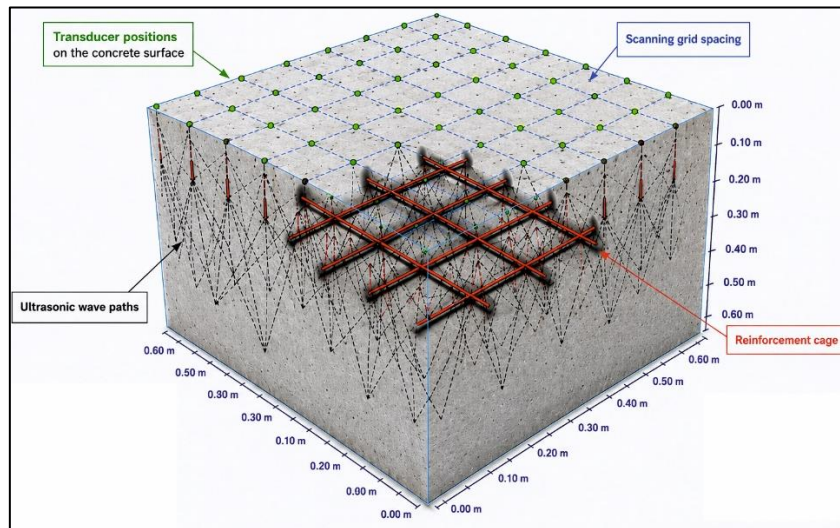
To improve diagnostic accuracy, a cross-scanning scheme was applied during the investigation. Measurements were performed in two mutually perpendicular directions. This approach increased the probability of detecting internal defects with complex spatial configurations.

Figure 4 - Scheme of the 3D ultrasonic investigation of a concrete structure (authors' material)
