## ASSESSMENT OF THE TECHNICAL CONDITION OF CONCRETE AND REINFORCED CONCRETE HYDRAULIC STRUCTURES USING 3D ULTRASONIC TOMOGRAPHY

**Abstract.** *The article presents the results of assessing the technical condition of the concrete and reinforced concrete structures of the emergency spillway of the Tasotkel Reservoir using the 3D ultrasonic tomography method based on the Betonoskop SK-1700 3D system. The study is aimed at detecting hidden defects, evaluating the internal structure of concrete, and analyzing deterioration processes under long-term seepage, hydrodynamic, and seismic impacts. During the investigation, spatial ultrasonic scanning of a 10×10 m section was performed with a diagnostic depth of up to 0.60 m. Three-dimensional tomographic models, ultrasonic wave velocity distribution maps, vertical and transverse sections, and engineering interpretations of defect zones were developed. It was established that the average ultrasonic wave velocity was approximately 3280 m/s, while minimum values in critically deteriorated areas decreased to 1680-1850 m/s. More than 35% of the investigated structural volume was found to be in a state of severe and critical deterioration, while

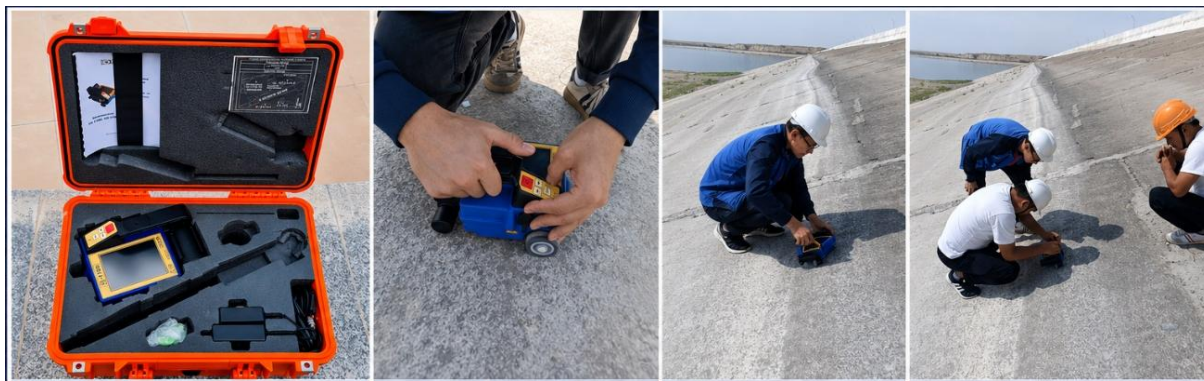
**Figure 3** - Field application of the CK-1700 3D ultrasonic tomography system during inspection of concrete structures at the Tasotkel Reservoir emergency spillway (authors' material)

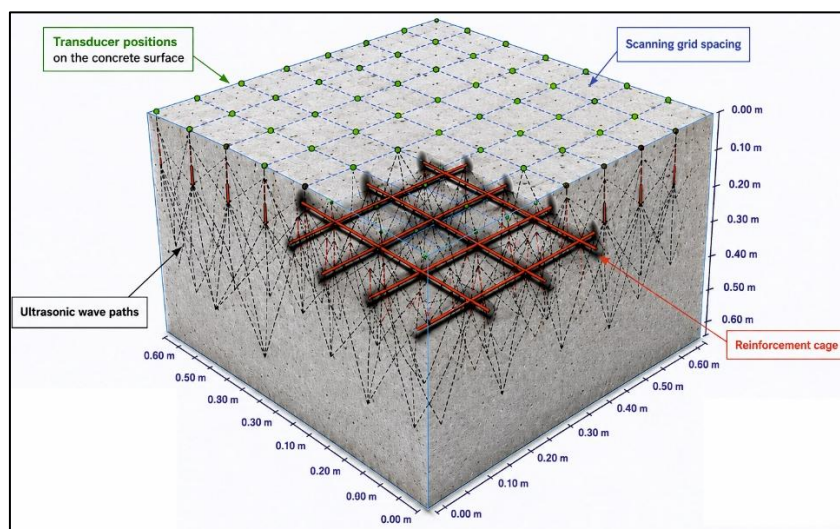
**Figure 4** - Scheme of the 3D ultrasonic investigation of a concrete structure (authors' material)

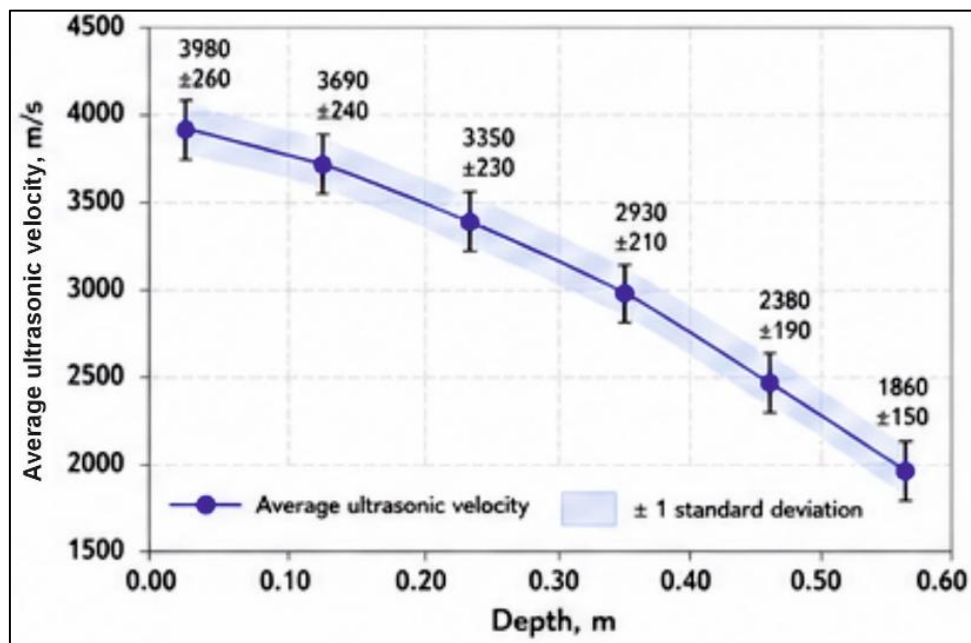
**Figure 12** shows the variation in ultrasonic wave velocity with investigation depth. The graph demonstrates a clear depth-dependent reduction in velocity. In the upper layer, within 0.00-0.10 m, the average velocity is approximately  $3980 \pm 260$  m/s. At a depth of 0.10-0.20 m, the velocity decreases to  $3690 \pm 240$  m/s. In the interval of 0.20-0.30 m, the average velocity decreases further to  $3350 \pm 230$  m/s. A more pronounced reduction is observed below 0.35 m, where the average velocity decreases to  $2930 \pm 210$  m/s in the 0.30-0.40 m interval and to  $2380 \pm 190$  m/s in the 0.40-0.50 m interval. At depths of 0.50-0.60 m, the average velocity reaches only  $1860 \pm 150$  m/s. This trend indicates accelerated deterioration below approximately 0.35 m, which is consistent with the expected location of moisture accumulation, debonding, and interface degradation. Therefore, the lower part of the lining and the concrete-foundation contact zone should be considered the most vulnerable structural region.

Figure 12 - Variation in ultrasonic wave velocity with investigation depth (authors' material)

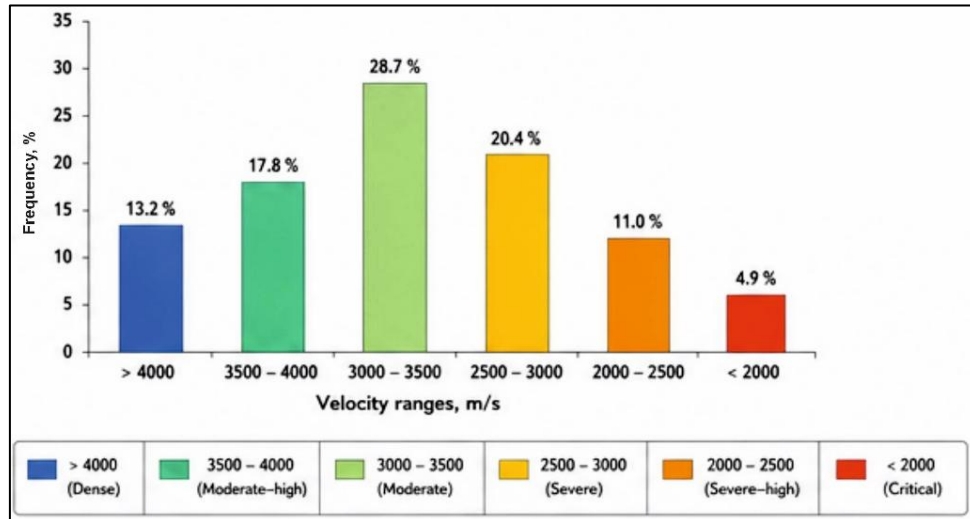
Figure 13 presents the statistical distribution of ultrasonic wave velocities based on 623,061 valid voxels. The mean velocity is 3280 m/s, while the median velocity is 3210 m/s. The standard deviation is 704 m/s, which confirms significant acoustic heterogeneity of the investigated concrete volume. The minimum and maximum recorded velocities are 1680 m/s and 4480 m/s, respectively. The coefficient of variation is 21.4%. The histogram shows that the largest fraction of the investigated volume falls within the 3000-3500 m/s range, accounting for 28.7%. The 3500-4000 m/s range accounts for 17.8%, while the high-velocity range above 4000 m/s accounts for 13.2%. The severe deterioration interval of 2500-3000 m/s accounts for 20.4%, and the 2000-2500 m/s interval accounts for 11.0%. Critical zones with velocities below 2000 m/s account for 4.9%. This distribution confirms that the concrete lining is dominated by moderately deteriorated material, while localized critical defect zones are present and require engineering attention.

Figure 13 - Statistical distribution of ultrasonic wave velocities (authors' material)

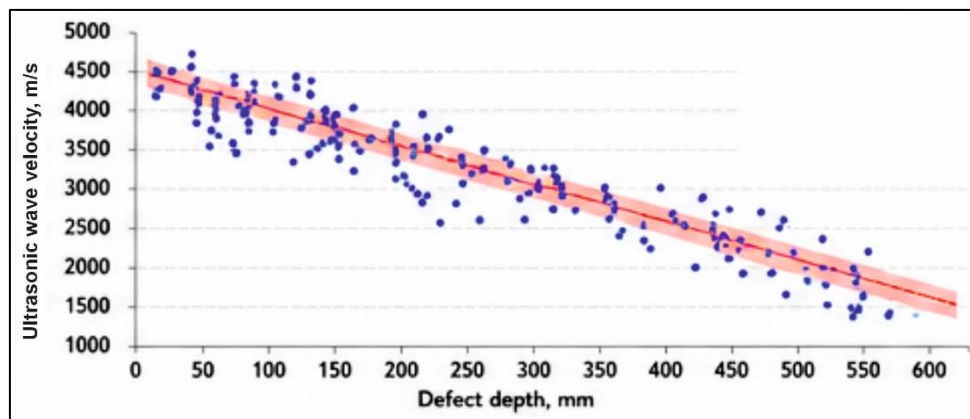
Figure 14 illustrates the correlation between ultrasonic wave velocity and defect depth. The scatter plot demonstrates a distinct negative correlation. The regression equation is expressed as  $y = -4.05x + 4240$ , with  $R^2 = 0.81$  and  $N = 152$  measurement points. This means that with increasing defect depth, ultrasonic velocity decreases systematically. Defects with depths of 0-50 mm are

characterized by velocities of approximately 3600-4300 m/s, with a mean value of 3930 m/s. Defects of 50-100 mm correspond to velocities of 3200-3900 m/s, with a mean value of 3560 m/s. For defects of 100-200 mm, velocities decrease to 2500-3400 m/s, with a mean value of 2890 m/s. Defects of 200-300 mm correspond to velocities of 1900-2700 m/s, with a mean value of 2250 m/s. When the defect depth exceeds 300 mm, the velocity drops below 2200 m/s, with an average value of approximately 1830 m/s. These results confirm that deeper defects are associated with stronger internal deterioration, increased porosity, possible void formation, and reduced contact between the concrete lining and the foundation.

Figure 14 - Relationship between ultrasonic wave velocity and defect depth (authors' material)

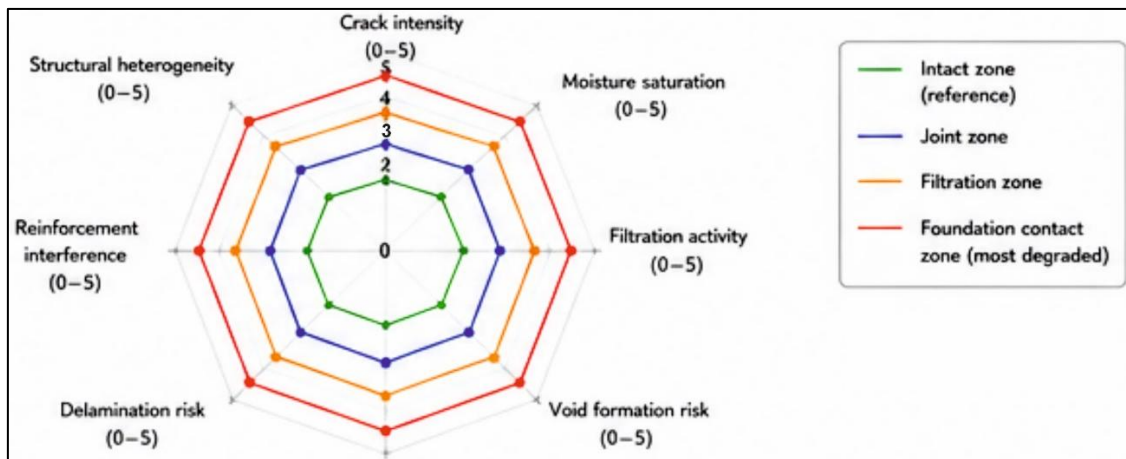
Figure 16 provides a comparative assessment of deterioration indicators in the investigated zones using a radar chart. The evaluated parameters include crack intensity, moisture saturation,

Figure 16 - Comparative assessment of deterioration indicators in different investigated zones (authors' material)

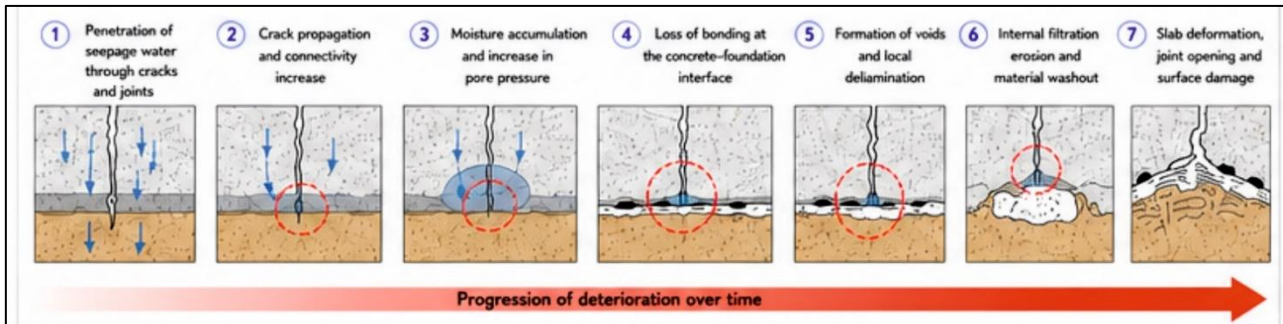
Figure 17 presents the proposed mechanism of filtration-induced deterioration of the concrete lining. The mechanism consists of seven sequential stages. First, seepage water penetrates through cracks and joints. Second, crack propagation and connectivity increase under repeated hydraulic and thermal loading. Third, moisture accumulates within the subsurface zone, causing an increase in pore pressure. Fourth, loss of bonding develops at the concrete-foundation interface. Fifth, local voids and delamination zones are formed. Sixth, internal filtration erosion and material washout occur. Finally, slab deformation, joint opening, and surface damage develop. This mechanism explains the spatial distribution of low-velocity zones observed in the tomographic data. It also links the ultrasonic results with the actual hydraulic deterioration processes typical for concrete linings of spillway structures.

**Figure 17** - Proposed mechanism of filtration-induced deterioration of the concrete lining (authors' material)
