## ASSESSMENT OF THE TECHNICAL CONDITION OF A DAM LOCATED IN A SEISMICALLY ACTIVE ZONE

**Abstract.** *The aim of this study is to assess the technical condition of a dam in a seismically active zone of Kazakhstan. The object is the pressure front of the Sh. Chokin Kapchagay hydropower plant. It consists of a 52 m hydraulic-fill river-bed dam, a 56 m gravel-rubble ravine dam with a sandy-loam screen, and a quartz-porphry rock abutment. The dams were designed for intensity 7 (MSK-64), but the site intensity was raised to 8 after the 1988 Spitak earthquake. The materials comprised the dynamic passports of the 2025 survey, settlement records and phreatic curves. The methods included in-situ P and S wave velocity profiling and pseudo-static slope-stability analysis. The seepage regime of both dams is stable. Mean settlement rates are 1.6-2.3 mm/yr for the river-bed dam and 2.06-3.8 mm/yr for the ravine dam, and relative compression does not exceed 0.010 %/yr. Wave velocities and dynamic modulus increase with depth without low-velocity zones. The fractured upper 2 m of the abutment has half the compressive strength of deeper rock. All slopes meet the Class I stability requirements at in

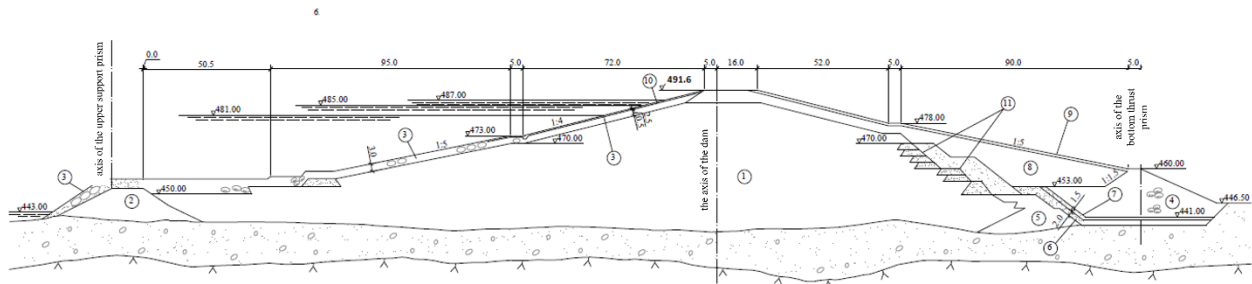
The river-bed dam is a hydraulic-fill earth dam (Fig. 1). It is 52.0 m high and 470 m long. The crest is 21 m wide, at elevation (el.) 491.6 m. The base is 406 m wide. The dam body (zone 1) was hydraulically filled to a height of 49.0 m. It consists of fine-grained, uniform aeolian sand from borrow pit No. 3 ( $k = 2.5\text{--}5.0$  m/day). Construction began in 1965. The dam was accepted into operation in December 1970.

The design provides seismic stability through flat slopes, rock-fill surcharges and loading berms. The surcharges are 3 m thick and cover both slopes. The upstream slope is 1:4 above a berm at el. 473.0 m and 1:5 below it. The downstream slope is 1:4 above a 5 m wide berm at el. 478.0 m and 1:5 below it.

The upstream loading berm (zone 2) consists of gravel-rubble soil from borrow pit No. 16 ( $k = 2.5\text{--}5.0$  m/day). Its top is at el. 456.0 m. Rock fill (zone 3;  $k = 200$  m/day) covers the berm and the upstream slope. The downstream loading berm (zone 4) is built of rock fill ( $k = 200$  m/day). Its top is at el. 460.0 m, and its crest is 6 m wide. This berm also serves as a drainage prism. Three transition layers separate it from the dam body:

- zone 5: natural sand-gravel mix from borrow pit No. 9 ( $k = 35$  m/day);
- zone 6: natural sand-gravel mix from the tailrace channel excavation ( $k = 40$  m/day);
- zone 7: crushed stone,  $d = 0.2\text{--}8.0$  mm ( $k = 200$  m/day).

Sand from borrow pit No. 3b (zone 8;  $k = 2.5\text{--}5.0$  m/day) surcharges the downstream slope and the crest. A 0.5 m layer of gravel-rubble soil (zone 9;  $k = 2.5\text{--}5.0$  m/day) protects the downstream slope. Above el. 472.0 m, the upstream slope is faced with monolithic reinforced-concrete slabs (zone 10). The slabs are  $10 \times 10$  m in plan and 0.20–0.30 m thick and rest on a crushed-stone bed. Containment dykes (zone 11) of dry-placed sand from borrow pit No. 3 bound the hydraulic-fill zone.

**Figure 1** - Typical cross-section of the river-bed dam (zones 1-11 are described in the text) [Author's material]

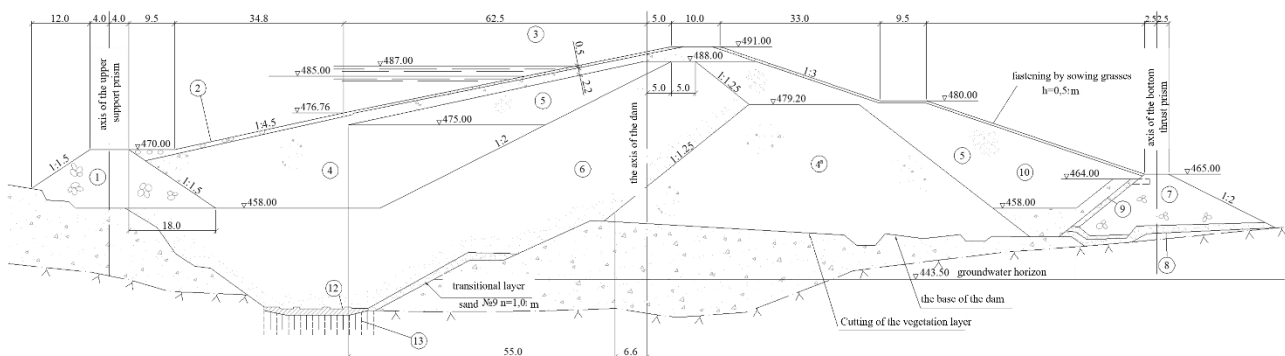
The ravine dam is an earthfill dam with an upstream screen (Fig. 2). Its height is 56.0 m from the base of the screen. The crest is 370 m long and 10 m wide. It lies at el. 491.0 m. The base is 270 m wide.

The upstream screen (zone 6) consists of sandy loam and sand from the spoil bank. Its  $k$  is 0.5 m/day, five to ten times lower than that of the dam body. A cut-off key connects the screen to the rock. The key contains a transition layer of sand-gravel mix from borrow pit No. 9 (zone 11;  $k = 35$  m/day). Blanket grouting (zone 13) treats the foundation beneath the key to a depth of 30 m. A concrete cap (zone 12) covers the grouted zone.

**Figure 2** - Typical cross-section of the ravine dam (zones 1-13 are described in the text) [Author's material]

Flat slopes and rock-fill loading berms provide seismic stability. The upstream slope is 1:5. The upstream berm (zone 1) and the slope protection (zone 2) are rock fill ( $k = 200$  m/day). Above el. 476.96 m, monolithic reinforced-concrete slabs face the slope (zone 3). The slabs are  $10 \times 10$  m in plan and 0.20 m thick. They rest on a crushed-stone filter. Joints divide the facing into 40 m sections. Below el. 476.96 m, rock fill 1.0 m thick protects the slope.

The downstream slope is 1:3. A berm 9.5 m wide lies at el. 480.0 m. Gravel-rubble soil seeded with grass protects the slope. The downstream berm (zone 7;  $k = 200$  m/day) is rock fill. It also serves as a drainage prism. Its top is at el. 465.0 m. Its crest is 5 m wide. The berm rests on sand-gravel mix from borrow pit No. 9 (zone 8;  $k = 35$  m/day). Gravel-rubble soil from borrow pit No. 16 forms the transition between the berm and the dam body (zone 10;  $k = 2.5-5.0$  m/day). A crushed-stone layer with  $d = 0.2-80$  mm completes the filter (zone 9;  $k = 200$  m/day).

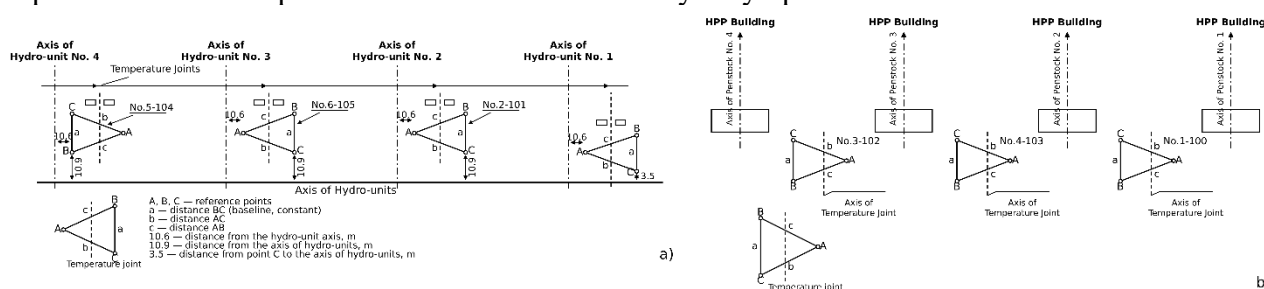
**Figure 3** – Layout of the Radon VB-Shch joint gauges with reference points A, B and C: (a) HPP building, el. 446.0 m; (b) water intake [Author's material]

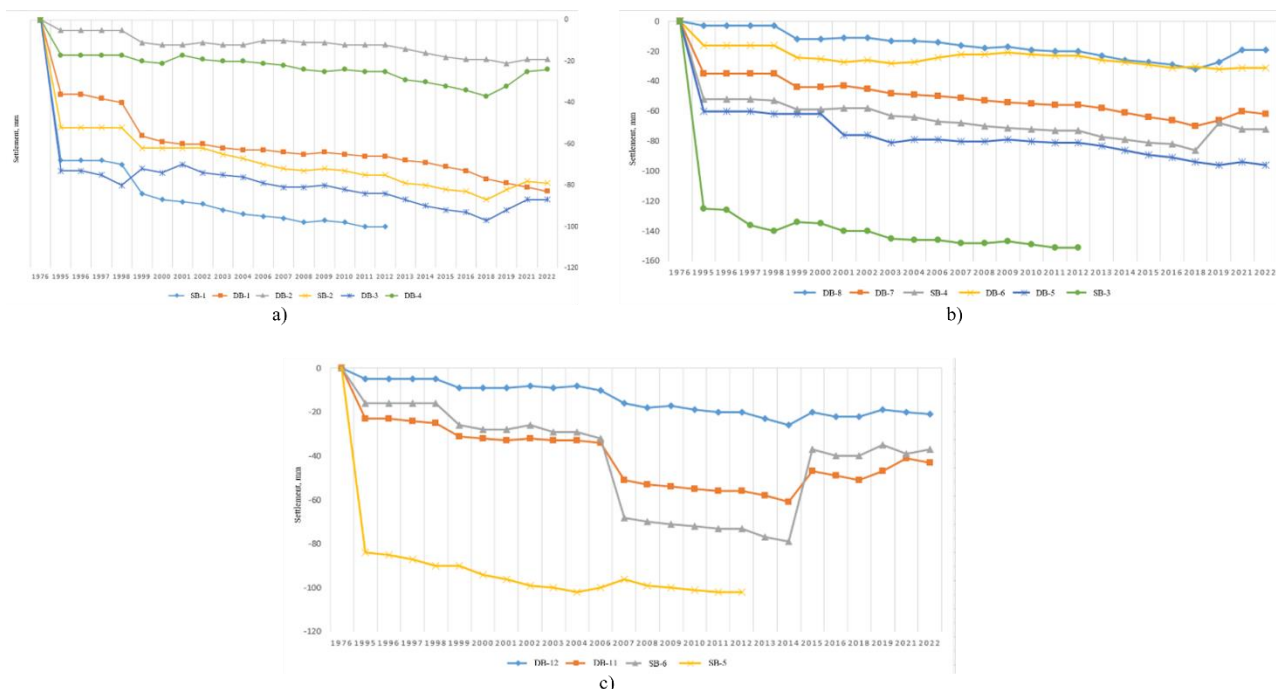
Section 2 (Fig. 7b) shows the widest range of settlement. SB-3 settled by about 125 mm before 1995. By 2012, it reached about 151 mm. This is the largest value on the river-bed dam. The other benchmarks settled less: DB-5 by 96 mm, SB-4 by 72 mm, DB-7 by 62 mm, DB-6 by 31 mm and DB-8 by 19 mm. After 1995, the curves flatten. From 2018 to 2021, SB-4, DB-8 and DB-7 rose by 10-18 mm. The large settlement of SB-3 may indicate a locally more compressible zone in the fill or foundation. The available data cannot confirm this.

rose by about 42 mm and DB-11 by about 14 mm. DB-12 settled least, by 5-26 mm over the whole period. After 2015, all benchmarks in this section are stable.

**Figure 7** - Settlement of the river-bed dam benchmarks: (a) Section 1; (b) Section 2; (c) Section 3. The time axis is not to scale for 1976–1995 [Author's material]

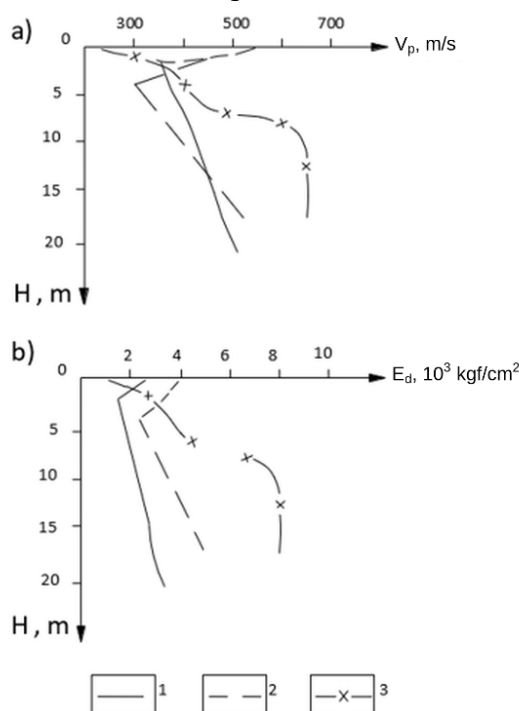
Figure 8 - Depth profiles at the river-bed dam: (a)  $V_p$ ; (b)  $E_d$  [Author's material]

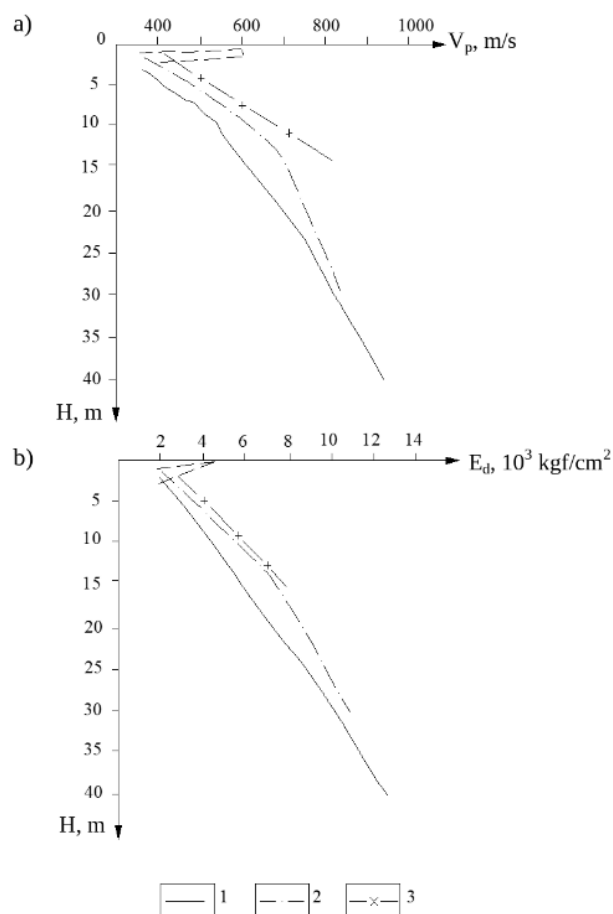
Beneath the crest,  $V_p$  increases from 360 m/s at 2 m to 920 m/s at 40 m. The profile crosses the aeolian sand, the sandy-loam screen and the gravel-rubble soil.  $E_d$  increases from about 190 to 1220 MPa. In the saturated foundation,  $V_p$  rises to 1900 m/s and  $\nu$  to 0.45. This transition lies at 42 m beneath the crest. Beneath the berm, it lies at 31 m. Beneath the downstream loading berm, it lies at 18 m.

In the rock fill (2-10 m),  $V_p$  is 440-680 m/s and  $V_s$  is 240-340 m/s.  $\nu$  is 0.29-0.33. In the sand and gravel-rubble zones,  $\nu$  is lower, 0.22-0.26 (Table 4). At equal depth, velocities and moduli are higher than on the river-bed dam. At 35-40 m,  $V_p$  reaches 870-920 m/s and  $E_d$  1.1-1.2 GPa. The coarser gravel-rubble soils of the ravine dam explain this difference.

Figure 9 - Depth profiles at the ravine dam: (a)  $V_p$ ; (b)  $E_d$  [Author's material]

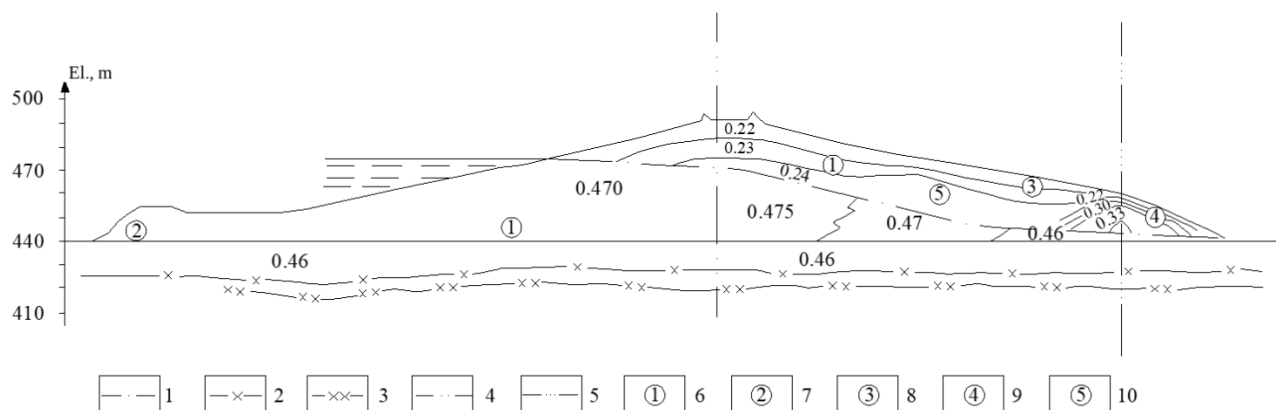
The sections across the dams confirm these trends. Figs. 10 and 11 show the phreatic surface, the bedrock surface and the surface of sound rock. They also show the dam axis and the loading-berm axes. Fig. 11 also shows the base of the dam. The numbered zones are the dam materials. In Fig. 10, zone 1 is hydraulic-fill aeolian sand. Zones 2 and 5 are gravel-rubble soil. Zone 3 is aeolian fill sand. Zone 4 is rock fill. In Fig. 11, zone 4 is gravel-rubble soil. Zone 5 is aeolian sand. Zone 6 is sandy loam and sand. Zone 7 is rock fill.

On the river-bed dam,  $v$  is laterally uniform (Fig. 10). Most of the dam body lies below the phreatic surface. Over most of the section,  $v$  is therefore 0.46-0.475. Lower values (0.22-0.24) occur only in the unsaturated zone near the crest. In the rock fill at the downstream toe,  $v$  is 0.30-0.33. The section shows no local anomaly of  $v$ . There is no indication of disturbed fill.

Figure 10 - Distribution of  $v$  across the river-bed dam [Author's material]

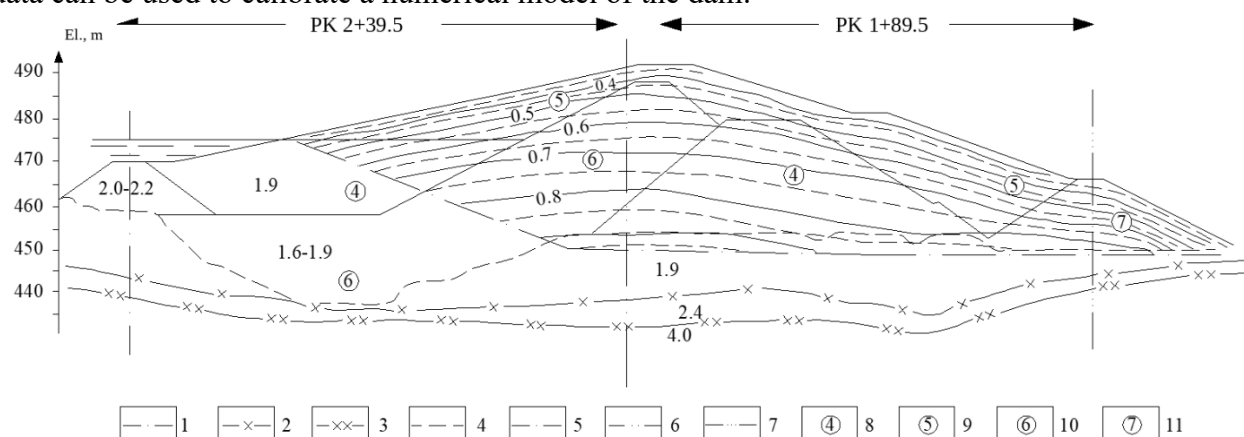
On the ravine dam,  $V_p$  was mapped across Sections PK 2+39.5 and PK 1+89.5 (Fig. 11). In the unsaturated zone,  $V_p$  increases with depth from 0.4 to 0.8 km/s. Below the phreatic surface, it rises to 1.6-2.2 km/s. In the underlying rock, it reaches 2.4-4.0 km/s. The velocity contours follow the dam zoning. They show no local low-velocity zone. The profiles obtained here describe the dam materials. The recorded earthquake response of the dam [16] describes the structure as a whole. Together, these data can be used to calibrate a numerical model of the dam.

**Figure 11** - Distribution of  $V_p$  across the ravine dam [Author's material]

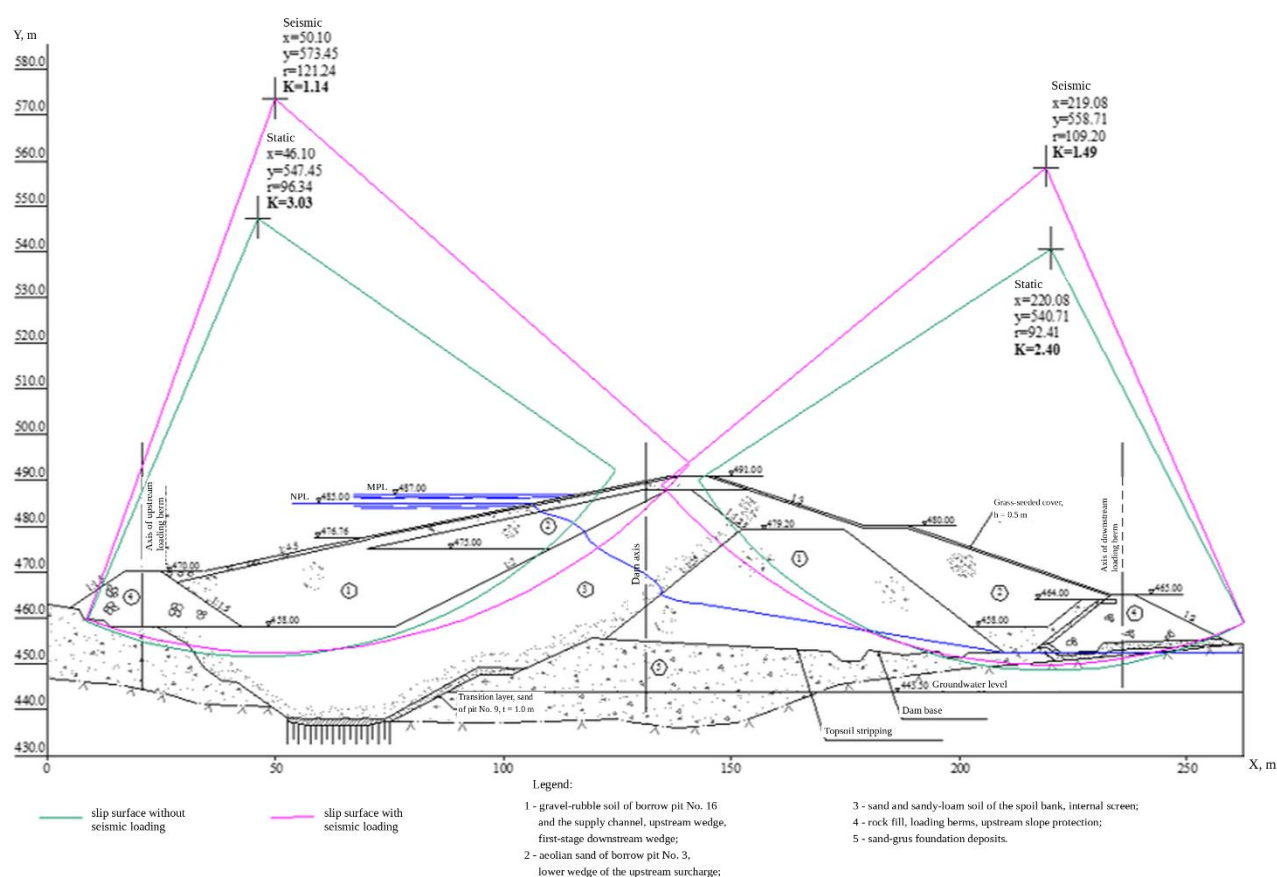
Seismic loading shifts the critical circle. On the ravine dam, the radius increases from 96.3 to 121.2 m upstream. Downstream, it increases from 92.4 to 109.2 m. On the river-bed dam, the radius increases from 99.8 to 111.7 m downstream. Upstream, it decreases from 125.9 to 119.6 m.

The numbered zones are the dam materials. In Fig. 12, zone 1 is gravel-rubble soil of borrow pit No. 16 and the supply channel. Zone 2 is aeolian sand of borrow pit No. 3. Zone 3 is the sandy-loam screen. Zone 4 is the rock fill of the loading berms and upstream slope protection. Zone 5 is the sand-grus foundation. In Fig. 13, zones 1 and 3 are aeolian hydraulic-fill sand of borrow pit No. 3. Zone 6 is the alluvial gravel-sand foundation. Zone 7 is the rock fill of the downstream toe. Zone 8 is the fractured quartz porphyry of the foundation.

**Figure 12** – Slope stability of the ravine dam at seismic intensity 9 [Author's material]

In the basic combination, all slopes exceed the normative minimum of 1.32. The margin is a factor of 1.75 or more. At the current site intensity of 8, all slopes exceed the special-combination minimum of 1.18 by a wide margin. The smallest value is 1.63, on the upstream slopes of both dams.

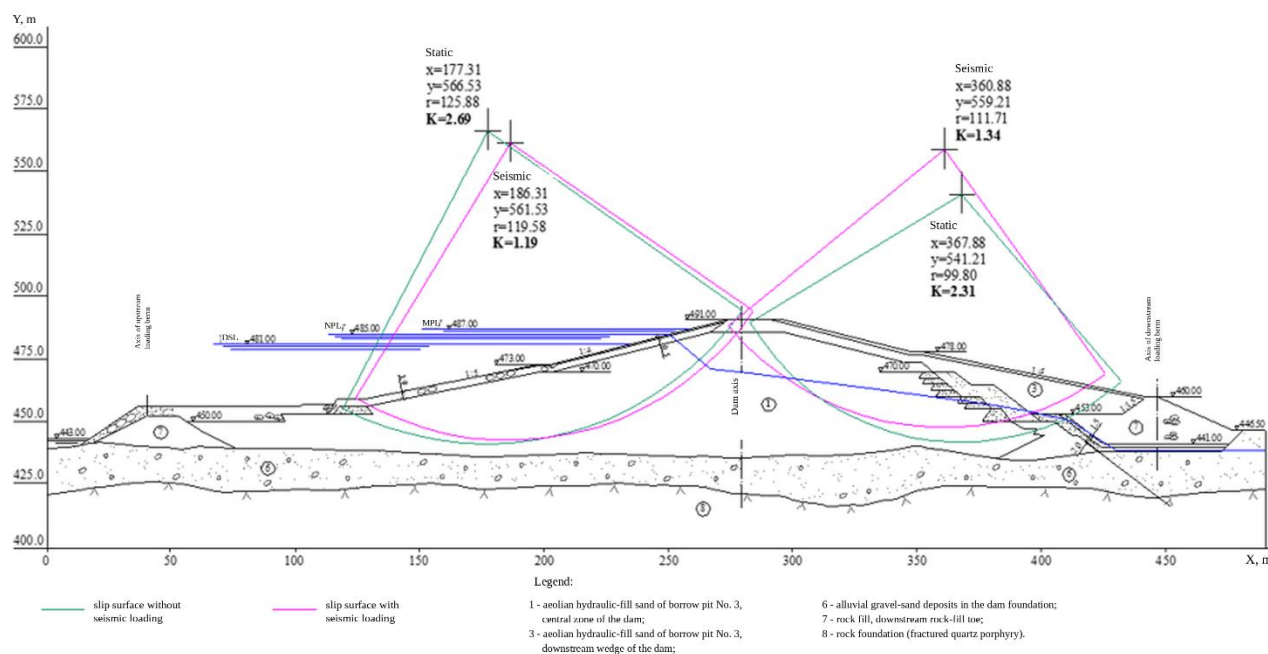
Intensity 9 is the check level. It is one point above the current site intensity. At this level, the upstream slope of the river-bed dam just meets the requirement, with  $K_s = 1.19$  (Fig. 13). The upstream slope of the ravine dam is the governing case (Fig. 12). Its  $K_s$  of 1.14 is 3.4 % below the normative minimum. The pseudo-static method is conservative. A refined dynamic analysis of this slope is nevertheless recommended. The upstream slopes of both dams are the critical elements of the pressure front. They should have priority in monitoring.

Figure 13 – Critical slip surfaces of the river-bed dam at seismic intensity 9 [Author's material]
