## ASSESSMENT OF THE TECHNICAL CONDITION OF A DAM LOCATED IN A SEISMICALLY ACTIVE ZONE

**Abstract.** *The aim of this study is to assess the technical condition of a dam in a seismically active zone of Kazakhstan. The object is the pressure front of the Sh. Chokin Kapchagay hydropower plant. It consists of a 52 m hydraulic-fill river-bed dam, a 56 m gravel-rubble ravine dam with a sandy-loam screen, and a quartz-porphry rock abutment. The dams were designed for intensity 7 (MSK-64), but the site intensity was raised to 8 after the 1988 Spitak earthquake. The materials comprised the dynamic passports of the 2025 survey, settlement records and phreatic curves. The methods included in-situ P and S wave velocity profiling and pseudo-static slope-stability analysis. The seepage regime of both dams is stable. Mean settlement rates are 1.6-2.3 mm/yr for the river-bed dam and 2.06-3.8 mm/yr for the ravine dam, and relative compression does not exceed 0.010 %/yr. Wave velocities and dynamic modulus increase with depth without low-velocity zones. The intensely fractured upper 2 m of the abutment has half the compressive strength of deeper rock. All slopes meet the Class I stability requirem

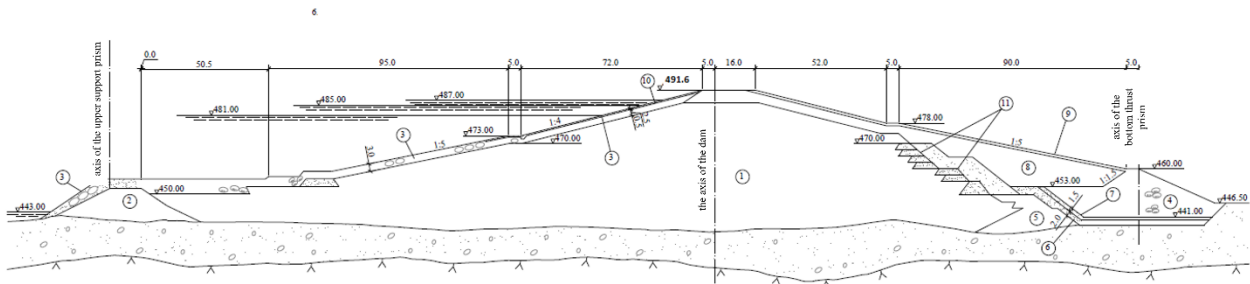
The river-bed dam is a hydraulic-fill earth dam (Fig. 1). It is 52.0 m high and 470 m long. The crest is 21 m wide, at elevation (el.) 491.6 m. The base is 406 m wide. The dam body (zone 1) was hydraulically filled to a height of 49.0 m. It consists of fine-grained, uniform aeolian sand from borrow pit No. 3 ( $k = 2.5\text{--}5.0$  m/day). Construction began in 1965. The dam was accepted into operation in December 1970.

The design provides seismic stability through flat slopes, rock-fill surcharges and loading berms. The surcharges are 3 m thick and cover both slopes. The upstream slope is 1:4 above a berm at el. 473.0 m and 1:5 below it. The downstream slope is 1:4 above a 5 m wide berm at el. 478.0 m and 1:5 below it.

The upstream loading berm (zone 2) consists of gravel-rubble soil from borrow pit No. 16 ( $k = 2.5\text{--}5.0$  m/day). Its top is at el. 456.0 m. Rock fill (zone 3;  $k = 200$  m/day) covers the berm and the upstream slope. The downstream loading berm (zone 4) is built of rock fill ( $k = 200$  m/day). Its top is at el. 460.0 m, and its crest is 6 m wide. This berm also serves as a drainage prism. Three transition layers separate it from the dam body:

- zone 5: natural sand-gravel mix from borrow pit No. 9 ( $k = 35$  m/day);
- zone 6: natural sand-gravel mix from the tailrace channel excavation ( $k = 40$  m/day);
- zone 7: crushed stone,  $d = 0.2\text{--}8.0$  mm ( $k = 200$  m/day).

Sand from borrow pit No. 3b (zone 8;  $k = 2.5\text{--}5.0$  m/day) surcharges the downstream slope and the crest. A 0.5 m layer of gravel-rubble soil (zone 9;  $k = 2.5\text{--}5.0$  m/day) protects the downstream slope. Above el. 472.0 m, the upstream slope is faced with monolithic reinforced-concrete slabs (zone 10). The slabs are  $10 \times 10$  m in plan and 0.20–0.30 m thick and rest on a crushed-stone bed. Containment dykes (zone 11) of dry-placed sand from borrow pit No. 3 bound the hydraulic-fill zone.

**Figure 1** - Typical cross-section of the river-bed dam (zones 1-11 are described in the text) [Author's material]

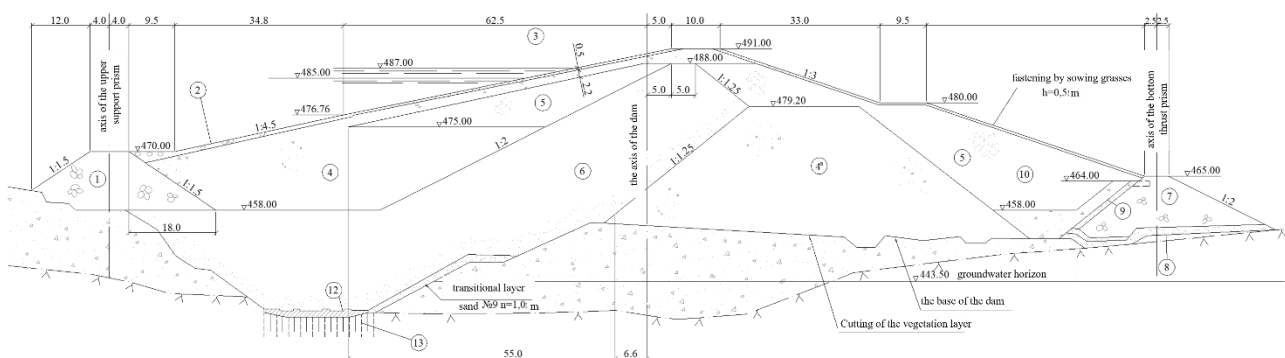
The ravine dam is an earthfill dam with an upstream screen (Fig. 2). Its height is 56.0 m from the base of the screen. The crest is 370 m long and 10 m wide. It lies at el. 491.0 m. The base is 270 m wide.

The upstream screen (zone 6) consists of sandy loam and sand from the spoil bank. Its  $k$  is 0.5 m/day, five to ten times lower than that of the dam body. A cut-off key connects the screen to the rock. The key contains a transition layer of sand-gravel mix from borrow pit No. 9 (zone 11;  $k = 35$  m/day). Blanket grouting (zone 13) treats the foundation beneath the key to a depth of 30 m. A concrete cap (zone 12) covers the grouted zone.

**Figure 2** - Typical cross-section of the ravine dam (zones 1-13 are described in the text) [Author's material]

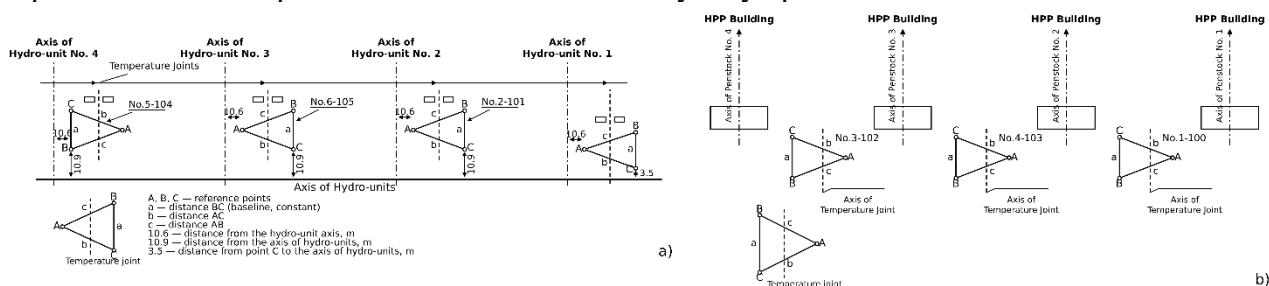
**Figure 3** – Layout of the Radon VB-Shch joint gauges with reference points A, B and C: (a) HPP building, el. 446.0 m; (b) water intake [Author's material]

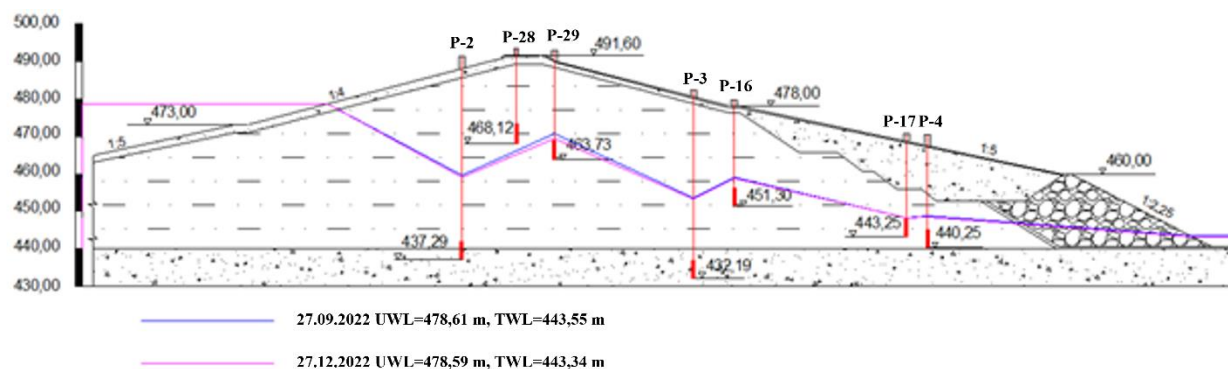
In all sections, the piezometric head decreases from the upstream to the downstream face. The largest head loss occurs in the upstream part of each dam. During the survey, the headwater was about 6.4 m below the normal pool level (el. 478.6 m against el. 485.0 m). Some piezometers in the upstream wedge of the ravine dam were therefore dry.

Figure 4 - Phreatic curves in Section 2 (PK 2+50) of the river-bed dam [Author's material]

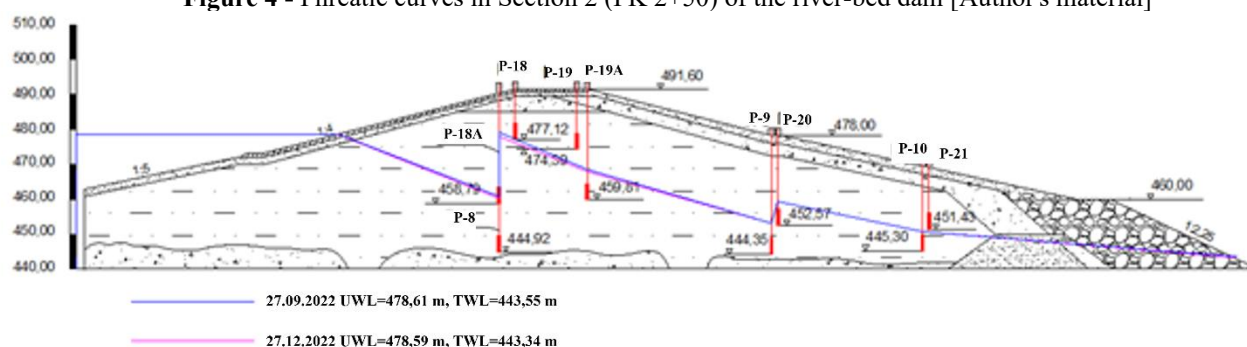
Figure 5 - Phreatic curves in Section 3 (PK 3+50) of the river-bed dam [Author's material]

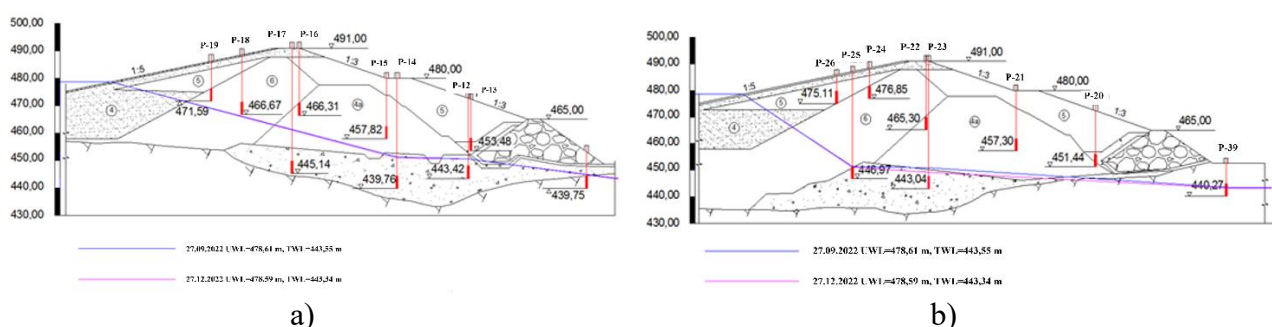
and 4 (PK 2+39.5) (Fig. 6). All curves are based on two piezometric surveys made in September and December. The headwater level was 478.61 m in September and 478.59 m in December. The tailwater level was 443.55 m and 443.34 m, respectively. The two surveys were made at almost the same headwater level. Their curves therefore characterise the seepage regime at one reservoir stage.

Figure 6 - Phreatic curves in the ravine dam: (a) Section 3 (PK 1+89.5); (b) Section 4 (PK 2+39.5) [Author's material]

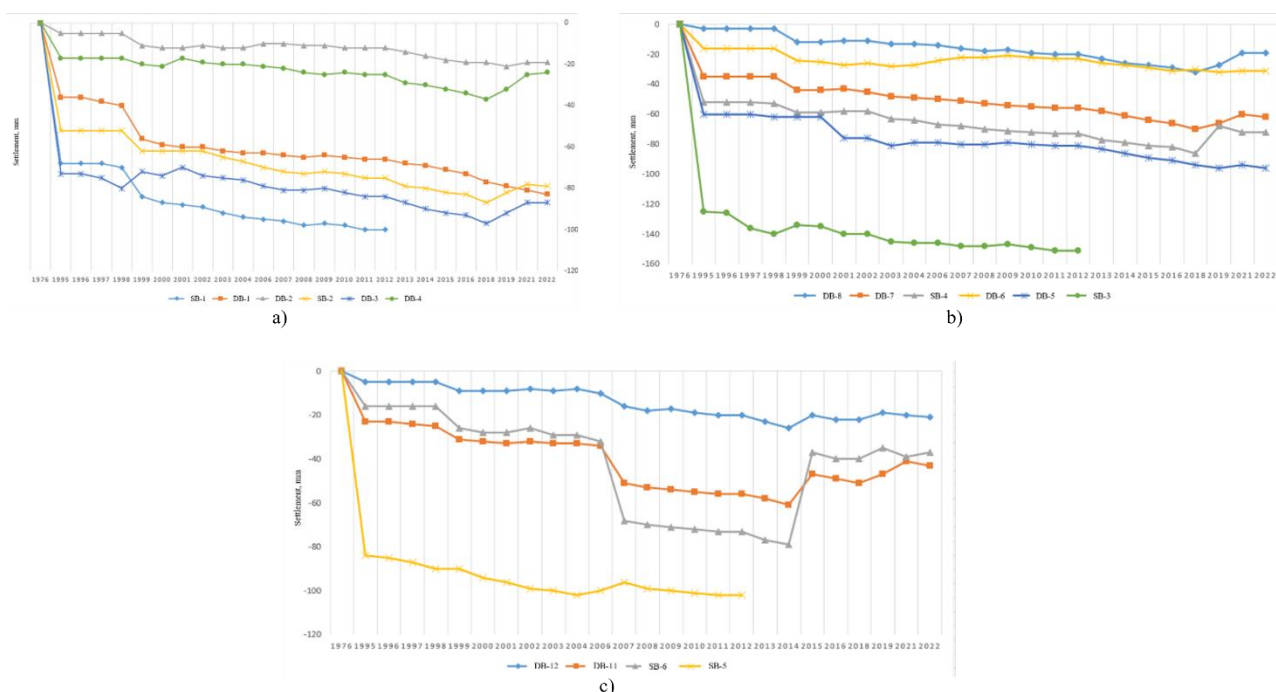
Section 2 (Fig. 7b) shows the widest range of settlement. SB-3 settled by about 125 mm before 1995. By 2012, it reached about 151 mm. This is the largest value on the river-bed dam. The other benchmarks settled less: DB-5 by 96 mm, SB-4 by 72 mm, DB-7 by 62 mm, DB-6 by 31 mm and DB-8 by 19 mm. After 1995, the curves flatten. From 2018 to 2021, SB-4, DB-8 and DB-7 rose by 10-18 mm. The large settlement of SB-3 may indicate a locally more compressible zone in the fill or foundation. The available data cannot confirm this.

rose by about 42 mm and DB-11 by about 14 mm. DB-12 settled least, by 5-26 mm over the whole period. After 2015, all benchmarks in this section are stable.

**Figure 7** - Settlement of the river-bed dam benchmarks: (a) Section 1; (b) Section 2; (c) Section 3. The time axis is not to scale for 1976–1995 [Author's material]

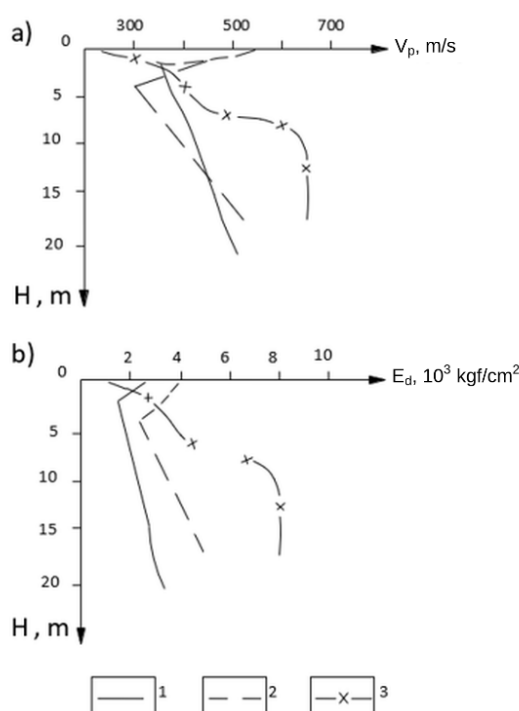
**Figure 8** - Depth profiles at the river-bed dam: (a)  $V_p$ ; (b)  $E_d$  [Author's material]

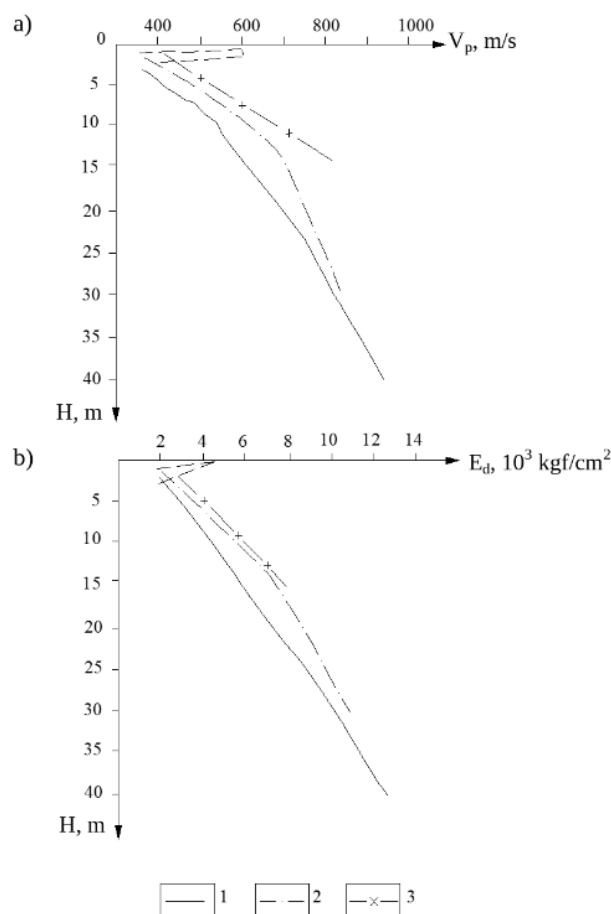
Beneath the crest,  $V_p$  increases from 360 m/s at 2 m to 920 m/s at 40 m. The profile crosses the aeolian sand, the sandy-loam screen and the gravel-rubble soil.  $E_d$  increases from about 190 to 1220 MPa. In the saturated foundation,  $V_p$  rises to 1900 m/s and  $\nu$  to 0.45. This transition lies at 42 m beneath the crest. Beneath the berm, it lies at 31 m. Beneath the downstream loading berm, it lies at 18 m.

In the rock fill (2-10 m),  $V_p$  is 440-680 m/s and  $V_s$  is 240-340 m/s.  $\nu$  is 0.29-0.33. In the sand and gravel-rubble zones,  $\nu$  is lower, 0.22-0.26 (Table 4). At equal depth, velocities and moduli are higher than on the river-bed dam. At 35-40 m,  $V_p$  reaches 870-920 m/s and  $E_d$  1.1-1.2 GPa. The coarser gravel-rubble soils of the ravine dam explain this difference.

Figure 9 - Depth profiles at the ravine dam: (a)  $V_p$ ; (b)  $E_d$  [Author's material]

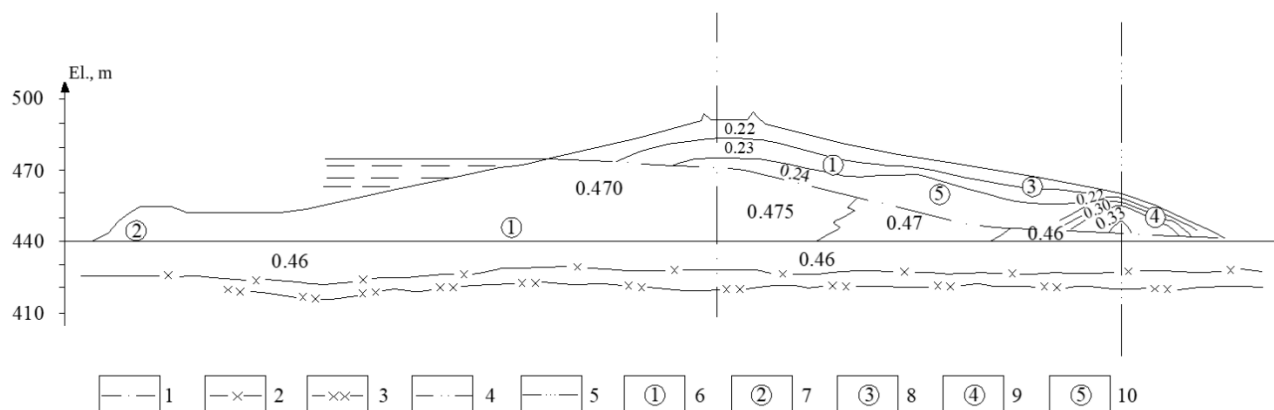
On the river-bed dam,  $v$  is laterally uniform (Fig. 10). Most of the dam body lies below the phreatic surface. Over most of the section,  $v$  is therefore 0.46-0.475. Lower values (0.22-0.24) occur only in the unsaturated zone near the crest. In the rock fill at the downstream toe,  $v$  is 0.30-0.33. The section shows no local anomaly of  $v$ . There is no indication of disturbed fill.

Figure 10 - Distribution of  $v$  across the river-bed dam [Author's material]

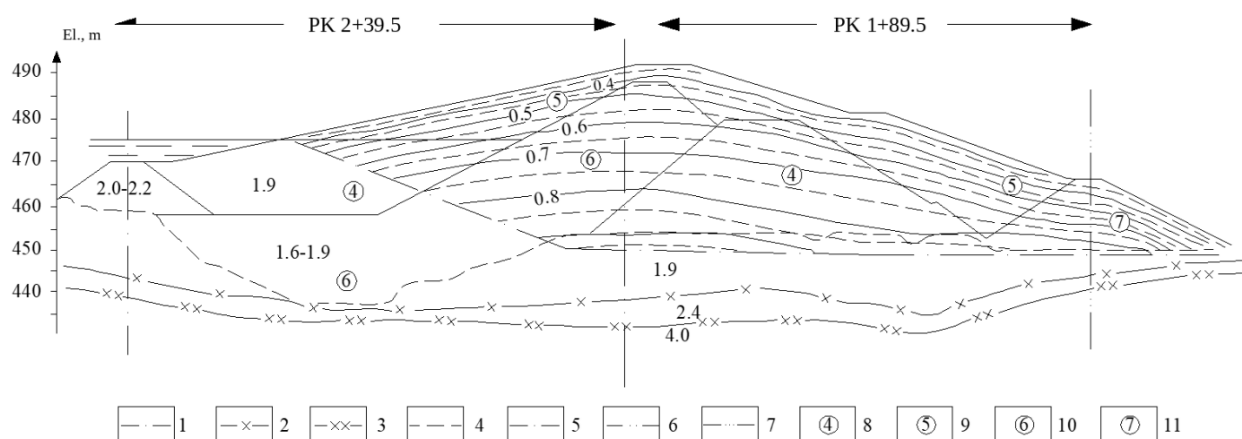
On the ravine dam,  $V_p$  was mapped across Sections PK 2+39.5 and PK 1+89.5 (Fig. 11). In the unsaturated zone,  $V_p$  increases with depth from 0.4 to 0.8 km/s. Below the phreatic surface, it rises to 1.6-2.2 km/s. In the underlying rock, it reaches 2.4-4.0 km/s. The velocity contours follow the dam zoning. They show no local low-velocity zone. The profiles obtained here describe the dam materials. The recorded earthquake response of the dam [16] describes the structure as a whole. Together, these data can be used to calibrate a numerical model of the dam.

**Figure 11** - Distribution of  $V_p$  across the ravine dam [Author's material]

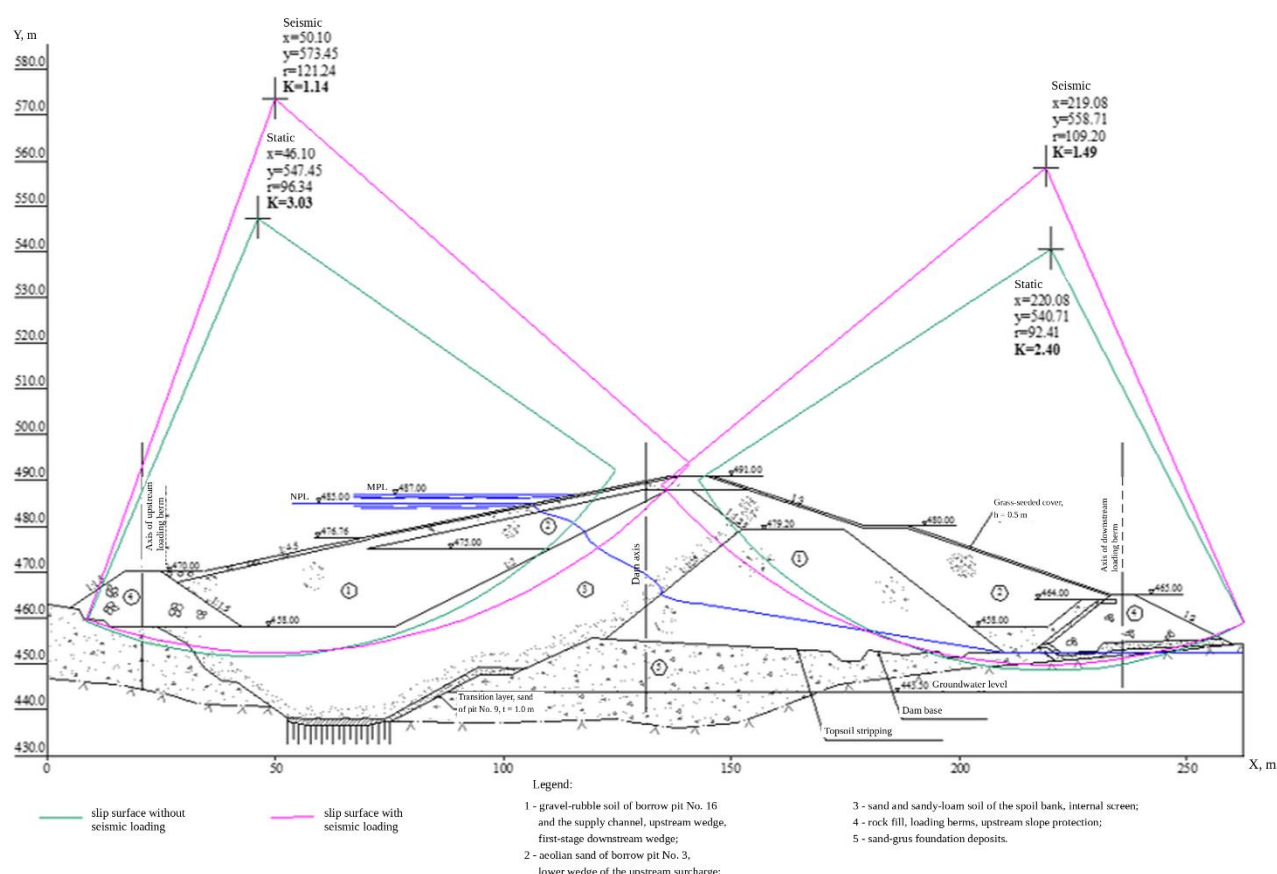
Seismic loading shifts the critical circle. On the ravine dam, the radius increases from 96.3 to 121.2 m upstream. Downstream, it increases from 92.4 to 109.2 m. On the river-bed dam, the radius increases from 99.8 to 111.7 m downstream. Upstream, it decreases from 125.9 to 119.6 m.

The numbered zones are the dam materials. In Fig. 12, zone 1 is gravel-rubble soil of borrow pit No. 16 and the supply channel. Zone 2 is aeolian sand of borrow pit No. 3. Zone 3 is the sandy-loam screen. Zone 4 is the rock fill of the loading berms and upstream slope protection. Zone 5 is the sand-grus foundation. In Fig. 13, zones 1 and 3 are aeolian hydraulic-fill sand of borrow pit No. 3. Zone 6 is the alluvial gravel-sand foundation. Zone 7 is the rock fill of the downstream toe. Zone 8 is the fractured quartz porphyry of the foundation.

**Figure 12** – Slope stability of the ravine dam at seismic intensity 9 [Author's material]

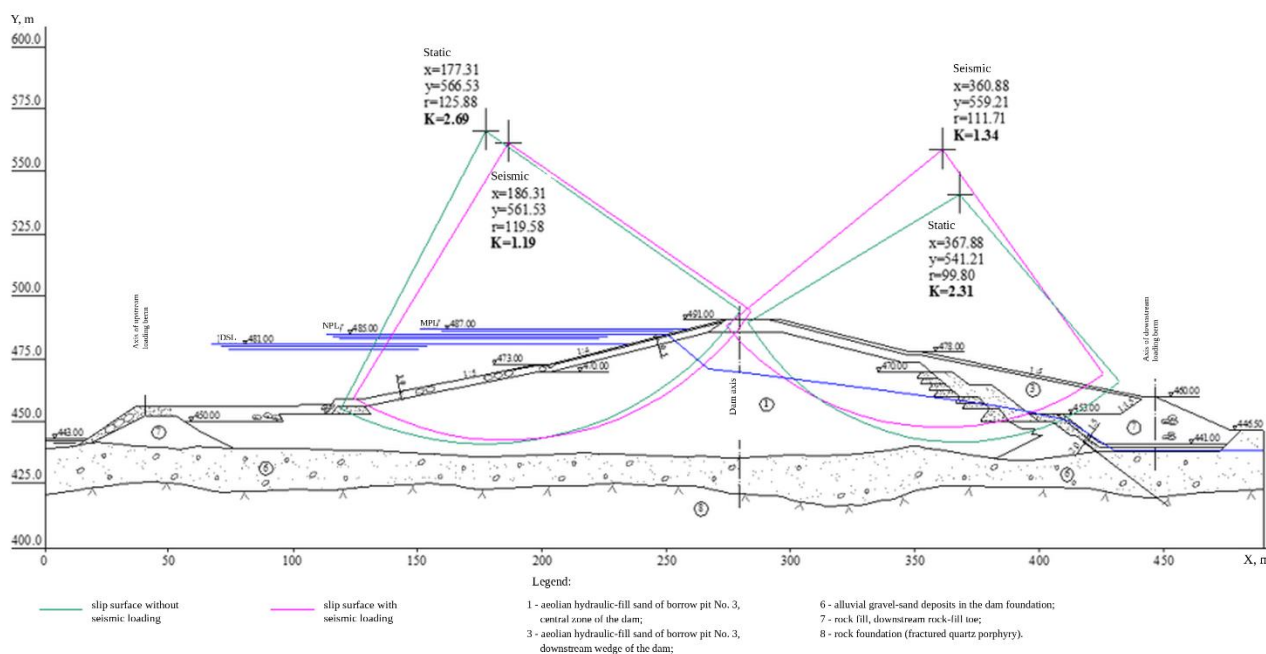
Intensity 9 is the check level. It is one point above the current site intensity. At this level, the upstream slope of the river-bed dam just meets the requirement, with  $K_s = 1.19$  (Fig. 13). The upstream slope of the ravine dam is the governing case (Fig. 12). Its  $K_s$  of 1.14 is 3.4 % below the normative minimum. The pseudo-static method is conservative. A refined dynamic analysis of this slope is nevertheless recommended. The upstream slopes of both dams are the critical elements of the pressure front. They should have priority in monitoring.

Figure 13 – Critical slip surfaces of the river-bed dam at seismic intensity 9 [Author's material]
