## ASSESSMENT OF THE TECHNICAL CONDITION OF A DAM LOCATED IN A SEISMICALLY ACTIVE ZONE

**Abstract.** *The aim of this study is to assess the technical condition of a dam in a seismically active zone of Kazakhstan. The object is the pressure front of the Sh. Chokin Kapchagay hydropower plant. It consists of a 52 m hydraulic-fill river-bed dam, a 56 m gravel-rubble ravine dam with a sandy-loam screen, and a quartz-porphry rock abutment. The dams were designed for intensity 7 (MSK-64), but the site intensity was raised to 8 after the 1988 Spitak earthquake. The materials comprised the dynamic passports of the 2025 survey, settlement records and phreatic curves. The methods included in-situ P and S wave velocity profiling and pseudo-static slope-stability analysis. The seepage regime of both dams is stable. Mean settlement rates are 1.6-2.3 mm/yr for the river-bed dam and 2.06-3.8 mm/yr for the ravine dam, and relative compression does not exceed 0.010 %/yr. Wave velocities and dynamic modulus increase with depth without low-velocity zones. The intensely fractured upper 2 m of the abutment has half the compressive strength of deeper rock. All slopes meet the Class I stability requirem

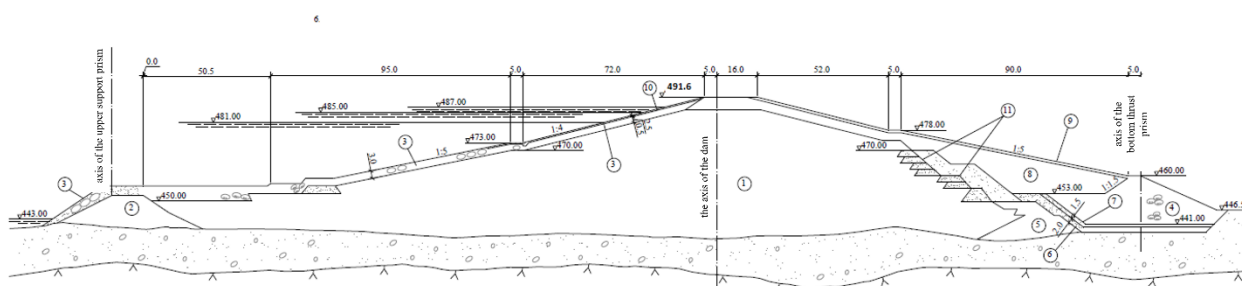
The river-bed dam is a hydraulic-fill earth dam (Fig. 1). It is 52.0 m high and 470 m long. The crest is 21 m wide, at elevation (el.) 491.6 m. The base is 406 m wide. The dam body (zone 1) was hydraulically filled to a height of 49.0 m. It consists of fine-grained, uniform aeolian sand from borrow pit No. 3 ( $k = 2.5\text{--}5.0$  m/day). Construction began in 1965. The dam was accepted into operation in December 1970.

**Figure 1** - Typical cross-section of the river-bed dam (zones 1-11 are described in the text) [Author's material]

The design provides seismic stability through flat slopes, rock-fill surcharges and loading berms. The surcharges are 3 m thick and cover both slopes. The upstream slope is 1:4 above a berm at el. 473.0 m and 1:5 below it. The downstream slope is 1:4 above a 5 m wide berm at el. 478.0 m and 1:5 below it.

The upstream loading berm (zone 2) consists of gravel-rubble soil from borrow pit No. 16 ( $k = 2.5\text{--}5.0$  m/day). Its top is at el. 456.0 m. Rock fill (zone 3;  $k = 200$  m/day) covers the berm and the upstream slope. The downstream loading berm (zone 4) is built of rock fill ( $k = 200$  m/day). Its top is at el. 460.0 m, and its crest is 6 m wide. This berm also serves as a drainage prism. Three transition layers separate it from the dam body:

- zone 5: natural sand-gravel mix from borrow pit No. 9 ( $k = 35$  m/day);
- zone 6: natural sand-gravel mix from the tailrace channel excavation ( $k = 40$  m/day);
- zone 7: crushed stone,  $d = 0.2\text{--}8.0$  mm ( $k = 200$  m/day).

Sand from borrow pit No. 3b (zone 8;  $k = 2.5\text{--}5.0$  m/day) surcharges the downstream slope and the crest. A 0.5 m layer of gravel-rubble soil (zone 9;  $k = 2.5\text{--}5.0$  m/day) protects the downstream slope. Above el. 472.0 m, the upstream slope is faced with monolithic reinforced-concrete slabs (zone 10). The slabs are  $10 \times 10$  m in plan and 0.20–0.30 m thick and rest on a crushed-stone bed. Containment dykes (zone 11) of dry-placed sand from borrow pit No. 3 bound the hydraulic-fill zone.

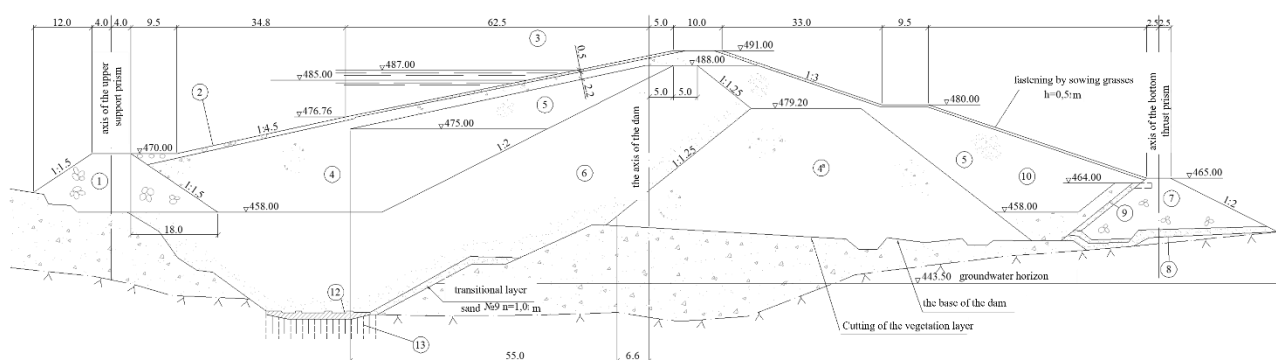
The ravine dam is an earthfill dam with an upstream screen (Fig. 2). Its height is 56.0 m from the base of the screen. The crest is 370 m long and 10 m wide. It lies at el. 491.0 m. The base is 270 m wide.

**Figure 2** - Typical cross-section of the ravine dam (zones 1-13 are described in the text) [Author's material]

The first-stage dam body (zone 4a) consists of soil from the supply-channel excavation ( $k = 2.5-5.0$  m/day). Two upstream wedges enlarge it:

The upstream screen (zone 6) consists of sandy loam and sand from the spoil bank. Its  $k$  is 0.5 m/day, five to ten times lower than that of the dam body. A cut-off key connects the screen to the rock. The key contains a transition layer of sand-gravel mix from borrow pit No. 9 (zone 11;  $k = 35$  m/day). Blanket grouting (zone 13) treats the foundation beneath the key to a depth of 30 m. A concrete cap (zone 12) covers the grouted zone.

Flat slopes and rock-fill loading berms provide seismic stability. The upstream slope is 1:5. The upstream berm (zone 1) and the slope protection (zone 2) are rock fill ( $k = 200$  m/day). Above el. 476.96 m, monolithic reinforced-concrete slabs face the slope (zone 3). The slabs are  $10 \times 10$  m in plan and 0.20 m thick. They rest on a crushed-stone filter. Joints divide the facing into 40 m sections. Below el. 476.96 m, rock fill 1.0 m thick protects the slope.

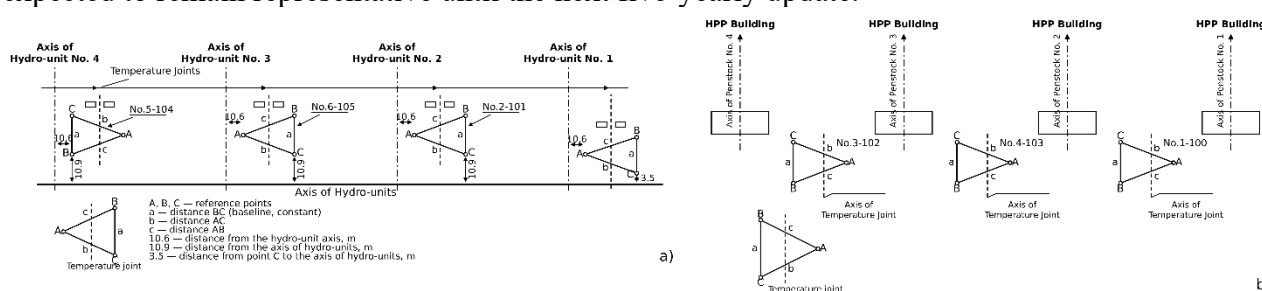
**Figure 3** – Layout of the Radon VB-Shch joint gauges with reference points A, B and C: (a) HPP building, el. 446.0 m; (b) water intake [Author's material]

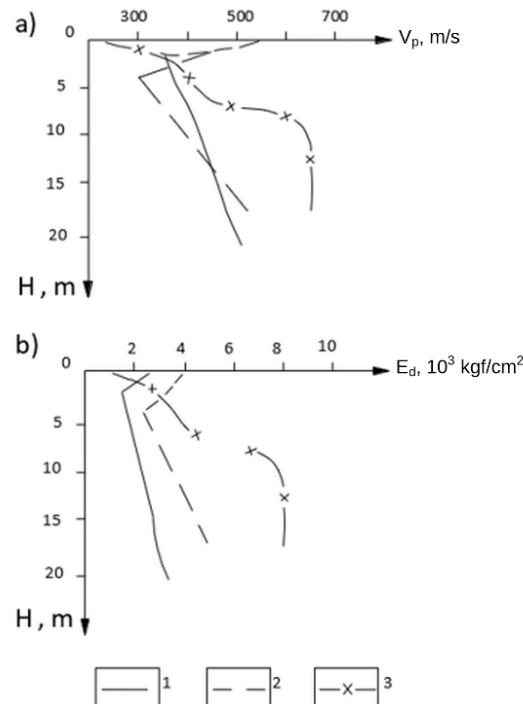
**Figure 8** - Depth profiles at the river-bed dam: (a)  $V_p$ ; (b)  $E_d$  [Author's material]

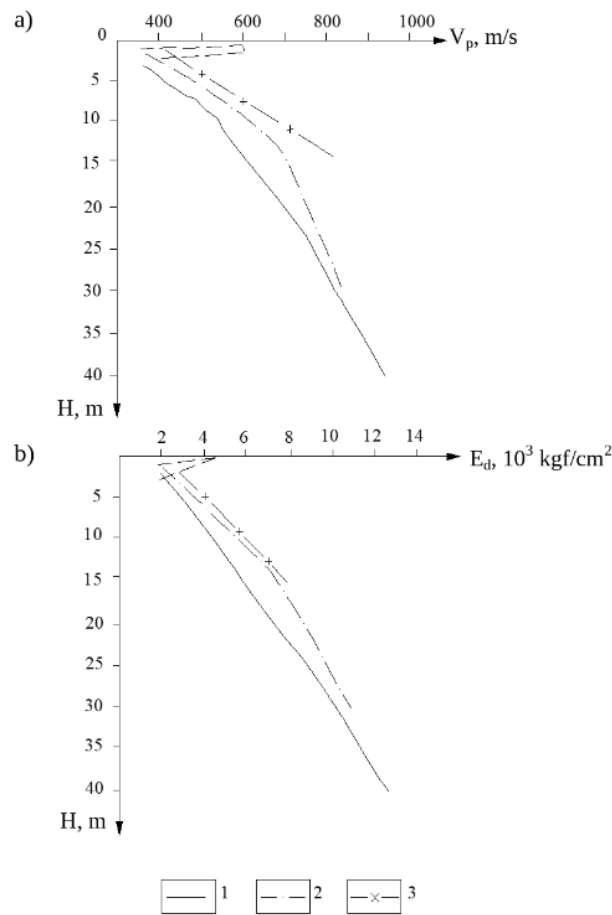
Beneath the crest,  $V_p$  increases from 360 m/s at 2 m to 920 m/s at 40 m. The profile crosses the aeolian sand, the sandy-loam screen and the gravel-rubble soil.  $E_d$  increases from about 190 to 1220 MPa. In the saturated foundation,  $V_p$  rises to 1900 m/s and  $\nu$  to 0.45. This transition lies at 42 m beneath the crest. Beneath the berm, it lies at 31 m. Beneath the downstream loading berm, it lies at 18 m.

In the rock fill (2-10 m),  $V_p$  is 440-680 m/s and  $V_s$  is 240-340 m/s.  $\nu$  is 0.29-0.33. In the sand and gravel-rubble zones,  $\nu$  is lower, 0.22-0.26 (Table 4). At equal depth, velocities and moduli are higher than on the river-bed dam. At 35-40 m,  $V_p$  reaches 870-920 m/s and  $E_d$  1.1-1.2 GPa. The coarser gravel-rubble soils of the ravine dam explain this difference.

Figure 9 - Depth profiles at the ravine dam: (a)  $V_p$ ; (b)  $E_d$  [Author's material]

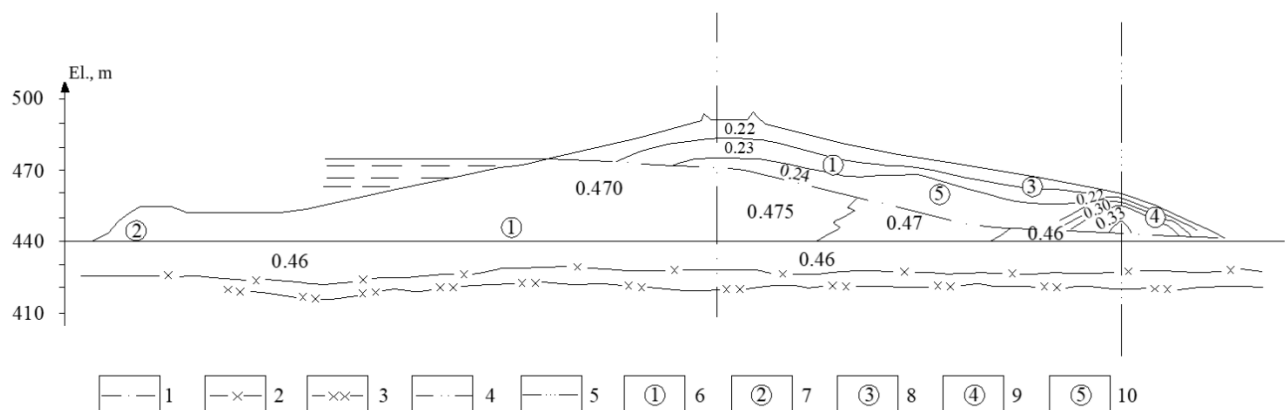
The sections across the dams confirm these trends. Figs. 10 and 11 show the phreatic surface, the bedrock surface and the surface of sound rock. They also show the dam axis and the loading-berm axes. Fig. 11 also shows the base of the dam. The numbered zones are the dam materials. In Fig. 10, zone 1 is hydraulic-fill aeolian sand. Zones 2 and 5 are gravel-rubble soil. Zone 3 is aeolian fill sand. Zone 4 is rock fill. In Fig. 11, zone 4 is gravel-rubble soil. Zone 5 is aeolian sand. Zone 6 is sandy loam and sand. Zone 7 is rock fill.

On the river-bed dam,  $v$  is laterally uniform (Fig. 10). Most of the dam body lies below the phreatic surface. Over most of the section,  $v$  is therefore 0.46-0.475. Lower values (0.22-0.24) occur only in the unsaturated zone near the crest. In the rock fill at the downstream toe,  $v$  is 0.30-0.33. The section shows no local anomaly of  $v$ . There is no indication of disturbed fill.

Figure 10 - Distribution of  $v$  across the river-bed dam [Author's material]

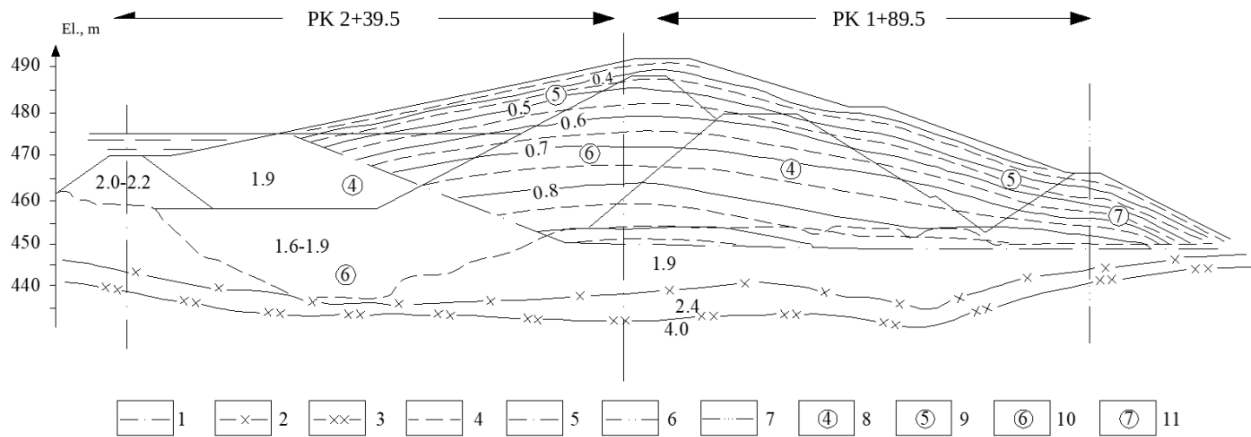
On the ravine dam,  $V_p$  was mapped across Sections PK 2+39.5 and PK 1+89.5 (Fig. 11). In the unsaturated zone,  $V_p$  increases with depth from 0.4 to 0.8 km/s. Below the phreatic surface, it rises to 1.6-2.2 km/s. In the underlying rock, it reaches 2.4-4.0 km/s. The velocity contours follow the dam zoning. They show no local low-velocity zone. The profiles obtained here describe the dam materials. The recorded earthquake response of the dam [16] describes the structure as a whole. Together, these data can be used to calibrate a numerical model of the dam.

**Figure 11** - Distribution of  $V_p$  across the ravine dam [Author's material]
